**VERIDIAN REMOTE REDESIGNED AIR BAG INJURY  
INVESTIGATION  
SCI TECHNICAL SUMMARY REPORT**

**NASS CDS CASE NO. 1998-11-110E**

**VEHICLE - 1998 MERCURY SABLE**

**CRASH DATE - JUNE, 1998**

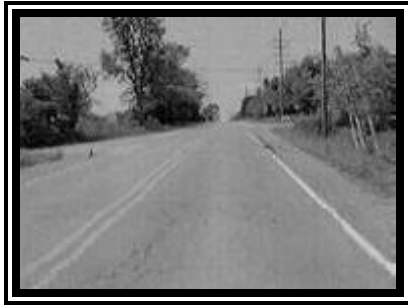
The 19 year old female driver of the 1998 Mercury Sable was operating the vehicle southbound (**Figure 1**) when she slowed in anticipation of the left turn (east) onto the rural connector. The driver reported to police that she became distracted by a stationary westbound vehicle as she initiated the left

**Figure 1. Southbound approach for the 1998 Mercury Sable.**

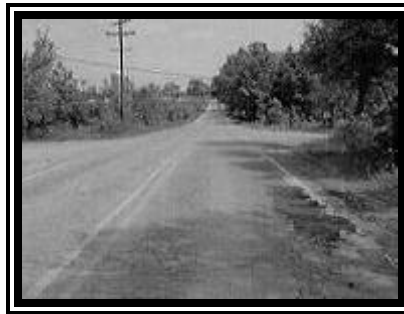
turn. The 51 year old male driver of the 1997 Ford Taurus was operating the vehicle northbound (**Figure 2**) and proceeding straight when he observed the southbound Mercury cross his path of travel. Upon recognition of the impending harmful event, the driver steered right in avoidance.

**Figure 2. Northbound approach for the 1997 Ford Taurus.**

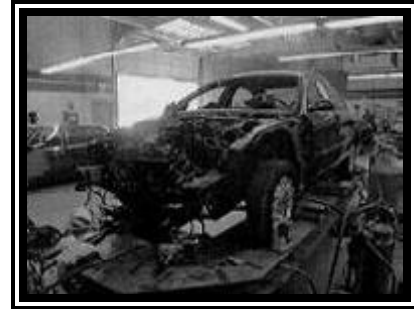
The 1998 Mercury Sable sustained moderate frontal damage as a result of the impact with the Ford Taurus. The direct contact damage and associated crush profile could not be obtained as the vehicle was under repair at the time of inspection (**Figure 3**). Reduction in the right side wheelbase measured 4.0 cm (1.6 in). The windshield was fractured from (exterior) impact forces and the (interior) front right air bag module cover flap. All tempered glazing remained intact.

**Figure 3. Dismantled 1998 Mercury Sable.**

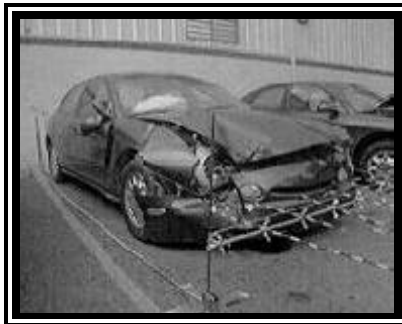
**Figure 4. Overlapping frontal damage to the 1997 Ford Taurus.**

The 1997 Ford Taurus also sustained moderate frontal damage as a result of the impact with the Mercury Sable (**Figure 4**). The direct contact damage relating to this initial impact could not be identified due to masking by the subsequent tree impacts, however, paint transfers were noted along the front bumper. The hood was deformed up and rearward from engagement against the tree. The right fender was deformed rearward. Reduction in the right side wheelbase measured 3.0 cm (1.2 in).

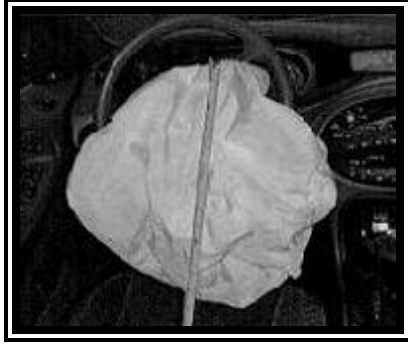
The 1998 Mercury Sable was equipped with redesigned frontal air bags for the driver and front right passenger positions (**Figures 5 & 6**). The air bags had deployed as a result of the crash. The driver air bag was housed in the center of the steering wheel with a horizontally oriented flap tear seam (H-configuration). No contact evidence was identified on the air bag or exterior surface of the module cover flaps. The flaps were asymmetrical in shape. The bag was tethered by two internal straps and vented by two ports located at the 11 o'clock and 1 o'clock sectors on the rear aspect of the air bag.

Figure 5. 1998 Mercury Sable redesigned driver air bag.

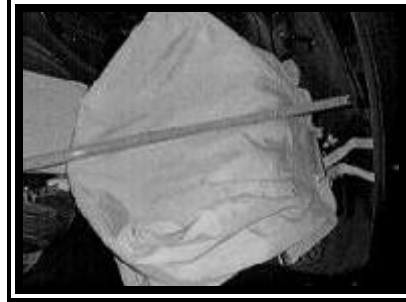
The front right passenger air bag deployed from the right top instrument panel area with a single cover flap design hinged at the forward aspect. No contact evidence was identified on the air bag or exterior surface of the module cover flap. The cover flap was rectangular in shape. The bag was tethered by one internal strap. No vent ports or cutoff switch were reported for the front right passenger air bag.

Figure 6. 1998 Mercury Sable redesigned passenger air bag.

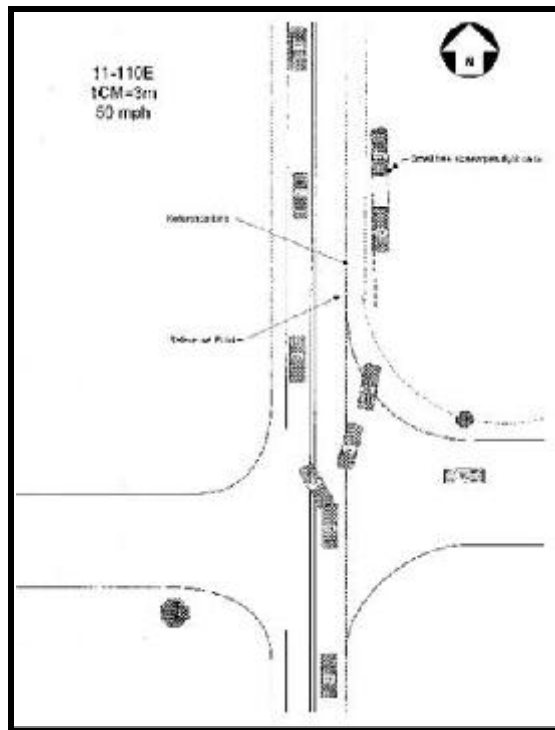
Figure 7. NASS Scene Diagram.

This two vehicle crash occurred during the early evening hours of June, 1998. At the time of the crash, it was daylight with no adverse conditions as the roads were dry. The crash occurred at a rural/straight 4-leg intersection which had a positive grade for southbound traffic (see **Figure 7 - page 5**). The asphalt roadways were bordered by narrow paved shoulders with a wooded area approximately 3.0 meters (9.8 feet) to the east. The posted speed limit at the crash site was 80 km/h (50 mph) with east/westbound traffic controlled by stop signs.

As the Mercury Sable crossed the northbound lane of the 4-leg urban intersection, the front right area impacted the front left area of the Ford Taurus resulting in moderate damage to both vehicles. Although the impact-induced deceleration was sufficient to deploy the Mercury's redesigned frontal air bag system, WinSMASH computed velocity changes could not be generated due to the repair status of the Mercury and masking damage profile of the opposing Ford. At this point, the Ford was re-directed in a northeasterly direction and departed the roadway where the right side surface and frontal area struck two trees (respectively) resulting in moderate damage. The Mercury Sable rotated counterclockwise and came to rest in the intersection facing northeast as the Ford Taurus came to rest approximately 36.0 meters (118.1 feet) north of the intersection (against the trees) also facing northeast.
