**REDESIGNED AIR BAG SPECIAL STUDY (RABSS)  
SCI TECHNICAL SUMMARY REPORT**

**NASS RABSS CASE NO. 1998-11-805G**

**RABSS VEHICLE - 1998 FORD ESCORT ZX2**

**CRASH DATE - JULY, 1998**

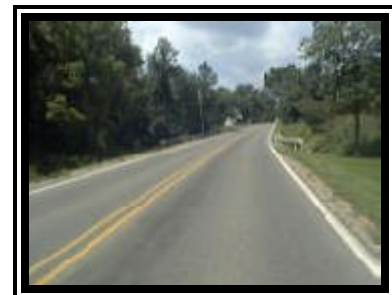
The 23 year old female driver of the 1998 Ford Escort was operating the vehicle westbound and negotiating a right curve (**Figure 1**) when she apparently had fallen asleep and allowed the vehicle to depart the left (south) pavement edge in a forward tracking mode.

**Figure 1. Westbound approach for the 1998 Ford Escort ZX2.**

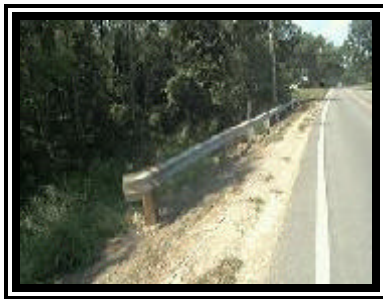
As the Ford exited the south pavement edge of the rural two lane roadway, it encountered a steep embankment which pitched the front end slightly downward. The right windshield/header area struck the end section of a W-beam guardrail (**Figure 2**) resulting in moderate damage. Although coded as unknown in the NASS case file, the Collision Deformation Classification (CDC) for this initial impact to the Ford Escort was 12-FZGW-7. The guardrail penetrated the passenger compartment prior to separation as the vehicle continued down the embankment in a slight clockwise rotation. The Ford traveled approximately 11.0 meters (36.1 feet) into a wooded area as the front left area impacted a large diameter tree (**Figure 3**) resulting in moderate damage. This was the first significant structural contact, therefore, the air bag system probably deployed at this time, late in the crash sequence. The impact induced deceleration was sufficient to deploy the Ford's redesigned frontal air bag system. The damage algorithm of the WinSMASH program computed a (barrier equivalent) velocity change of 33.1 km/h (20.6 mph). The specific longitudinal component was -32.6 km/h (-20.3 mph). The CDC for this second and final impact to the Ford Escort was 12-FYEN-3. At this point, the Ford rotated counterclockwise approximately 20 degrees and came to rest in close proximity to the tree facing southwest.

Figure 2. Guardrail impact area (end section replaced).

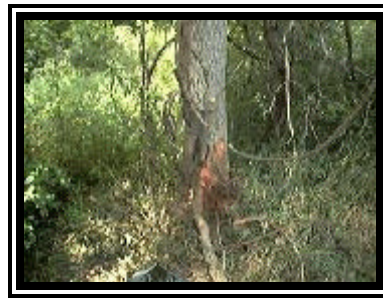
Figure 3. Impacted tree.

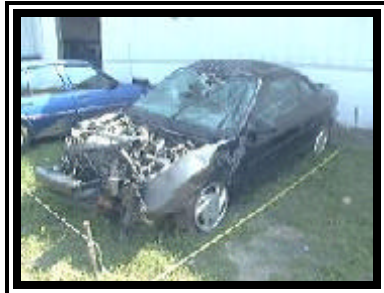
The 1998 Ford Escort ZX2 sustained moderate frontal damage as a result of the impact with the tree (**Figures 4 & 5**). The direct contact damage began 33.0 cm (13.0 in) to the left of the front left bumper corner and extended 33.0 cm (13.0 in) inboard. The impact deformed the full frontal width resulting in a combined direct and induced damage length (Field L) of 112.0 cm (44.1 in). Six crush measurements were documented at the level of the reinforcement bar (bumper cover separation): C1= 19.0 cm (7.5 in), C2= 42.0 cm (16.5 in), C3= 48.0 cm (18.9 in), C4= 22.0 cm (8.7 in), C5= 9.0 cm (3.5 in), C6= 2.0 cm (0.8 in). The hood and grille assembly separated from the vehicle during the crash sequence. Both fenders were deformed which restricted/deflated the front wheels/tires. The windshield was holed and fractured from the guardrail impact with minimal penetration noted into the passenger compartment. The windshield header and surrounding roof area was deformed with the backlight glazing disintegrated. Reduction in the left side wheelbase measured 10.0 cm (3.9 in).

**Figure 4. Frontal damage to the 1998 Ford Escort ZX2.**

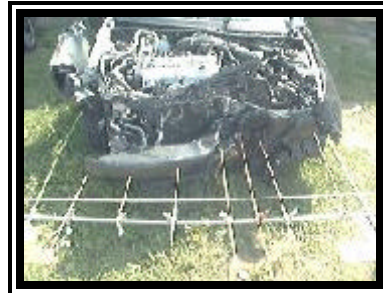
**Figure 5. Crush depth.**

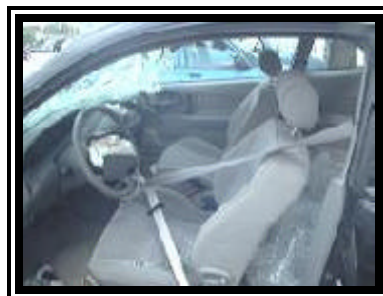
Interior damage to the Ford Escort identified through the NASS vehicle inspection was minimal and was attributed to occupant contact (**Figure 6**). A scuff mark was documented to the left knee bolster (rigid plastic type). Intrusions into the passenger compartment included 2.0 cm (0.8 in) of vertical header intrusion, 10.0 cm (3.9 in) of longitudinal windshield intrusion and 10.0 cm (3.9 in) of longitudinal exterior object (guardrail) intrusion. No deformation was noted to the steering wheel hub/rim (tilt column placed between the full up and center position).

**Figure 6. Interior view.**

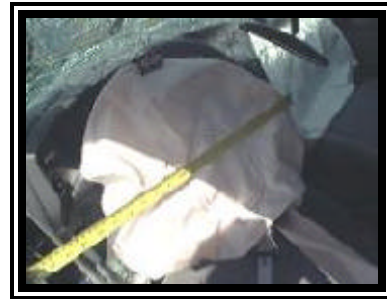
The 1998 Ford Escort ZX2 was equipped with redesigned frontal air bags for the driver and front right passenger positions. The air bags had deployed as a result of the crash. The driver air bag was housed in the center of the steering wheel with a horizontally oriented flap tear seam (H-configuration). No contact evidence was identified on the air bag or exterior surface of the module cover flaps. The flaps were asymmetrical in shape as the upper flap measured 22.0 cm (8.7 in) in width and 11.0 cm (4.3 in) in height while the lower flap measured 22.0 cm (8.7 in) in width along the upper portion, 14.0 cm (5.5 in) along the lower portion and 9.0 cm (3.5 in) in height. The NASS researcher measured the diameter of the driver air bag at 44.0 cm (17.3 in) in its deflated state (**Figure 7**). The bag was tethered by two internal straps and vented by two ports located at the 11 o'clock and 1 o'clock sectors on the rear aspect of the air bag.

**Figure 7. 1998 Ford Escort ZX2 redesigned driver air bag.**

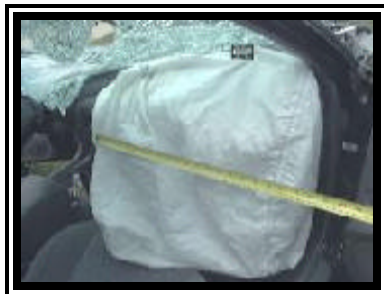
**Figure 8. 1998 Ford Escort ZX2 redesigned passenger air bag.**

The front right passenger air bag deployed from the right mid-instrument panel area with a single cover flap design hinged at the top aspect. The cover flap was rectangular in shape and measured 33.0 cm (13.0 in) in width and 19.0 cm (7.5 in) in height. Although no contact evidence was identified on the exterior surface of the module cover flap, blood spattering was documented to the (rear) upper right quadrant of the air bag. The NASS researcher measured the passenger air bag at 60.0 cm (23.6 in) in width and 70.0 cm (27.6 in) in height in its deflated state (**Figure 8**). No internal tether straps were present. The bag was vented by two ports located at the 10 o'clock and 2 o'clock sectors on the side aspect of the air bag. No cutoff switch was reported for the front right redesigned passenger air bag.

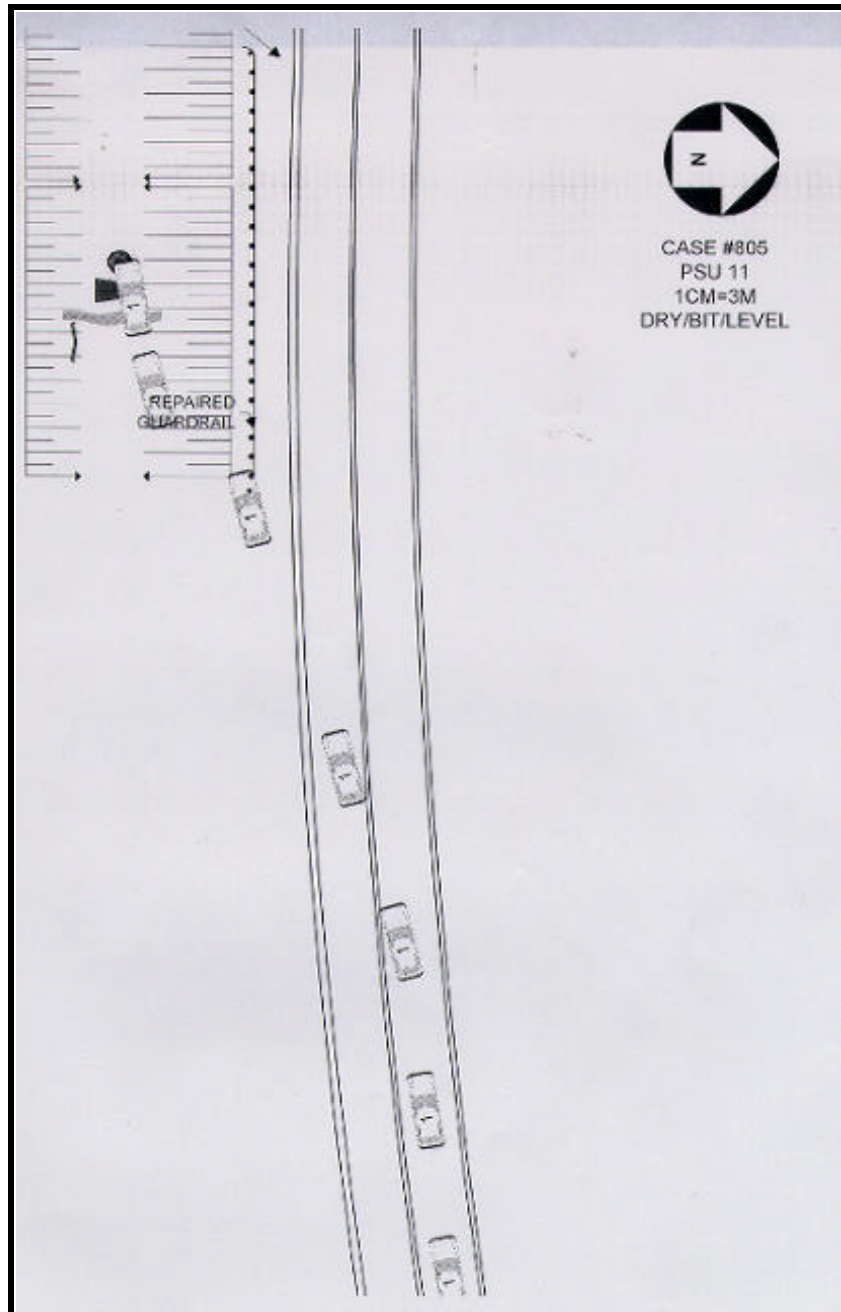
Figure 9. NASS Scene Diagram.

This single vehicle crash occurred during the early morning hours of July, 1998. At the time of the crash, it was dark (street not lighted) with no adverse conditions as the roads were dry. The crash occurred off the south pavement edge of a level two lane east/west asphalt roadway (see **Figure 9 - page 5**) which curved right for westbound traffic. No traffic control was present at the scene which had a posted speed limit of 89 km/h (55 mph). The roadside environment featured a W-beam guardrail and a steep embankment to the south.
