**REDESIGNED AIR BAG SPECIAL STUDY (RABSS)
SCI TECHNICAL SUMMARY REPORT**

NASS RABSS CASE NO. 1998-11-807G

RABSS VEHICLE - 1998 FORD ESCORT SE

CRASH DATE - AUGUST, 1998

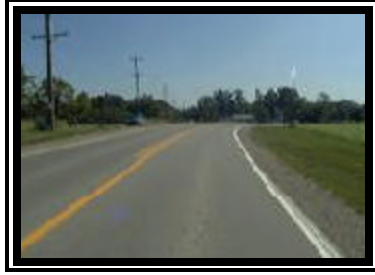
Figure 1. Southbound approach for the 1998 Ford Escort SE.

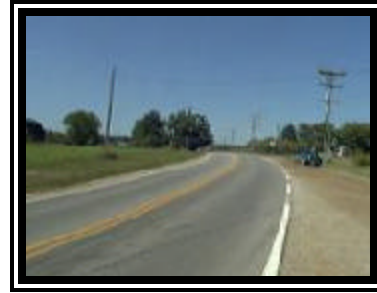
Figure 2. Northbound approach for the 1993 Chevrolet C-1500 pickup truck.

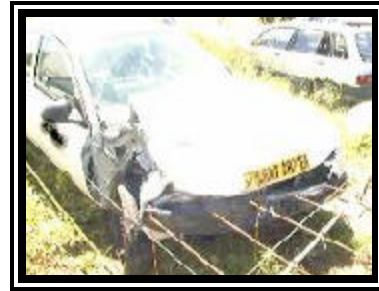
The 1998 Ford Escort SE sustained moderate frontal damage as a result of the impact with the Chevrolet pickup (**Figure 3**). The direct contact damage began at the front right bumper corner and extended 90.0 cm (35.4 in) inboard. The impact deformed the full frontal width resulting in a combined direct and induced damage length (Field L) of 125.0 cm (49.2 in). Six crush measurements were documented at the level of the reinforcement bar (*bumper fascia separation*): C1= 0 cm, C2= 11.0 cm (4.3 in), C3= 24.0 cm (9.4 in), C4= 38.0 cm (15.0 in), C5= 40.0 cm (15.7 in), C6= 45.0 cm (17.7 in). The Collision Deformation Classification (CDC) for this impact to the Ford was 01-FDEW-2 with a principal direction of force of (+)20 degrees. The grille and right headlight assembly fractured and separated from the vehicle during the collision sequence. The right fender was displaced rearward which restricted/deflated the right front wheel/tire. The hood was displaced up and rearward from the impact force. Induced buckling was noted to the roof area at the right B-pillar. Reduction in the right side wheelbase measured 7.0 cm (2.8 in). The windshield was fractured from (exterior) impact forces and the (interior) front right air bag module cover flap .

Figure 3. Front right damage to the 1998 Ford Escort SE (image washed out).

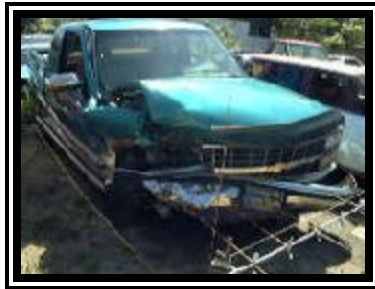
Figure 4. Front right damage to the 1993 Chevrolet C-1500 pickup truck.

The 1993 Chevrolet C-1500 pickup truck sustained moderate frontal damage as a result of the impact with the Ford Escort (**Figure 4**). The direct contact damage began at the front right bumper corner and extended 52.0 cm (20.5 in) inboard. The impact deformed the full frontal width resulting in a combined direct and induced damage length (Field L) of 128.0 cm (50.4 in). The CDC for this impact to the Chevrolet was 01-FREW-4 with a principal direction of force of (+)30 degrees. The hood was deformed up and rearward from the impact force. The right fender was deformed rearward which restricted/deflated the right front wheel/tire. Induced buckling was noted to the roof area at the right B-pillar along with outward bowing of the right door frame. Reduction in the right side wheelbase measured 34.0 cm (13.4 in).

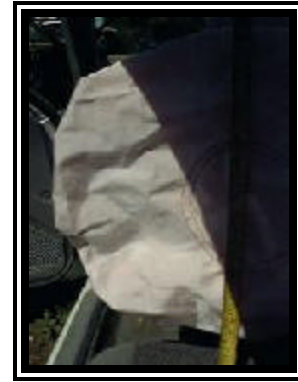
passenger positions. The air bags had deployed as a result of the crash. The driver air bag was housed in the center of the steering wheel with a horizontally oriented flap tear seam (H-configuration). No contact evidence was identified on the air bag or exterior surface of the module cover flaps. The flaps were asymmetrical in shape as the upper flap measured 20.0 cm (7.9 in) in width and 7.0 cm (2.8 in) in height while the lower flap measured 20.0 cm (7.9 in) in width and 10.0 cm (3.9 in) in height. The NASS researcher measured the diameter of the driver air bag at 44.0 cm (17.3 in) in its deflated state (**Figure 5**). The bag was tethered by two internal straps and vented by two ports located at the 11 o'clock and 1 o'clock sectors on the rear aspect of the air bag.

Figure 5. 1998 Ford Escort SE redesigned driver air bag.

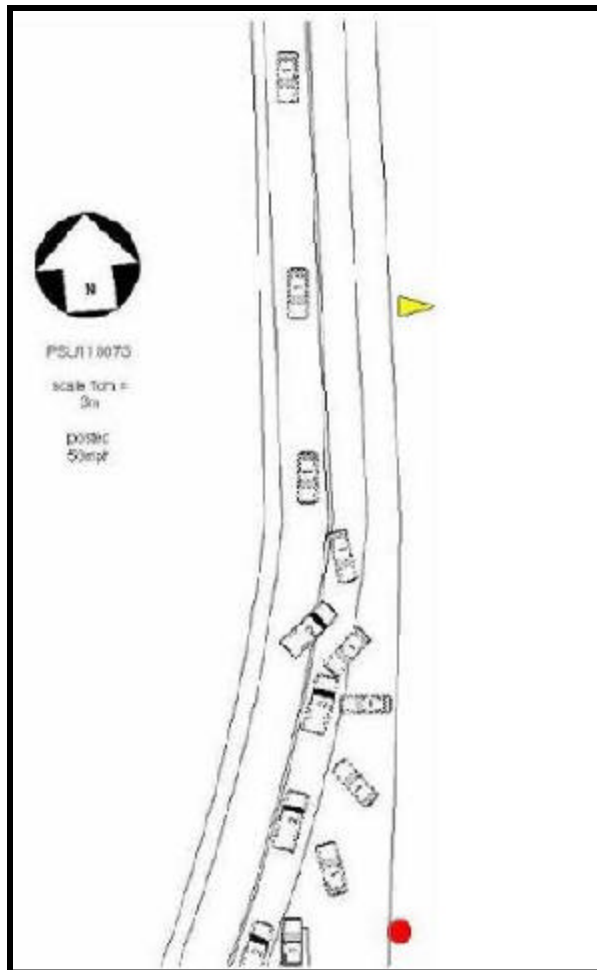
This two vehicle crash occurred during the afternoon hours of August, 1998. At the time of the crash, it was daylight with no adverse conditions as the roads were dry. The crash occurred in the northbound lane of a 2-lane (level/asphalt) rural roadway (**see Figure 6 - page 5**) which curved right for southbound traffic. No traffic control was present at the scene which had a posted speed limit of 80 km/h (50 mph).

Figure 6. NASS Scene Diagram (physical plant and impact configuration plotted incorrectly by researcher).
