**REDESIGNED AIR BAG SPECIAL STUDY (RABSS)
SCI TECHNICAL SUMMARY REPORT**

NASS RABSS CASE NO. 1998-11-808G

RABSS VEHICLE - 1998 FORD ESCORT ZX2

CRASH DATE - AUGUST, 1998

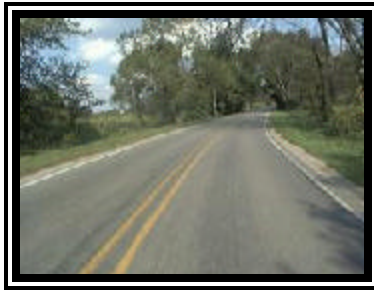
The 22 year old male driver of the 1998 Ford Escort was operating the vehicle eastbound and negotiating a right curve (**Figure 1**) at a (driver reported) speed of 121 km/h (75 mph) when he allowed the vehicle to cross the centerline and depart the left (north) pavement edge (**Figure 2**). The driver steered right/braked in an attempt to regain control as the vehicle continued alongside the shoulder in a northeasterly direction approximately 27.0 meters (88.6 feet) prior to the collision.

Figure 1. Eastbound approach for the 1998 Ford Escort ZX2.

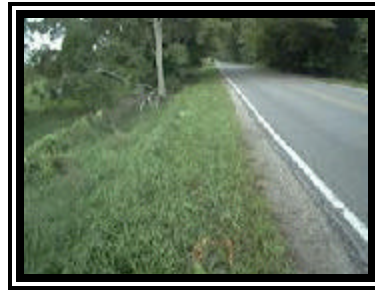
Figure 2. Eastbound approach off the north pavement edge.

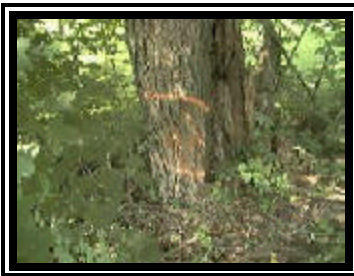
As the Ford Escort entered the wooded area alongside the north shoulder, the front left area impacted a 45.0 cm (17.7 in) diameter tree (**Figure 3**) resulting in moderate damage. The WinSMASH damage algorithm computed a (barrier equivalent) velocity change of 34.4 km/h (21.4 mph) with a longitudinal component of -33.9 km/h (-21.1 mph). The impact induced deceleration was sufficient to deploy the Ford's redesigned frontal air bag system. At this point, the vehicle rotated counterclockwise and continued its post-impact trajectory in a northeasterly direction approximately 55.0 meters (180.5 feet) across a private yard (**Figures 4 & 5**) as the right side wheels dug into the soft soil. This tripping mechanism initiated a 4-quarter turn right side rollover resulting in moderate top damage. The Ford came to rest (upright) facing northwest.

Figure 3. North view of impacted tree.

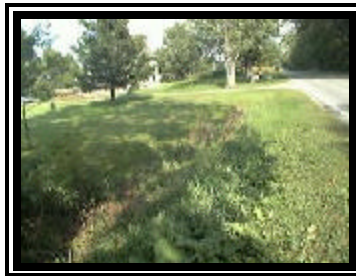
Figure 4. Post-impact trajectory northeast into rollover area.

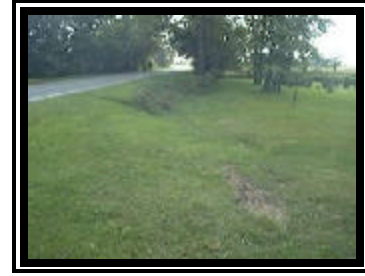
Figure 5. Lookback view from final rest (southwest) showing rollover furrowing to the soft soil.

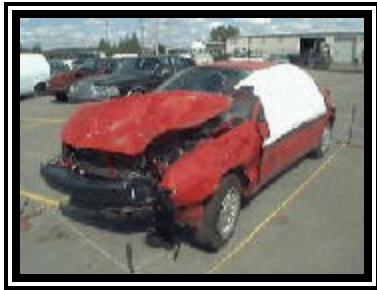
The 1998 Ford Escort ZX2 sustained moderate frontal damage as a result of the impact with the tree (**Figure 6**). The direct contact damage began 4.0 cm (1.6 in) to the right of the front left bumper corner and extended 45.0 cm (17.7 in) inboard. The impact deformed the full frontal width resulting in a combined direct and induced damage length (Field L) of 130.0 cm (51.2 in). Six crush measurements were documented at the level of the reinforcement bar (*bumper fascia separation*): C1= 36.0 cm (14.2 in), C2= 53.0 cm (20.9 in), C3= 33.0 cm (13.0 in), C4= 17.0 cm (6.7 in), C5= 6.0 cm (2.4 in), C6= 3.0 cm (1.2 in). The Collision Deformation Classification (CDC) for this initial impact to the Ford was 12-FLEW-3 with a principal direction of force of (-)10 degrees. The left fender was displaced rearward which restricted the left front wheel/tire (not deflated) and jammed the left door. The hood was displaced up and rearward from engagement against the tree. Reduction in the left side wheelbase measured 2.0 cm (0.8 in). The windshield was fractured along with disintegrated left front/rear tempered glazing.

Figure 6. Front left damage to the 1998 Ford Escort ZX2.

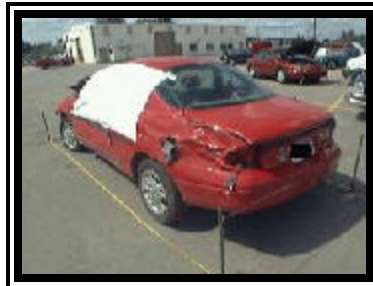
Direct contact damage was also identified to the top and side surfaces of the Ford attributed to the rollover (**Figure 7**). The tripping mechanism deformed the right front wheel and deflated the right rear tire (not restricted). Mud/dirt was also embedded in the right side wheels/rims and forward door seam. A maximum crush value of 6.0 cm (2.4 in) was approximated along the left windshield header/roof side rail area. *Although assigned to the left side surface in the NASS case file, the correct CDC for this non-horizontal impact is 00-TDDO-3 (non-horizontal impacts are assigned based on plane of greatest crush, not greatest contact).*

Figure 7. Left side and top rollover damage.

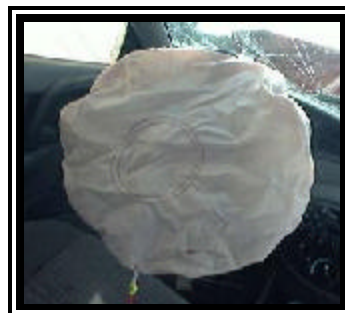
The 1998 Ford Escort ZX2 was equipped with redesigned frontal air bags for the driver and front right passenger positions. The air bags had deployed as a result of the crash. The driver air bag was housed in the center of the steering wheel with a horizontally oriented flap tear seam (H-configuration). The flaps were nearly symmetrical in shape as the upper flap measured 22.0 cm (8.7 in) in width and 9.0 cm (3.5 in) in height while the lower flap measured 22.0 cm (8.7 in) in width and 11.0 cm (4.3 in) in height. Although no contact evidence was identified on the exterior surface of the module cover flaps, blood spattering was noted to the upper left quadrant of the air bag.

The NASS researcher measured the diameter of the driver air bag at 46.0 cm (18.1 in) in its deflated state (**Figure 9**). The bag was tethered by two internal straps and vented by two ports located at the 11 o'clock and 1 o'clock sectors on the rear aspect of the air bag.

Figure 9. 1998 Ford Escort ZX2 redesigned driver air bag.

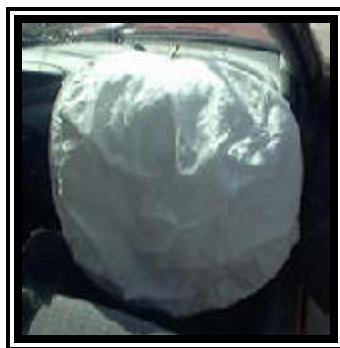
Figure 10. 1998 Ford Escort ZX2 redesigned passenger air bag.

The front right passenger air bag deployed from the right mid-instrument panel area with a single cover flap design hinged at the top aspect. No contact evidence was identified on the air bag or exterior surface of the module cover flap. The cover flap was rectangular in shape and measured 33.0 cm (13.0 in) in width and 21.0 cm (8.3 in) in height. The NASS researcher measured the passenger air bag at 70.0 cm (27.6 in) in width and 65.0 cm (25.6 in) in height in its deflated state (**Figure 10**). No internal tether straps were present. The bag was vented by two ports located at the 10 o'clock and 2 o'clock sectors on the side aspect of the air bag. Black vinyl transfers were noted to the lower (centered) section of the air bag from expansion within the module. No cutoff switch was reported for the front right air bag.
