**REDESIGNED AIR BAG SPECIAL STUDY (RABSS)  
SCI TECHNICAL SUMMARY REPORT**

**NASS RABSS CASE NO. 1998-11-809E**

**RABSS VEHICLE - 1998 DODGE STRATUS**

**CRASH DATE - SEPTEMBER, 1998**

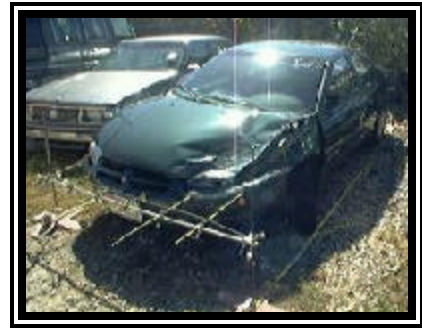
The 1998 Dodge Stratus sustained moderate frontal damage as a result of the impact with the Mercury Tracer (**Figure 3**). The direct contact damage began at the front left bumper corner and extended 62.0 cm (24.4 in) inboard. The impact deformed the full frontal width resulting in a combined direct and induced damage length (Field L) of 148.0 cm (58.3 in). Six crush measurements were documented at the level of the bumper: C1= 7.0 cm (2.8 in), C2= 6.0 cm (2.4 in), C3= 2.0 cm (0.8 in), C4= 2.0 cm (0.8 in), C5= 4.0 cm (1.6 in), C6= 5.0 cm (2.0 in).

The Collision Deformation Classification (CDC) for this impact to the Dodge was 12-FYEW-1 with a principal direction of force of 0 degrees. Direct contact damage was documented to the hood and left fender areas (left front wheel deflated not restricted) attributed to the trunk hatch and right quarter panel of the Mercury. Reduction in the left side wheelbase measured 18.0 cm (7.1 in). All glazing remained undamaged.

**Figure 3. Front left damage to the 1998 Dodge Stratus.**

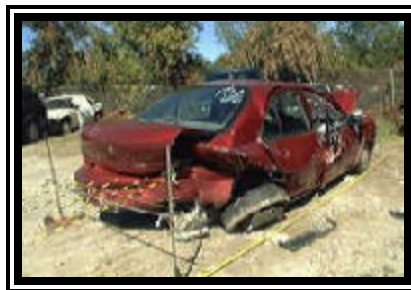
The 1998 Mercury Tracer sustained moderate rear damage as a result of the impact with the Dodge Stratus (**Figure 4**). The direct contact damage began at the rear right bumper corner and extended 91.0 cm (35.8 in) inboard. The impact deformed the full end width resulting in a combined direct and induced damage length (Field L) of 107.0 cm (42.1 in). A maximum crush value of 43.0 cm (16.9 in) was documented at the C6 position. The Collision Deformation Classification (CDC) for this impact to the Mercury was 06-BZEW-4 with a principal direction of force of 180 degrees. The right quarter panel was deformed forward which restricted/deflated the right rear wheel/tire. The trunk hatch was displaced up and rearward from the impact force. Induced buckling was noted to the roof area at the right B and C-pillars. Reduction in the right side wheelbase measured 11.0 cm (4.3 in). Direct contact damage was also noted to the front right area attributed to the secondary impact (**Figure 5**). Post-crash extrication damage was identified at the right front door. The windshield was fractured from (exterior) impact forces and the (interior) front right air bag module cover flap.

**Figure 4. Rear right damage to the 1998 Mercury Tracer LS.**

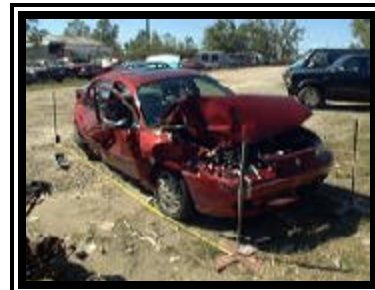
**Figure 5. Front right damage to the 1998 Mercury Tracer LS.**

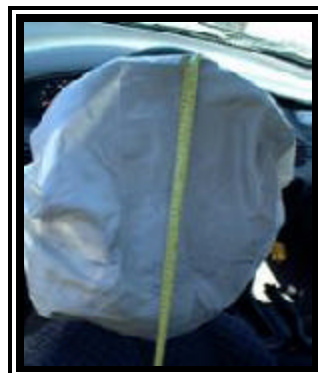
The 1998 Dodge Stratus was equipped with redesigned frontal air bags for the driver and front right passenger positions. The air bags had deployed as a result of the crash. The driver air bag was housed in the center of the steering wheel with a horizontally oriented flap tear seam (H-configuration). No contact evidence was identified on the air bag or exterior surface of the module cover flaps. The flaps were asymmetrical in shape as the upper flap measured 23.0 cm (9.1 in) in width and 10.0 cm (3.9 in) in height while the lower flap measured 23.0 cm (9.1 in) in width and 6.8 cm (2.7 in) in height. Multiple black vinyl transfers were noted to the upper left quadrant of the air bag face from expansion within the module. The NASS researcher measured the diameter of the driver air bag at 52.0 cm (20.5 in) in its deflated state (**Figure 6**). The bag was tethered by two internal straps (vent ports unknown).

**Figure 6. 1998 Dodge Stratus redesigned driver air bag.**

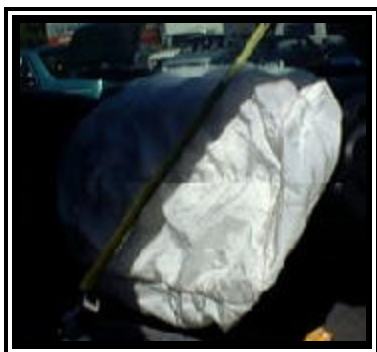
The front right passenger air bag deployed from the right top instrument panel area with a single cover flap design hinged at the forward aspect. No contact evidence was identified on the air bag or exterior surface of the module cover flap. The cover flap was rectangular in shape and measured 39.0 cm (15.4 in) in width and 22.0 cm (8.7 in) in height. The NASS researcher measured the passenger air bag at 38.0 cm (15.0 in) in width and 48.0 cm (18.9 in) in height in its deflated state (**Figure 7**). The bag was tethered by two internal straps. No vent ports were present. No cutoff switch was found for the front right air bag. The right mid-instrument panel area fractured from the air bag deployment (**Figure 8**).

**Figure 7. 1998 Dodge Stratus redesigned passenger air bag.**

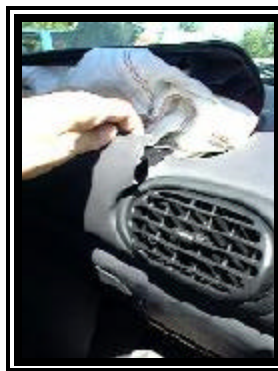
**Figure 8. Damage to the right instrument panel from the passenger air bag deployment.**
