**REDESIGNED AIR BAG SPECIAL STUDY (RABSS)  
SCI TECHNICAL SUMMARY REPORT**

**NASS RABSS CASE NO. 1998-11-811G**

**RABSS VEHICLE - 1998 JEEP CHEROKEE SPORT**

**CRASH DATE - OCTOBER, 1998**

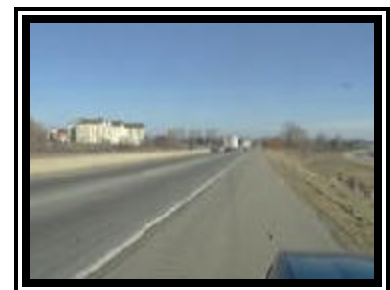
The 21 year old female driver of the 1998 Jeep Cherokee was operating the vehicle eastbound (**Figure 1**) on the inboard lane at a (driver reported) speed of 105 km/h (65 mph) when she failed to notice traffic slowing ahead. Upon recognition of the impending harmful event, she steered left/braked and entered the median divider in a counterclockwise rotation.

**Figure 1. East view showing environment and vehicle approach.**

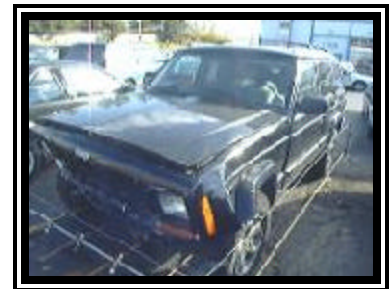
The 1998 Jeep Cherokee sustained moderate frontal damage as a result of the impact with the concrete barrier (**Figure 2**). The direct contact damage encompassed the full frontal width resulting in a combined direct and induced damage length (Field L) of 140.0 cm (55.1 in). Six crush measurements were documented at the level of the bumper: C1= 11.0 cm (4.3 in), C2= 12.0 cm (4.7 in), C3= 14.0 cm (5.5 in), C4= 19.0 cm (7.5 in), C5= 19.0 cm (7.5 in), C6= 27.0 cm (10.6 in). The left fender was deformed (no wheels restricted or deflated) with minor hood displacement noted. Direct contact damage was also documented to the right rear area attributed to the second barrier impact. This direct damage began at the right rear bumper corner and extended forward 20.0 cm (7.9 in) with no sheet metal crush noted. All glazing was undamaged. No reduction in the wheelbase was identified.

**Figure 2. Frontal damage to the 1998 Jeep Cherokee.**

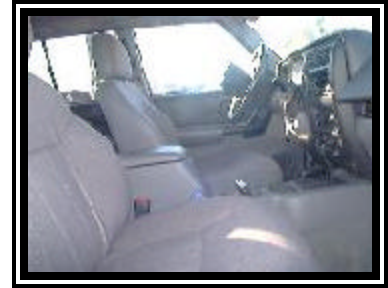
There was no damage to the interior surfaces of the Jeep Cherokee from intrusions or occupant contact (**Figure 3**).

**Figure 3. Interior view of the 1998 Jeep Cherokee.**

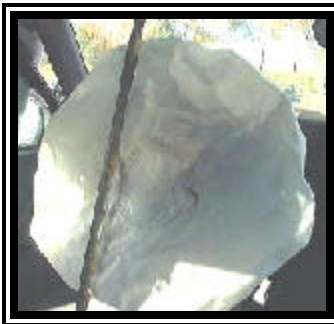
The 1998 Jeep Cherokee was equipped with redesigned frontal air bags for the driver and front right passenger positions. The air bags had deployed as a result of the crash. The driver air bag was housed in the center of the steering wheel with a single cover flap design hinged at the top aspect. The flap was rectangular in shape and measured 16.0 cm (6.3 in) in width and 13.0 cm (5.1 in) in height. Although no contact evidence was identified on the exterior surface of the module cover flap, several transfers were identified on the face of the air bag. Eye makeup was documented to the right upper quadrant of the air bag along with lipstick transfers to the lower right quadrant (**Figure 5**). In addition, base makeup transfers were documented to the upper and lower sections of the air bag. The NASS researcher measured the diameter of the driver air bag at 54.0 cm (21.3 in) in its deflated state (**Figure 4**). The bag was tethered by four internal straps. No vent ports were present.

**Figure 4. 1998 Jeep Cherokee redesigned driver air bag.**

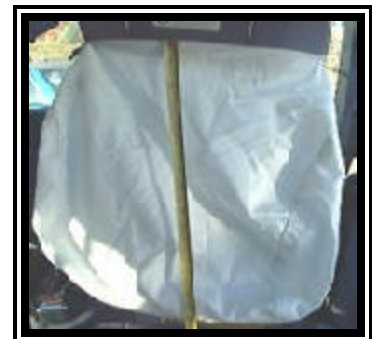
The front right passenger air bag deployed from the right mid-instrument panel area with a single cover flap design hinged at the top aspect. No contact evidence was identified on the air bag or exterior surface of the module cover flap. The cover flap was rectangular in shape and measured 38.0 cm (15.0 in) in width and 16.0 cm (6.3 in) in height. The NASS researcher measured the passenger air bag at 50.0 cm (19.7 in) in width and 56.0 cm (22.0 in) in height in its deflated state (**Figure 6**). No internal tether straps or vent ports were present. No cutoff switch was reported for the front right redesigned passenger air bag.

**Figure 6. 1998 Jeep Cherokee redesigned passenger air bag.**

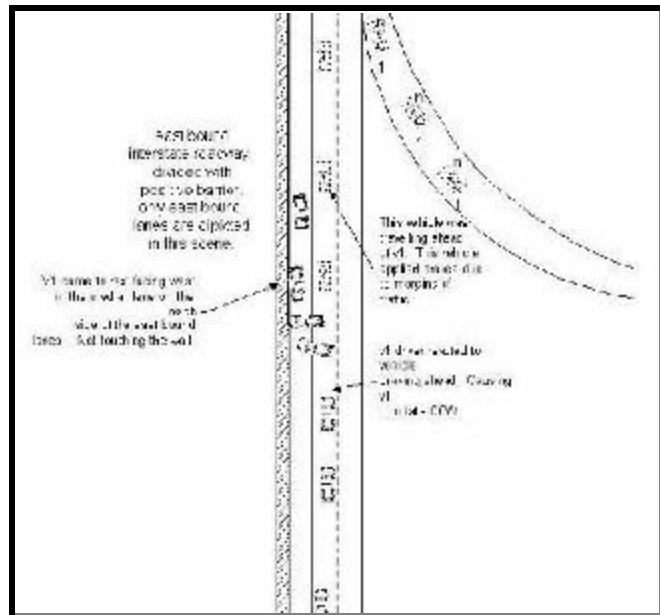
**Figure 7. NASS Scene Diagram.**

This single vehicle crash occurred during the afternoon hours of October, 1998. At the time of the crash, it was daylight with no adverse conditions as the roads were dry. The crash occurred in the median area of a straight and level 4-lane east/west highway (see **Figure 7 - page 4**). The asphalt roadway was bordered by paved shoulders and divided by a concrete (jersey) barrier. No traffic control was present at the scene which had a posted speed limit of 113 km/h (70 mph).
