**REDESIGNED AIR BAG SPECIAL STUDY (RABSS)
SCI TECHNICAL SUMMARY REPORT**

NASS RABSS CASE NO. 1998-11-814E

RABSS VEHICLE - 1998 CHEVROLET CAVALIER

CRASH DATE - NOVEMBER, 1998

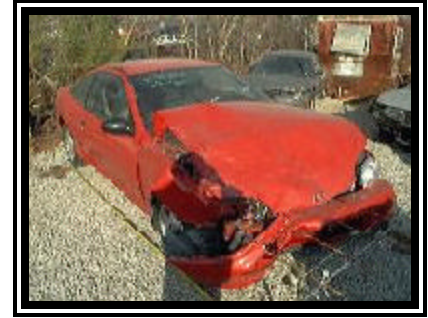
The 1998 Chevrolet Cavalier sustained moderate frontal damage as a result of the impact with the Ford Aerostar (**Figure 3**). The direct contact damage began at the front right bumper corner and extended 88.0 cm (34.6 in) inboard. The impact deformed the full frontal width resulting in a combined direct and induced damage length (Field L) of 131.0 cm (51.6 in). Six crush measurements were documented at the level of the bumper: C1= 4.0 cm (1.6 in), C2= 8.0 cm (3.1 in), C3= 12.0 cm (4.7 in), C4= 16.0 cm (6.3 in), C5= 34.0 cm (13.4 in), C6= 24.0 cm (9.4 in). The Collision Deformation Classification (CDC) for this impact to the Chevrolet was 12-FZEW-2 with a principal direction of force of (-)10 degrees. An indentation was noted to the right portion of the bumper attributed to the front right bumper corner of the Ford. The grille and right headlight assembly fractured and separated from the vehicle during the collision sequence. The right fender was displaced rearward which restricted the right front wheel/tire (not deflated). The hood was deformed up and rearward from the impact force. Induced buckling was noted to the roof area at the right A-pillar. Reduction in the right and left side wheelbase measured 8.0 cm (3.1 in). The windshield was fractured from (exterior) impact forces and the (interior) front right air bag module cover flap. All tempered glazing remained undamaged.

Figure 3. Front right damage to the 1998 Chevrolet Cavalier 2-door coupe.

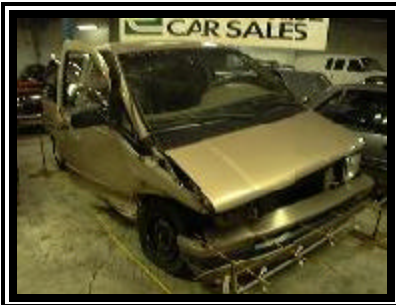
Figure 4. Front right damage to the 1992 Ford Aerostar minivan.

The 1992 Ford Aerostar minivan sustained moderate frontal damage as a result of the impact with the Chevrolet Cavalier (**Figure 4**). The direct contact damage began at the front right bumper corner and extended 36.0 cm (14.2 in) inboard. The impact deformed the full end width resulting in a combined direct and induced damage length (Field L) of 163.0 cm (64.2 in). The CDC for this impact to the Ford was 01-FREE-3 with a principal direction of force of (+)20 degrees. The grille and right headlight assembly fractured and separated from the vehicle during the crash sequence. Additional direct contact damage was noted to the right fender area from sustained contact between the vehicles during

spinout. This damage pattern deformed the fender rearward and to the left which restricted/deflated the right front wheel/tire. Reduction in the right side wheelbase measured 28.0 cm (11.0 in).

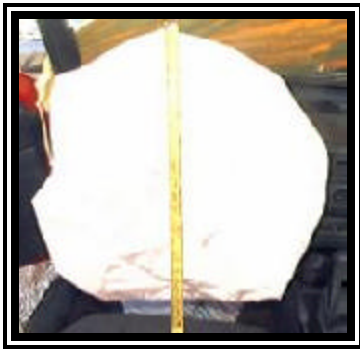
The 1998 Chevrolet Cavalier was equipped with redesigned frontal air bags for the driver and front right passenger positions. The air bags had deployed as a result of the crash. The driver air bag was housed in the center of the steering wheel with a vertically oriented flap tear seam (I-configuration). The flaps were symmetrical in shape and measured 8.0 cm (3.1 in) in width and 12.0 cm (4.7 in) in height. Although no contact evidence was identified on the exterior surface of the module cover flaps, a lipstick transfer was documented at the upper left quadrant of the air bag face (**Figure 6**). The NASS researcher measured the diameter of the driver air bag at 56.0 cm (22.0 in) in its deflated state (**Figure 5**). No internal tether straps were present. The bag was vented by two ports located at the 9 o'clock and 3 o'clock sectors on the rear aspect of the air bag.

Figure 5. 1998 Chevrolet Cavalier redesigned driver air bag.

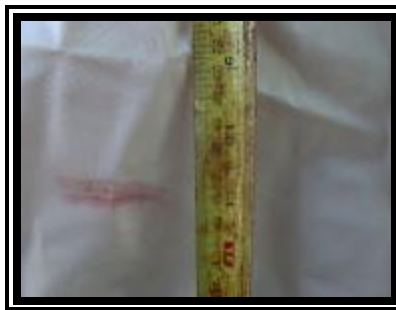
Figure 6. Lipstick transfer to the driver redesigned air bag.

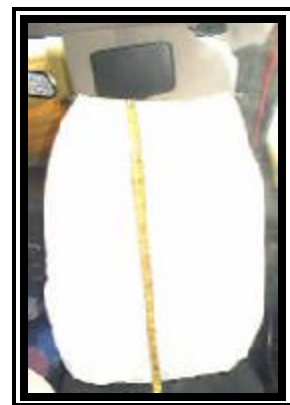
The front right passenger air bag deployed from the right top instrument panel area with a single cover flap design hinged at the forward aspect. No contact evidence was identified on the air bag or exterior surface of the module cover flap. The cover flap was rectangular in shape and measured 31.0 cm (12.2 in) in width and 12.0 cm (4.7 in) in height. The NASS researcher measured the passenger air bag at 46.0 cm (18.1 in) in width and 66.0 cm (26.0 in) in height in its deflated state (**Figure 7**). No vent ports or internal tether straps were present. No cutoff switch was found for the front right air bag.

Figure 7. 1998 Chevrolet Cavalier redesigned passenger air bag.
