**REDESIGNED AIR BAG SPECIAL STUDY (RABSS)
SCI TECHNICAL SUMMARY REPORT**

NASS CDS CASE NO. 1998-12-150E

RABSS VEHICLE - 1998 BUICK LESABRE LIMITED

CRASH DATE - AUGUST, 1998

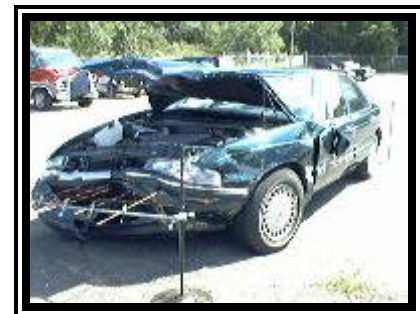
The 1998 Buick LeSabre sustained moderate frontal damage as a result of the impact with the Dodge van (**Figure 3**). The direct contact damage began at the front left bumper corner and extended 98.0 cm (38.6 in) inboard. The impact deformed the full frontal width resulting in a combined direct and induced damage length (Field L) of 130.0 cm (51.2 in). Six crush measurements were documented at the level of the reinforcement bar (*partial bumper fascia separation*): C1= 21.0 cm (8.3 in), C2= 27.0 cm

Figure 3. Frontal damage to the 1998 Buick LeSabre Limited.

(10.6 in), C3= 37.0 cm (14.6 in), C4= 31.0 cm (12.2 in), C5= 24.0 cm (9.4 in), C6= 16.0 cm (6.3 in). The (*SCI revised*) Collision Deformation Classification (CDC) for this impact to the Buick was 71-FDEW-2 with a principal direction of force of (-)40 degrees (principal direction of force incremented to reflect end shifting to the right). The end structure shifted approximately 14.0 cm (5.5 in) to the right. The grille assembly fractured and separated from the vehicle during the collision sequence. The fenders were displaced rearward which restricted the right front wheel/tire (not deflated). The hood was deformed up and rearward from engagement against the side surface of the Dodge. Reduction in the right side wheelbase measured 7.0 cm (2.8 in). The windshield was fractured from exterior impact forces (only) as all tempered glazing remained undamaged.

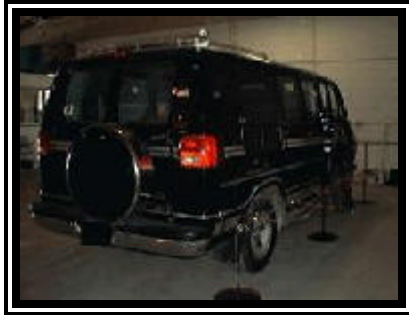
Figure 4. Right front side surface damage to the 1997 Dodge B250 van.

The 1997 Dodge B250 van sustained moderate right front side surface damage as a result of the impact with the Buick LeSabre (**Figure 4**). The direct contact damage began 56.0 cm (22.0 in) forward of the right front axle and extended 157.0 cm (61.8 in) rearward. The combined direct and induced damage length (Field L) began 59.0 cm (23.2 in) forward of the right front axle and extended 381.0 cm (150.0 in) rearward. A maximum crush value of 15.0 cm (5.9 in) was documented just rearward of the front axle. The (*SCI revised*) CDC for this impact to the Dodge was 02-RYEW-2 with a principal direction of force of (+)50 degrees. The right fender was deformed laterally to the left with minor outward bowing of the upper right front window frame noted (tempered glazing disintegrated).

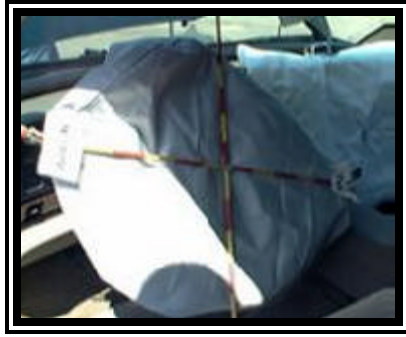
The 1998 Buick LeSabre was equipped with redesigned frontal air bags for the driver and front right passenger positions. The air bags had deployed as a result of the crash. The driver air bag was housed in the center of the steering wheel with a vertically oriented flap tear seam (I-configuration). The flaps were symmetrical and rectangular in shape. Although no contact evidence was identified on the exterior surface of the module cover flaps, skin tissue transfers were documented along the center portion and upper left quadrant of the air bag face. The NASS researcher measured the diameter of the driver air bag at 60.0 cm (23.6 in) in its deflated state (**Figure 5**). No internal tether straps were present. The bag was vented by two ports located at the 9 o'clock and 3 o'clock sectors on the rear aspect of the air bag.

Figure 5. 1998 Buick LeSabre redesigned driver air bag.

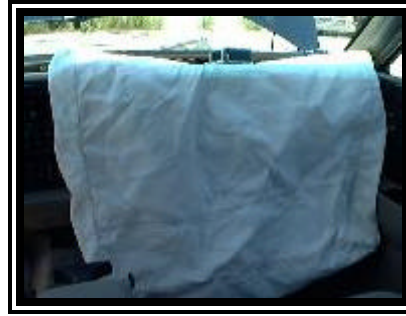
The front right passenger air bag deployed from the right mid-instrument panel area with a single cover flap design rectangular in shape and hinged at the top aspect. No contact evidence was identified on the air bag or exterior surface of the module cover flap. The NASS researcher measured the passenger air bag at 68.0 cm (26.8 in) in width and 53.0 cm (20.9 in) in height in its deflated state (**Figure 6**). No internal tether straps were present. The bag was vented by two ports located at the 9 o'clock and 3 o'clock sectors on the side aspect of the air bag. No cutoff switch was found for the front right air bag.

Figure 6. 1998 Buick LeSabre redesigned passenger air bag.
