**REDESIGNED AIR BAG SPECIAL STUDY (RABSS)  
SCI TECHNICAL SUMMARY REPORT**

**NASS CDS CASE NO. 1998-12-182K**

**RABSS VEHICLE - 1998 FORD ESCORT LX**

**CRASH DATE - SEPTEMBER, 1998**

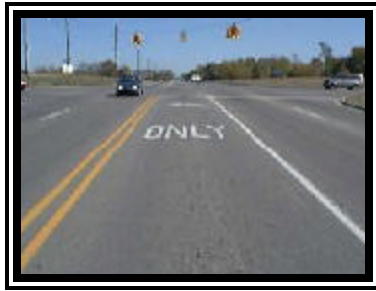
**Figure 1. Eastbound approach trajectory for the 1998 Ford Escort LX.**

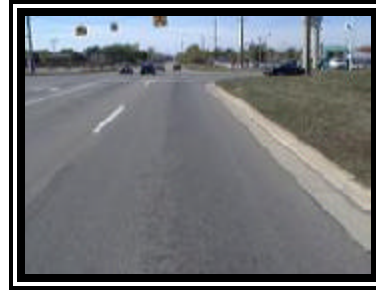
**Figure 2. Westbound approach trajectory for the 1989 Buick Park Avenue (wrong lane photographed by the NASS researcher).**

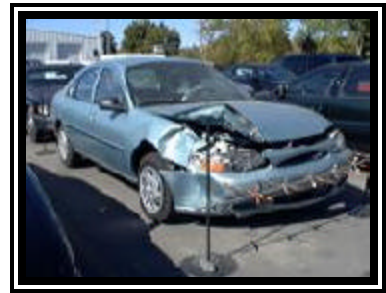
The 1998 Ford Escort LX sustained moderate frontal damage as a result of the impact with the Buick Park Avenue (**Figure 3**). Although coded as a full frontal impact in the NASS case file, the (SCI revised) direct contact damage began at the front right bumper corner and extended 32.0 cm (12.6 in) inboard. The impact deformed the full frontal width resulting in a combined direct and induced damage length (Field L) of 132.0 cm (52.0 in). Six crush measurements were documented at the level of the bumper: C1= 0 cm, C2= 0 cm, C3= 0 cm, C4= 2.0 cm (0.8 in), C5= 6.0 cm (2.4 in), C6= 10.0 cm (3.9 in). The Collision Deformation Classification (CDC)

for this impact to the Ford was 01-FREE-2 with a principal direction of force of (+)20 degrees. The right hood area was deformed with direct contact damage noted to the right fender from sustained contact between the vehicle during spinout. The windshield was fractured from exterior impact forces and the (interior) front right passenger air bag.

**Figure 3. Front right damage to the 1998 Ford Escort LX.**

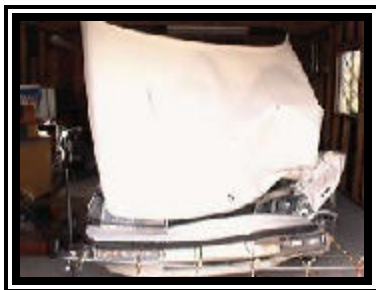
**Figure 4. Front left damage to the 1989 Buick Park Avenue.**

The 1989 Buick Park Avenue sustained moderate frontal damage as a result of the impact with the Ford Escort (**Figure 4**). The (SCI revised) direct contact damage began at the front left bumper corner and extended 60.0 cm (23.6 in) inboard. The impact deformed the full frontal width resulting in a combined direct and induced damage length (Field L) of 150.0 cm (59.1 in). The CDC for this impact to the Buick was 12-FYEW-2 with a principal direction of force of (-)10 degrees. The left fender was deformed rearward which restricted the left front wheel/tire (not deflated). Minor displacement of the hood was also noted. Reduction in the

left side wheelbase measured 5.0 cm (2.0 in).

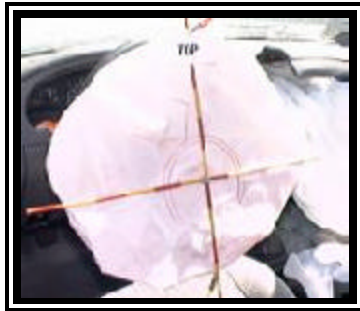
The 1998 Ford Escort LX was equipped with redesigned frontal air bags for the driver and front right passenger positions. The air bags had deployed as a result of the crash. The driver air bag was housed in the center of the steering wheel with a horizontally oriented flap tear seam (H-configuration). The flaps were asymmetrical in shape as the upper flap measured 22.0 cm (8.7 in) in width and 6.0 cm (2.4 in) in height while the lower flap measured 22.0 cm (8.7 in) in width and 10.0 cm (3.9 in) in height. Although no contact evidence was identified on the exterior surface of the module cover flaps, red nail polish was documented to the upper left quadrant of the air bag. The NASS researcher measured the diameter of the driver air bag at

40.0 cm (15.7 in) in its deflated state (**Figure 5**). The bag was tethered by two internal straps and vented by two ports located at the 11 o'clock and 1 o'clock sectors on the rear aspect of the air bag.

**Figure 5. 1998 Ford Escort LX redesigned driver air bag.**

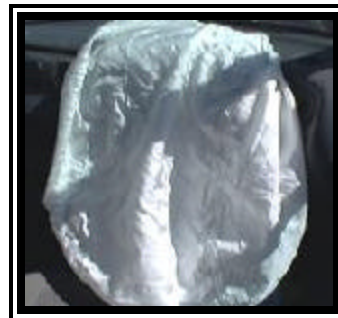
The front right passenger air bag deployed from the right mid-instrument panel area with a single cover flap design hinged at the top aspect. No contact evidence was identified on the exterior surface of the module cover flap. The cover flap was rectangular in shape and measured 32.0 cm (12.6 in) in width and 25.0 cm (9.8 in) in height. A small scuff mark was documented to the upper right quadrant of the air bag. The NASS researcher measured the passenger air bag at 40.0 cm (15.7 in) in width and 80.0 cm (31.5 in) in height in its deflated state (**Figure 6**). The bag was tethered by two internal tether straps and vented by two ports located at the 10 o'clock and 2 o'clock sectors on the side aspect of the air bag. No cutoff switch was documented for the front right passenger air bag.

**Figure 6. 1998 Ford Escort LX redesigned passenger air bag.**

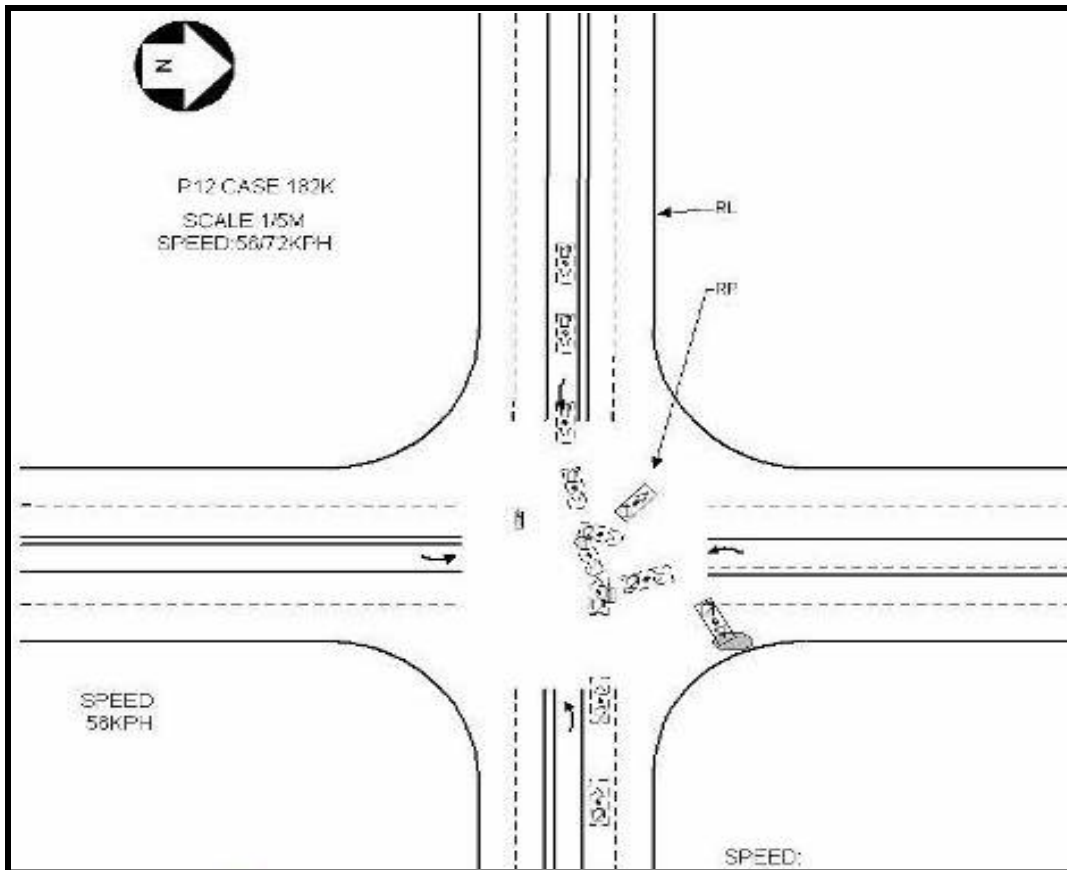
Figure 7. NASS Scene Diagram.

This two vehicle crash occurred during the late evening hours of September, 1998. At the time of the crash, it was dark (street lighted) with no adverse conditions as the roads were dry. The crash occurred in the westbound lanes of a five lane (straight/asphalt) 4-leg intersection (**see Figure 7 - page 6**). Traffic flow through the intersection was controlled by an overhead signal system. The posted speed limit at the crash site was 72 km/h (45 mph).
