REDESIGNED AIR BAG SPECIAL STUDY (RABSS) SCI TECHNICAL SUMMARY REPORT

NASS RABSS CASE NO. 1998-12-801E

RABSS VEHICLE - 1998 CADILLAC DEVILLE

CRASH DATE - AUGUST, 1998

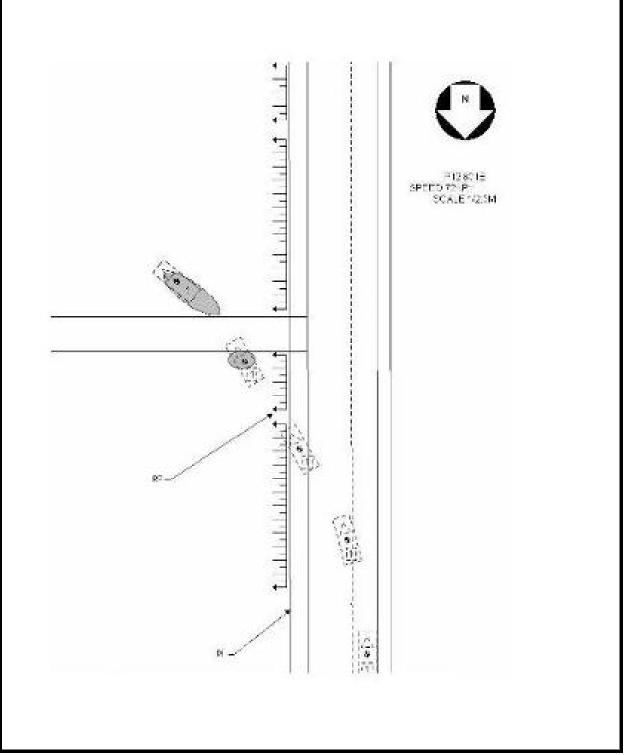
Figure 7. NASS Scene Diagram.

This single vehicle crash occurred during the afternoon hours of August, 1998. At the time of the crash, it was daylight with no adverse conditions as the roads were dry. The crash occurred off the east pavement edge of a straight and level two lane north/south concrete roadway (see Figure 7 - page 5). No traffic control was present at the scene which had a posted speed limit of 72 km/h (45 mph). The roadside environment featured paved shoulders, gravel driveways and a ditch located approximately 2.0 meters (0.8 feat) off the cast pavement edge (durth wat
