**REDESIGNED AIR BAG SPECIAL STUDY (RABSS)
SCI TECHNICAL SUMMARY REPORT**

NASS RABSS CASE NO. 1998-12-807G

RABSS VEHICLE - 1998 CHEVROLET S-10 PICKUP TRUCK

CRASH DATE - OCTOBER, 1998

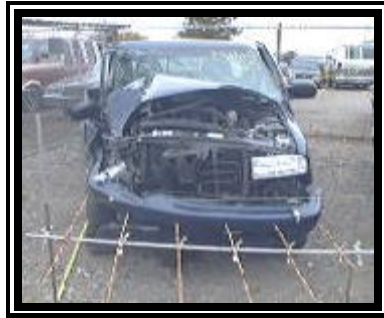
The 1998 Chevrolet S-10 pickup sustained moderate frontal damage as a result of the impact with the Ford pickup truck (**Figures 2 & 3**). The direct contact damage began at the front right bumper corner

and extended 14.0 cm (5.5 in) inboard. The impact deformed the full frontal width resulting in a combined direct and induced damage length (Field L) of 142.0 cm (56.0 in). Six crush measurements were documented at the level of the bumper: C1= 0 cm, C2= 2.0 cm (0.8 in), C3= 5.0 cm (2.0 in), C4= 6.0 cm (2.4 in), C5= 12.0 cm (4.7 in), C6= 29.0 cm (11.4 in). A secondary profile was taken at the radiator support level to capture the underride damage resulting in an *averaged profile* of: C1= 0 cm, C2= 2.0 cm (0.8 in), C3= 5.0 cm (2.0 in), C4= 13.0 cm (5.1 in), C5= 23.0 cm (9.1 in), C6= 41.0 cm (16.1 in). The hood was displaced rearward which impacted the windshield resulting in multiple component intrusions into the passenger compartment. Contact damage was documented rearward along the right side surface which measured 187.0 cm (73.6 in). This damage pattern deflated the right front tire and produced significant buckling at the right door (with tempered glazing disintegration), roof, header and A-pillar area. Post-crash damage was noted to the left door from a forced opening.

Figure 2. Frontal damage to the 1998 Chevrolet S-10 pickup truck.

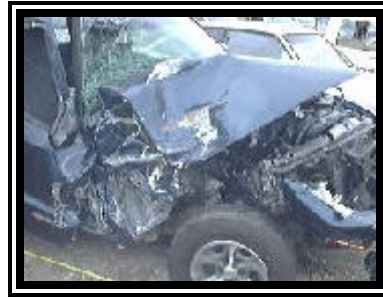
Figure 3. Rearward extent of the impact damage.

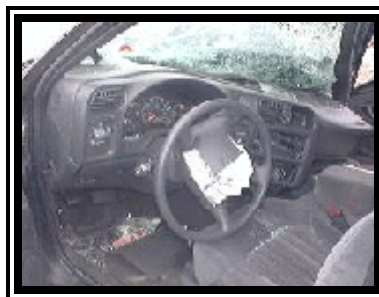
Interior damage to the Chevrolet pickup identified through the NASS vehicle inspection was moderate and was attributed to component intrusions (**Figure 4**). Occupant contact points were minimal as a scuff/skin transfer was documented to the left knee bolster (rigid plastic type). Longitudinal intrusions into the front right passenger space included 42.0 cm (16.5 in) of instrument panel, 30.0 cm (11.8 in) of windshield, 29.0 cm (11.4 in) of toepan and 9.0 cm (3.5 in) of header intrusions. Longitudinal intrusions into the center passenger space included 28.0 cm (11.0 in) of instrument panel, 22.0 cm (8.7 in) of windshield and 5.0 cm (2.0 in) of header intrusions. Lastly, a longitudinal instrument panel intrusion of 15.0 cm (5.9 in) was documented to the front left space.

Figure 4. Interior view.

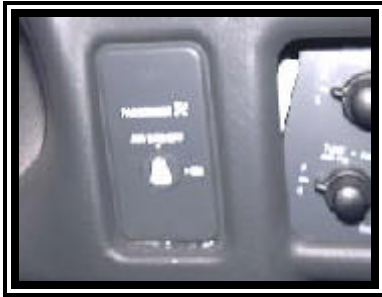
The 1998 Chevrolet S-10 pickup was equipped with redesigned frontal air bags for the driver and front right passenger positions. The driver air bag had deployed as a result of the crash while the passenger air bag was deactivated by the cutoff switch located on the center instrument panel (**Figures 5 & 6**). The driver air bag was housed in the center of the steering wheel with a vertically oriented flap tear seam (I-configuration). The flaps were symmetrical in shape and measured 10.0 cm (3.9 in) in width and 9.0 cm (3.5 in) in height. Although no contact evidence was identified on the exterior surface of the module cover flaps, a smudge and skin oil transfer were documented to the right upper quadrant of the air bag. The NASS researcher measured the diameter of the driver air bag at 64.0 cm (25.2 in) in its deflated state (**Figure 7**). The bag was tethered by two internal straps and vented by two ports located at the 10 o'clock and 2 o'clock sectors on the rear aspect of the air bag.

Figure 5. Redesigned passenger air bag cutoff switch (off).

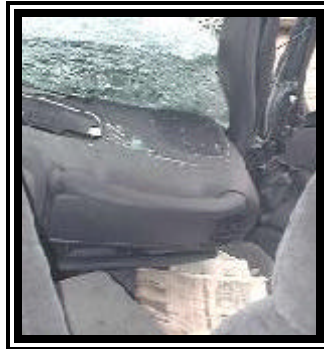
Figure 6. Front right passenger space.

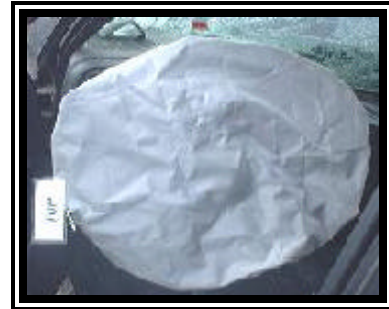
Figure 7. 1998 Chevrolet S-10 redesigned driver air bag.

At impact, the driver initiated a forward trajectory in response to the 12 o'clock impact force and loaded the manual restraint and deployed redesigned driver air bag. Loading of the manual restraint resulted in a contusion to the left shoulder. Driver loading of the redesigned air bag was evidenced by the smudge and skin oil transfer documented to the right upper quadrant of the air bag. He also sustained superficial lacerations to the anterior aspect of the right forearm from flying glass, evidenced by the nature of the injury sustained relative to the pre-crash placement of the right arm on the steering wheel rim which exposed the anterior aspect to flying glass from the right side tempered glazing. The combination of restraint options provided protection against further contact to the steering wheel hub/rim and windshield. The driver was not transported for treatment.
