**REDESIGNED AIR BAG SPECIAL STUDY (RABSS)
SCI TECHNICAL SUMMARY REPORT**

NASS CDS CASE NO. 1998-43-212A

**RABSS VEHICLES - 1998 PLYMOUTH GRAND VOYAGER SE
1998 FORD F-150 SUPER CAB PICKUP TRUCK**

CRASH DATE - AUGUST, 1998

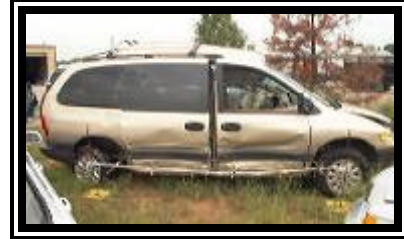
The 1998 Plymouth Grand Voyager sustained moderate right side damage as a result of the impact with the Ford Escort (**Figure 4**). The (*revised*) direct contact damage began 63.0 cm (24.8 in) forward of the right rear axle and extended 227.0 cm (89.4 in) forward. The (*revised*) combined direct and induced damage length (Field L) also measured 227.0 cm (89.4 in). Six (*revised*) crush measurements were documented at the level of the lower door: C1= 5.0 cm (2.0 in), C2= 0 cm, C3= 0 cm, C4= 1.0 cm (0.4 in), C5= 9.0 cm (3.5 in), C6= 5.0 cm (2.0 in). The contact damage was concentrated mainly within the passenger area with the right front glazing disintegrated by the impact force. The right rear wheel/tire was restricted and deflated from rearward displacement against the frame (snagging effect prior to vehicle separation).

Figure 4. Right side damage to the 1998 Plymouth Grand Voyager.

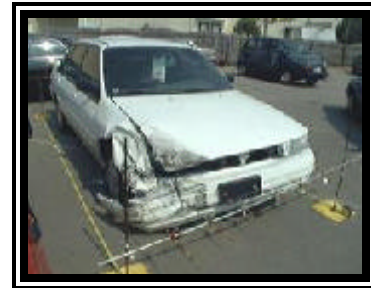
The 1995 Ford Escort LX sustained moderate frontal damage as a result of the impact with the Plymouth Grand Voyager (**Figure 5**). The (*revised*) direct contact damage began at the front right bumper corner and extended 40.0 cm (15.7 in) inboard. The hood was displaced rearward from engagement against the side surface of the Plymouth. Damage was also noted to the right fender which restricted/deflated the right front wheel/tire. Reduction in the right side wheelbase measured 7.0 cm (2.8 in). The windshield was undamaged.

Figure 5. Frontal damage to the 1995 Ford Escort LX.

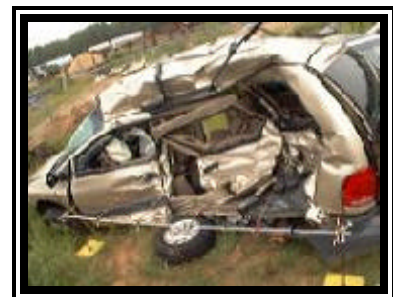
The Plymouth also sustained severe left side damage as a result of the impact with the Ford pickup (**Figure 6**). The (*revised*) direct contact damage began 145.0 cm (57.1 in) aft of the left front axle and extended 175.0 cm (68.9 in) rearward. The (*revised*) combined direct and induced damage length (Field L) began 65.0 cm (25.6 in) aft of the left front axle and extended 287.0 cm (113.0 in) rearward. Six (*revised*) crush measurements were documented at the level of the mid-door: C1= 1.0 cm (0.4 in), C2= 91.0 cm (35.8 in), C3= 62.0 cm (24.4 in), C4= 77.0 cm (30.3 in), C5= 47.0 cm (18.5 in), C6= 4.0 cm (1.6 in). A (*revised*) secondary profile was taken at the level of the sill to capture the structural compromise due to the left rear door failure, resulting in an *averaged profile* of: C1= 1.0 cm (0.4 in), C2= 66.0 cm (26.0 in), C3= 51.0 cm (20.1 in), C4= 60.0 cm (23.6 in), C5= 47.0 cm (18.5 in), C6= 4.0 cm (1.6 in). The height of the direct contact damage surpassed the level of the beltline which produced induced buckling to the roof and upper window frame area. All left side tempered glazing was disintegrated with induced displacement noted to the rear hatch assembly. The windshield was fractured with bond separation noted along the header area. The left rear wheel/tire separated from the axle during the collision sequence.

Figure 6. Left side damage to the 1998 Plymouth Grand Voyager.

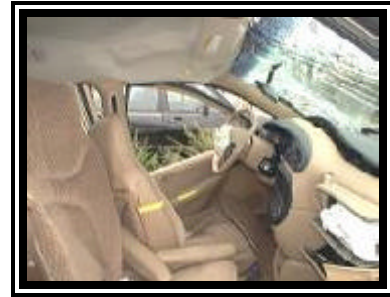
Interior damage to the Plymouth Grand Voyager identified through the NASS vehicle inspection was severe and was attributed to occupant contact and component intrusion (**Figure 7**). A scuff mark was documented to the left front door panel with the door hardware out of place. Hair strands were identified on the roof and left side rail. The front left restraint was cut by rescue during the driver's extrication from the vehicle. The top portion of the steering wheel rim was deformed forward 13.0 cm (5.1 in). No deformation was identified on the knee bolster (rigid plastic type). A blood smear was noted to the right aspect of the driver seat back which was displaced slightly forward by lateral and longitudinal component intrusions. The armrest located on the right aspect of the driver seat was also deformed to the right. The rear view mirror was displaced. A multitude of intrusions were (*revised*) documented to include the following:

Figure 7. Interior view.

Component	Intrusion	Direction
Left front door panel	25.0 cm (9.8 in)	Lateral
Left front roof side rail	32.0 cm (12.6 in)	Lateral
Left front sill	20.0 cm (7.9 in)	Lateral
Left B-pillar	31.0 cm (12.2 in)	Lateral
Left front window frame	27.0 cm (10.6 in)	Lateral
Left front roof area	18.0 cm (7.1 in)	Vertical
Center left seat back	43.0 cm (16.9 in)	Longitudinal
Center left door panel	57.0 cm (22.4 in)	Lateral
Center left roof side rail	33.0 cm (13.0 in)	Lateral
Center left window frame	52.0 cm (20.5 in)	Lateral
Center left sill	21.0 cm (8.3 in)	Lateral
Center left roof area	19.0 cm (7.5 in)	Vertical
Rear left roof side rail	37.0 cm (14.6 in)	Lateral
Rear left side panel	79.0 cm (31.1 in)	Lateral
Rear left window frame	66.0 cm (26.0 in)	Lateral
Rear left roof area	14.0 cm (5.5 in)	Vertical
Rear left sill	7.0 cm (2.8 in)	Lateral
Rear left C-pillar	77.0 cm (30.3 in)	Lateral
Rear left D-pillar	8.0 cm (3.1 in)	Lateral

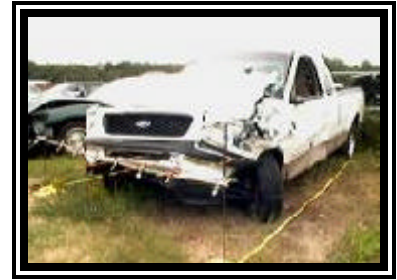
The 1998 Ford F-150 pickup sustained moderate frontal damage as a result of the impact with the Plymouth Grand Voyager (**Figure 8**). The direct contact damage encompassed the full frontal width resulting in a (*revised*) combined direct and induced damage length (Field L) of 145.0 cm (57.1 in). Six (*revised*) crush measurements were documented at the level of the bumper: C1= 53.0 cm (20.9 in), C2= 25.0 cm (9.8), C3= 20.0 cm (7.9 in), C4= 14.0 cm (5.5 in), C5= 9.0 cm (3.5 in), C6= 8.0 cm (3.1 in). The hood was displaced up and rearward from engagement against the side surface of the Plymouth. Direct contact damage was also noted to the left fender and door from sustained (wrap) contact between the vehicles during spinout. This damage pattern shattered the left front glazing and restricted/deflated the left front wheel/tire. The right front wheel was found to be deflated (not restricted). The windshield was fractured from exterior forces (only). Reduction in the left side wheelbase measured 43.0 cm (16.9 in). Reduction in the right side wheelbase measured 8.0 cm (3.1 in).

Figure 8. Frontal damage to the 1998 Ford F-150 pickup.

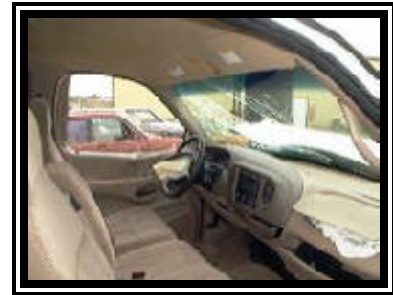
No interior damage to the Ford pickup was identified through the NASS vehicle inspection (**Figure 9**). No deformation was identified on the knee bolster (rigid plastic type) or steering wheel hub/rim (tilt column set to the center position). No intrusions were found in the vehicle.

Figure 9. Interior view.

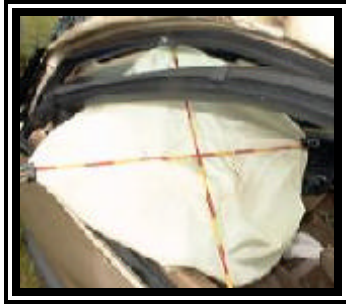
The 1998 Plymouth Grand Voyager was equipped with redesigned frontal air bags for the driver and front right passenger positions. The air bags had deployed as a result of the impact with the Ford pickup. Air bag warning labels were affixed to each sun visor. The driver air bag was housed in the center of the steering wheel with a horizontally oriented flap tear seam (H-configuration). No contact evidence was identified on the air bag or exterior surface of the module cover flaps. The flaps were asymmetrical in shape as the upper flap measured 18.0 cm (7.1 in) in width and 2.0 cm (0.8 in) in height while the lower flap measured 18.0 cm (7.1 in) in width and 10.0 cm (3.9 in) in height. The NASS researcher measured the diameter of the driver air bag at 62.0 cm (24.4 in) in its deflated state (**Figure 10**). No vent ports were identified during the NASS inspection. The bag was tethered by two internal straps.

Figure 10. 1998 Plymouth Grand Voyager redesigned driver air bag.

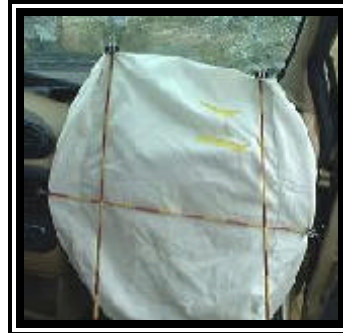
The front right passenger air bag deployed from the right mid-instrument panel area with a horizontally oriented flap tear seam (H-configuration). The cover flaps were rectangular and symmetrical in shape which measured 30.0 cm (11.8 in) in width and 7.0 cm (2.8 in) in height. Although no contact evidence was identified on the exterior surface of the module cover flaps, a blood smear was documented to the upper right quadrant of the air bag. The NASS researcher measured the passenger air bag at 44.0 cm

(17.3 in) in width and 65.0 cm (25.6 in) in height in its deflated state (**Figure 11**). No internal tether straps or vent ports were identified. No cutoff switch was reported for the front right redesigned passenger air bag.

Figure 11. 1998 Plymouth Grand Voyager redesigned passenger air bag.

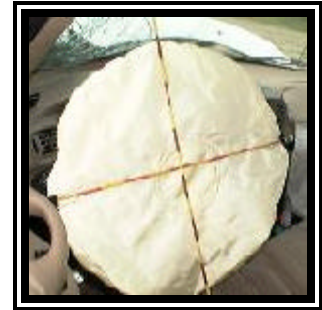
The 1998 Ford F-150 pickup was equipped with redesigned frontal air bags for the driver and front right passenger positions. The air bags had deployed as a result of the crash. Air bag warning labels were affixed to each sun visor. The driver air bag was housed in the center of the steering wheel with a single cover flap design. No contact evidence was identified on the air bag or exterior surface of the module cover flap. The flap measured 17.0 cm (6.7 in) in width along the upper portion and 20.0 cm (7.9 in) along the lower portion with a height of 15.0 cm (5.9 in). The NASS researcher measured the diameter of the driver air bag at 65.0 cm (25.6 in) in its deflated state (**Figure 12**). The bag was tethered by two internal straps and vented by two ports located at the 11 o'clock and 1 o'clock sectors on the rear aspect of the air bag.

Figure 12. 1998 Ford F-150 pickup redesigned driver air bag.

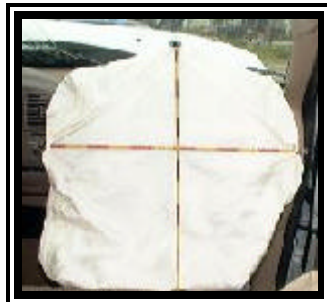
Figure 13. 1998 Ford F-150 redesigned passenger air bag.

The front right passenger air bag deployed from the right mid-instrument panel area with a single cover flap design hinged at the top aspect. No contact evidence was identified on the air bag or exterior surface of the module cover flap. The cover flap was rectangular in shape and measured 39.0 cm (15.4 in) in width and 18.0 cm (7.1 in) in height. The NASS researcher measured the passenger air bag at 60.0 cm (23.6 in) square in its deflated state (**Figure 13**). No vent ports or internal tether straps were present. A cutoff switch was documented to the center mid-instrument panel area and was set to the “on” position.

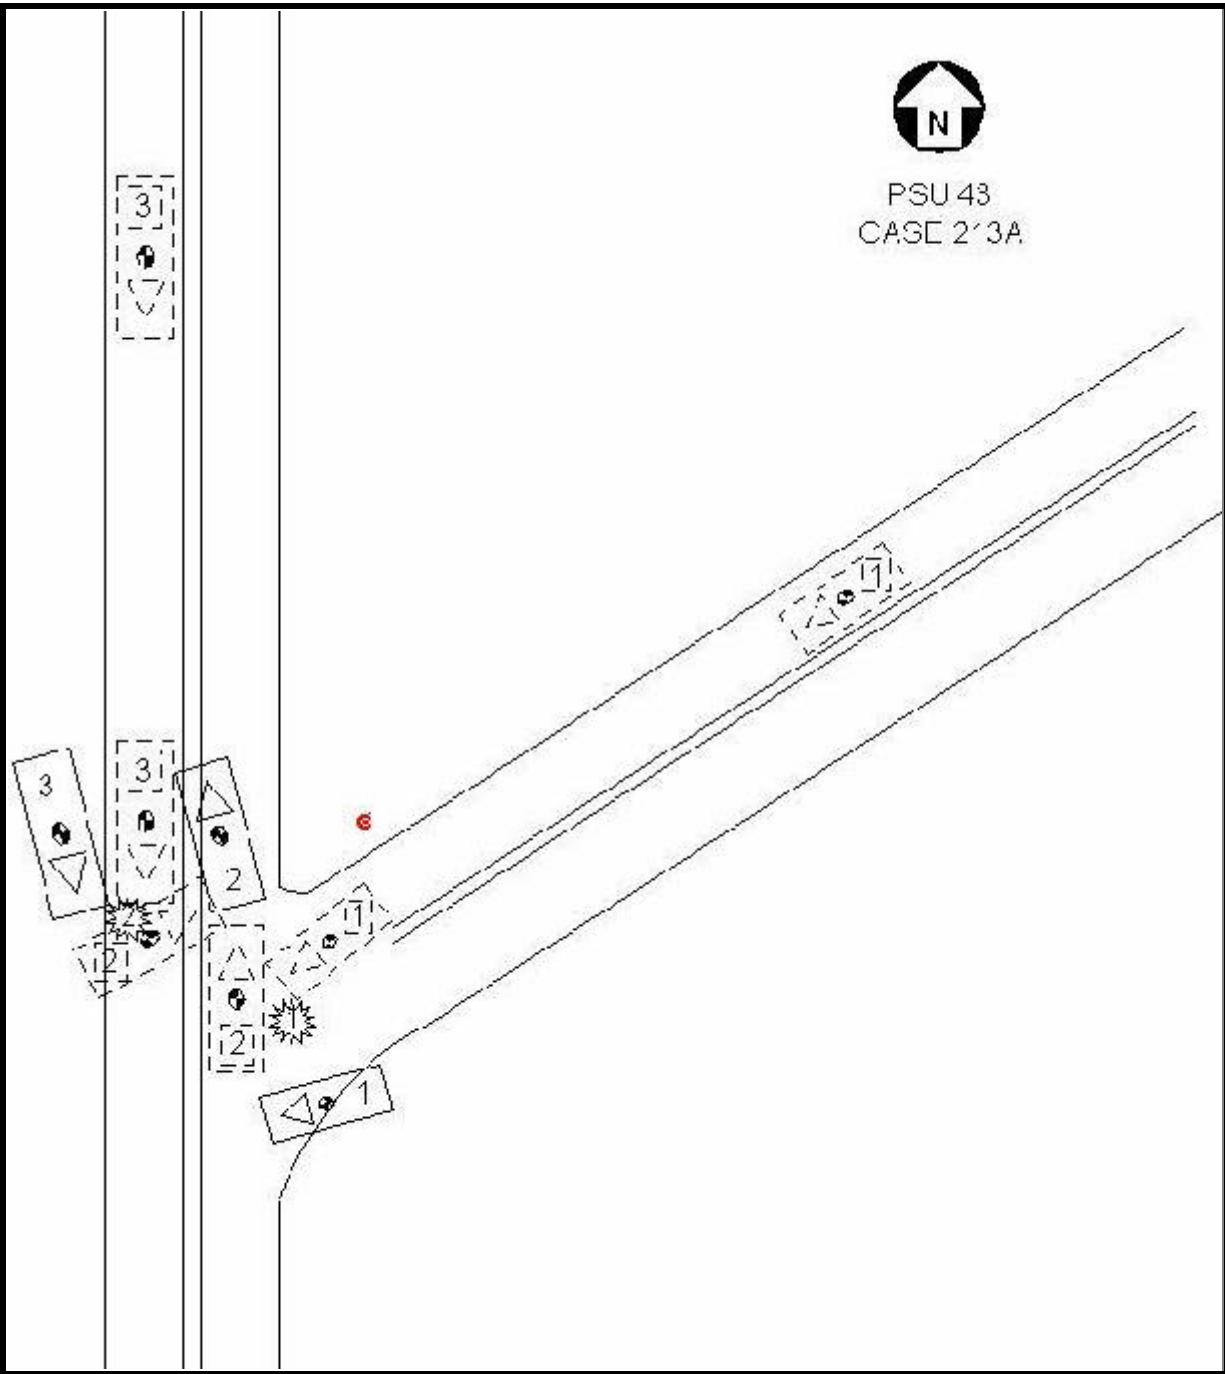
Figure 14. NASS Scene Diagram (physical plant erroneously documented as the physical evidence was omitted by the NASS researcher).
