REMOTE SIDE AIR BAG DEPLOYMENT/FATALITY INVESTIGATION

CALSPAN CASE NO. 1998-043-280A

VEHICLE - 1997 MERCEDES BENZ SL320

LOCATION - NORTH CAROLINA

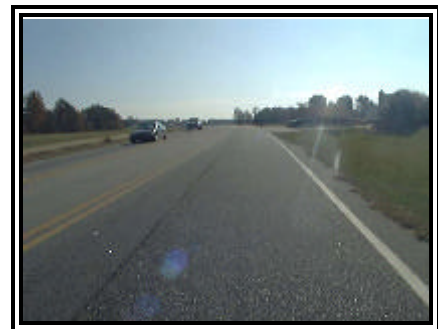
Figure 1 is a southbound approach view of the intersection.

Figure 1: Southbound trajectory view of the Toyota pick-up.

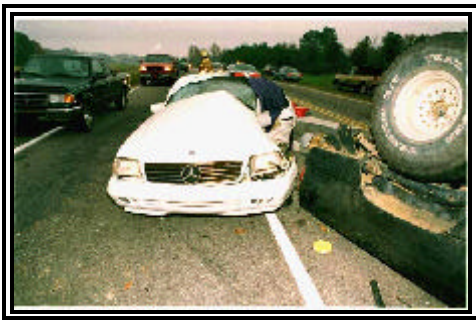
Figure 2: Southward view of the final rest position of the Mercedes.

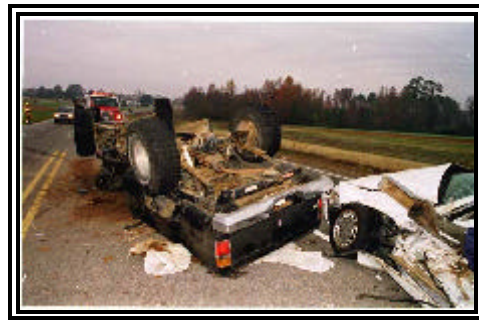
Figure 3: Northward view of the Toyota's final rest position.

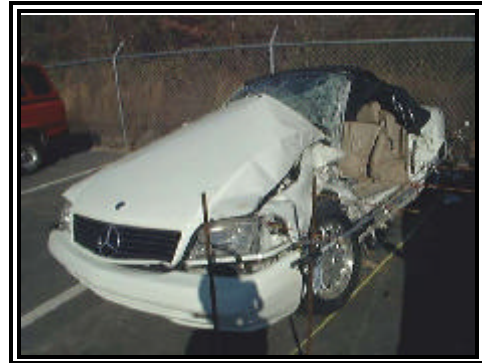
Figure 5: Left front three-quarter view.

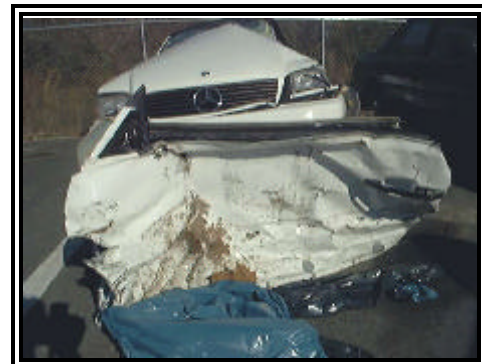
Figure 4 is a left front three-quarter view of the Mercedes. The vehicle sustained left side direct contact damage that began 60 cm (23.6 in) aft of the left front axle and extended rearward 165 cm (65.0 in). The impact involved the full frontal width of the Toyota and was centered approximately on the Mercedes left A-pillar and door. The maximum lateral deformation occurred in the area of the left A pillar and was measured to be approximately 42 cm (16.5 in). The crush profile measured over a damage length of 285 cm (112 in) was as follows: C1=0, C2=11.0 cm (4.3 in), C3=28.0 cm (11.0 in), C4=42.0 cm (16.5 in), C5=17 cm (6.7 in), C6=9.0 cm (3.5 in). The left door, **Figure 5**, intruded into the left front occupant space and was jammed shut by deformation. It was removed by rescue personnel during the extrication of the driver. There was also lateral deformation to the left front seat, foot well and instrument panel.

Figure 4: Left door exterior.

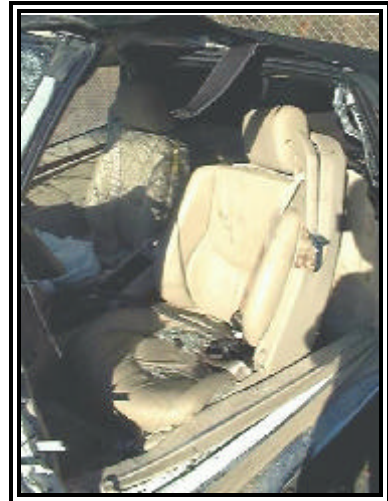
structures, refer to **Figure 6**. The restraint consisted of a continuous loop webbing with a sliding latch plate. The driver was properly restrained by the manual belt system at the time of the crash. On-scene photographs taken prior to the extrication of the driver depict the manual restraint in use at the time of the crash. Additionally, blood and body fluids were identified on the webbing during the inspection and are depicted in Figure 6.

Figure 6: View of the left front seat and integrated manual restraint.

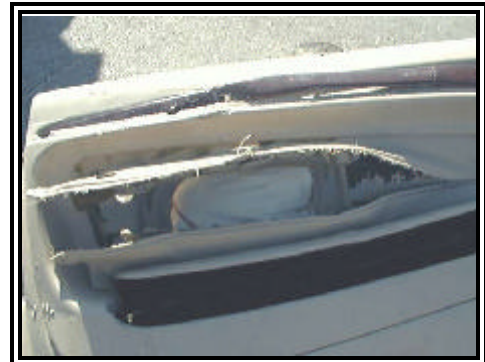
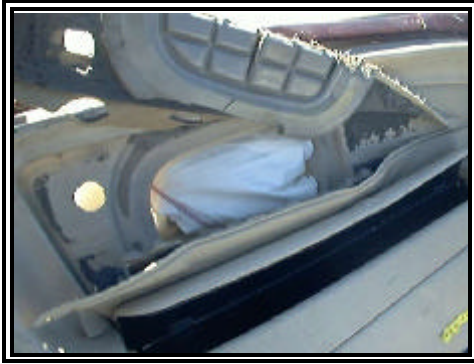
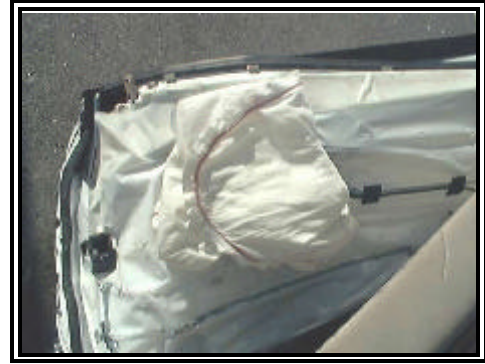
Figures 7-9 are views of the interior aspect of the left front door taken during the NASS inspection. The longitudinal seam of the interior trim panel tore open during deployment sequence, however the seam appeared to have opened in greater length than required (in consideration of the module's cover flaps). Further, the air bag did not deploy through the trim panel but remained partially folded and captured behind the door's interior trim panel post-crash. There was no contact evidence on the air bag. The police investigator, paramedics and driver's husband, responding to the crash, indicated the air bag did not properly deploy. In the crash, the Mercedes left side impact air bag did deploy. However, the normal deployment path of the air bag was impeded resulting in an altered deployment. The deployment is confirmed by several factors. First and most obvious is the condition of the trim panel, air bag and air bag module. The air bag is out of the module and the cover flaps and trim panel tore open during the deployment sequence. This condition can only occur through a deployment. Additionally, technical representatives from Mercedes-Benz USA inspected the vehicle subsequent to the NASS inspection and confirmed the deployment via electrical resistance tests of the SRS circuitry.

Figure 7: View of the left door's side impact air bag.

Figure 8: View of the side impact air bag through the cover flaps.

Figure 9: View of the side impact air bag.

The altered deployment sequence occurred as a result of an interference between the seat back of the left front seat and side air bag cover flaps of the intruding door. The left front seat was adjusted in a mid-to-forward track position consistent with the short stature of the driver. This forward track adjustment placed the seat back laterally adjacent to the mounted position of the side impact air bag. Although the side impact air bag typically inflates in approximately 20 milliseconds, the door probably began intruding into the occupant space within this time frame, considering the magnitude of the impact speed. As the air bag deployed, the cover flap on the interior trim contacted the outboard aspect of the seat. This contact impeded the rotation of the cover flaps and probably caused the vertical tear in the upper cover flap (**Figure 8** above) and the extended tear in the center trim panel seam, as the inflating bag attempted to “search” for a path out of the module. The rapidly expanding bag inflated behind the trim panel (in the hollow door’s interior). The air bag probably deflated faster than normal due to the compression (squeezing) of the bag between the intruding door and seat back. The driver probably received some benefit from the air bag, however the collision forces were probably not survivable with or without a side impact air bag.
