**REDESIGNED AIR BAG SPECIAL STUDY (RABSS)  
SCI TECHNICAL SUMMARY REPORT**

**NASS RABSS CASE NO. 1998-43-807G**

**RABSS VEHICLE - 1999 FORD F-250 SUPER CAB PICKUP TRUCK**

**CRASH DATE - SEPTEMBER, 1998**

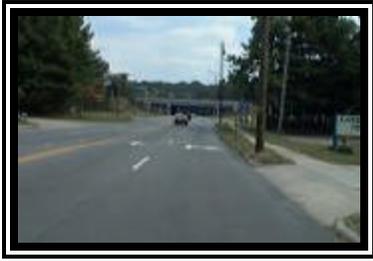
The 38 year old male driver of the 1999 Ford F-250 pickup truck was operating the vehicle eastbound in the curb lane (**Figure 1**) and proceeding straight when a non-contact vehicle traveling in the opposite direction made an abrupt left turn (in front of the Ford) to enter a private driveway. The driver of the Ford steered left in avoidance and entered the #2 curb lane where he encountered another non-contact vehicle that was stationary and facing east waiting to make a left turn (north). The driver steered right/braked and subsequently exited the right (south) pavement edge (**Figure 2**).

**Figure 1. Eastbound approach for the 1999 Ford F-250 pickup truck.**

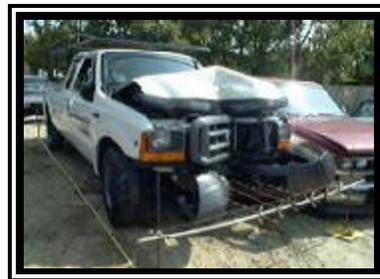
The Ford pickup truck sustained moderate frontal damage as a result of the impact with the utility pole (**Figure 3**). The direct contact damage was centered 10.0 cm (3.9 in) to the left of the end plane center point. The impact deformed the full frontal width resulting in a combined direct and induced damage length (Field L) of 103.0 cm (40.6 in). Six crush measurements were documented at the level of the bumper: C1 = 0 cm, C2 = 0 cm, C3 = 33.0 cm (13.0 in), C4 = 64.0 cm (25.2 in), C5 = 18.0 cm (7.1 in), C6 = 0 cm. The hood was displaced up and rearward from engagement against the utility pole. No induced damage was noted to the fenders or roof area. No bed to cab contact was identified. No wheels were restricted or deflated. The windshield was undamaged.

**Figure 3. 1999 Ford F-250 Super Cab pickup truck.**

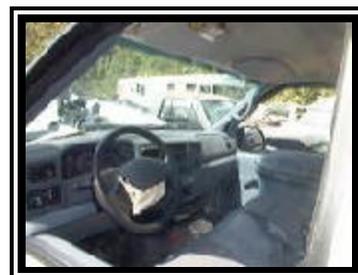
Interior damage to the Ford pickup truck identified through the NASS vehicle inspection was minimal and was attributed to occupant contact (**Figure 4**). No transfers or loading marks were noted to the available 3-point manual lap and shoulder belt systems. No contacts were found on the driver air bag or exterior surface of the module cover flaps. A scuff mark was documented to the front right instrument panel (air bag cavity panel). No deformation was noted to the fixed steering column or knee bolsters (rigid plastic type). No intrusions were identified to the vehicle.

**Figure 4. Interior view**

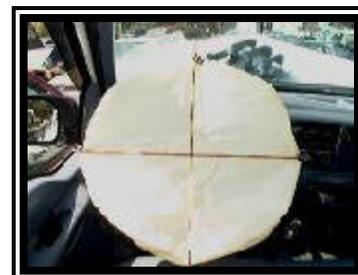
The 1999 Ford F-250 Super Cab pickup truck was equipped with a redesigned driver air bag (the vehicle had a delete option for the passenger side air bag). The air bag deployed as a result of the crash. The air bag was housed in the center of the steering wheel with a horizontally oriented flap tear seam (H-configuration). There was no contact evidence on the air bag or exterior surface of the module cover flaps. The flaps were asymmetrical in shape as the upper flap measured 19.5 cm (7.7 in) in width and 15.0 cm (5.9 in) in height. The NASS researcher measured the diameter of the air bag at 64.0 cm (25.2 in) in its deflated state (**Figure 5**). The bag was tethered by four internal straps and vented by two ports located at the 11 o'clock and 1 o'clock sectors on the rear aspect of the air bag.

**Figure 5. 1999 Ford F-250 pickup truck redesigned driver air bag.**

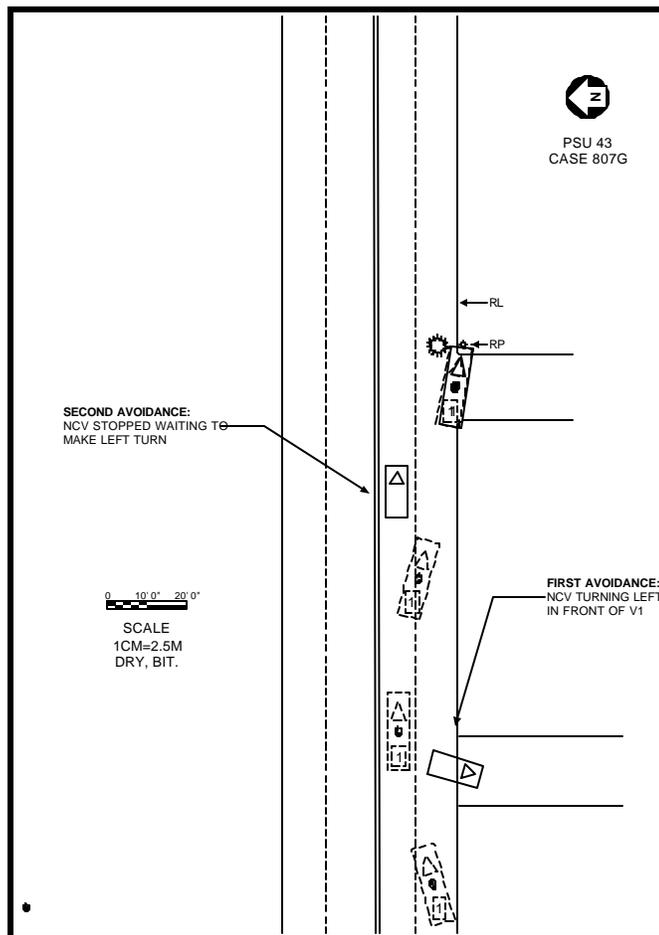
Figure 6. NASS Scene Diagram

This single vehicle crash occurred during the evening hours of September, 1998. At the time of the crash, it was daylight with no adverse conditions as the roads were dry. The crash occurred off the south pavement edge of an east/west 4-lane undivided asphalt roadway (see **Figure 6 - page 5**). The roadway was straight and level with a posted speed limit of 56 km/h (35 mph).
