**REDESIGNED AIR BAG SPECIAL STUDY (RABSS)
SCI TECHNICAL SUMMARY REPORT**

NASS RABSS CASE NO. 1998-45-802G

RABSS VEHICLE - 1998 SATURN SL2

CRASH DATE - JULY, 1998

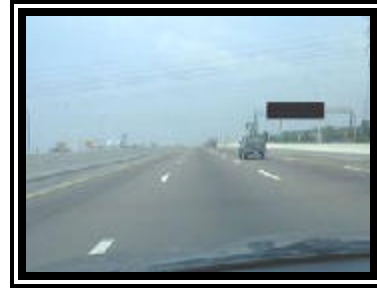
The 28 year old male driver of the White tractor-trailer was operating the vehicle westbound in the #2 inboard lane (**Figure 1**) when he changed lanes to the right. The 29 year old male driver of the 1998 Saturn SL2 was operating the vehicle westbound in the #2 outboard lane at a (driver reported) speed of 89 km/h (55 mph) and proceeding straight when he observed the truck encroach into his lane of travel. The driver of the Saturn reported no avoidance maneuvers.

Figure 1. Westbound approach for the 1989 White conventional tractor-trailer.

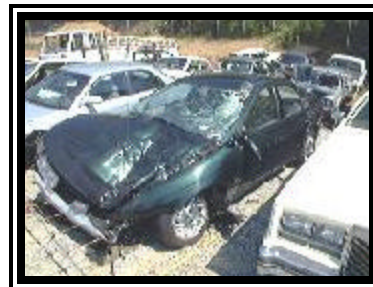
The 1998 Saturn SL2 sustained moderate frontal damage as a result of the impact with the tractor-trailer (**Figures 2 & 3**). The (secondary) direct contact damage began at the front left bumper corner and extended 67.0 cm (26.4 in) inboard. The impact deformed the full frontal width resulting in a combined direct and induced damage length (Field L) of 110.0 cm (43.3 in). Six crush measurements were documented at the level of the reinforcement bar (bumper cover separation): C1= 10.0 cm (3.9 in), C2= 9.0 cm (3.5 in), C3= 5.0 cm (2.0 in), C4= 2.0 cm (0.8 in), C5= 0 cm, C6= 0 cm. The left fender was displaced rearward and to the right which restricted the left front wheel/tire (not deflated). Underride damage consisted of an imprint to the hood surface from the trailer portion of the truck which extended rearward to the windshield header. A puncture hole was identified to the upper left windshield area and measured 20.0 cm x 10.0 cm (7.9 in x 3.9 in). Surface scratching was documented rearward along the left side surface attributed to the initial impact with the tractor portion. This damage pattern began 52.0 cm (20.5 in) aft of the left front axle and extended 301.0 cm (118.5 in) rearward. The front and rear bumper cover fascia separated from the vehicle during the crash sequence. All tempered glazing remained intact.

Figure 2. Frontal damage to the 1998 Saturn SL2.

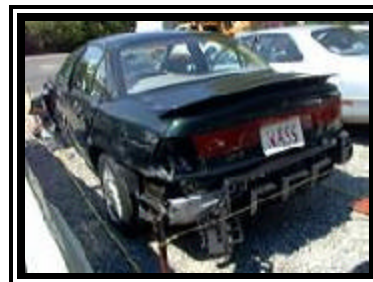
Figure 3. Left and rear damage.

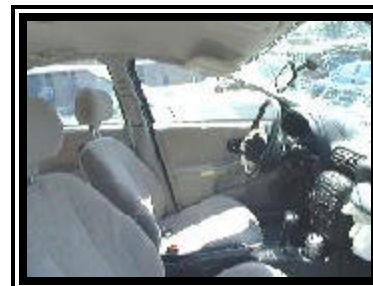
Interior damage to the Saturn identified through the NASS vehicle inspection was minimal and was attributed to occupant contact (**Figure 4**). A spider-web fracture pattern was documented to the left lower windshield. Scuff marks were found on the left side interior door surfaces and left knee bolster (rigid plastic type). A longitudinal windshield (and opposing vehicle) intrusion measured 3.0 cm (1.2 in). No deformation was noted to the steering wheel hub/rim (tilt column placed to the center position).

Figure 4. Interior view of the 1998 Saturn SL2.

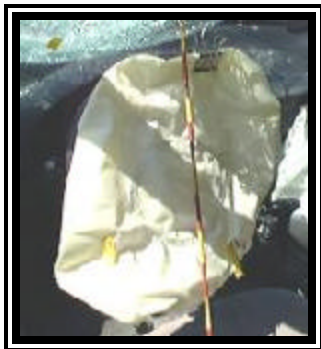
The 1998 Saturn SL2 was equipped with redesigned frontal air bags for the driver and front right passenger positions. The air bags had deployed as a result of the crash. The driver air bag was housed in the center of the steering wheel with a vertically oriented flap tear seam (I-configuration). Although no contact evidence was identified on the exterior surface of the module cover flaps, an orange fabric transfer was documented to the lower left quadrant along with blood spattering to the lower right quadrant of the air bag. The flaps were symmetrical in shape and measured 9.0 cm (3.5 in) in width and 13.0 cm (5.1 in) in height. The NASS researcher measured the diameter of the driver air bag at 42.0 cm (16.5 in) in its deflated state (**Figure 5**). The bag was tethered by four internal straps and vented by two ports located at the 11 o'clock and 1 o'clock sectors on the rear aspect of the air bag.

Figure 5. 1998 Saturn SL2 redesigned driver air bag.

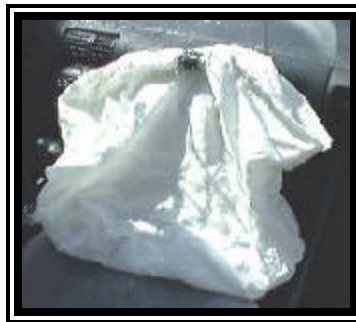
The front right passenger air bag deployed from the right mid-instrument panel area with a single cover flap design hinged at the top aspect. No contact evidence was identified on the air bag or exterior surface of the module cover flap. The cover flap was rectangular in shape and measured 30.0 cm (11.8 in) in width and 12.0 cm (4.7 in) in height. The NASS researcher measured the passenger air bag at 70.0 cm (27.6 in) in width and 50.0 cm (19.7 in) in height in its deflated state (**Figure 6**). No internal tether straps or vent ports were present. No cutoff switch was reported for the front right redesigned passenger air bag.

Figure 6. 1998 Saturn SL2 redesigned passenger air bag.

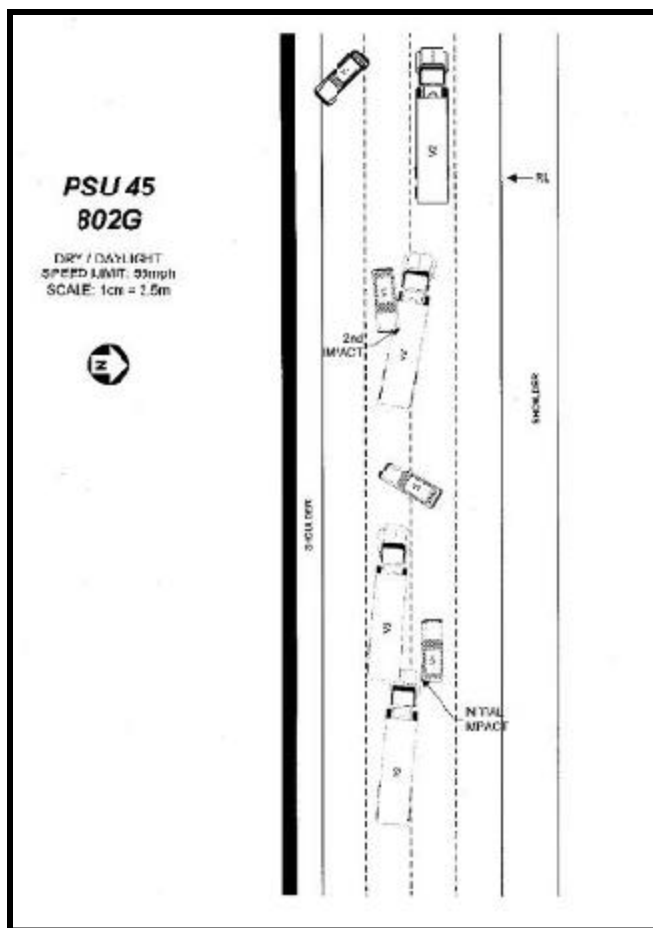
Figure 7. NASS Scene Diagram.

This two vehicle crash occurred during the afternoon hours of July, 1998. At the time of the crash, it was daylight with no adverse conditions as the roads were dry. The crash occurred in the westbound lanes of a straight (asphalt) 8-lane east/west interstate highway which was bordered by paved shoulders and divided by a raised concrete barrier (see **Figure 7 - page 6**). No traffic control was present at the scene which had a posted speed limit of 89 km/h (55 mph).
