Remote, Redesigned Air Bag Special Study  
Dynamic Science, Inc., Case Number (1998-048-081C)  
1998 Mitsubishi Mirage  
Alabama  
September, 1998

14. Sponsoring Agency Code	
15. Supplemental Notes					
16. Abstract  This remote investigation focused on the redesigned air bag system deployment of a 1998 Mitsubishi Mirage 4-door sedan. This minor injury crash occurred in September, 1998 in the evening. The weather was clear and the bituminous roadway was dry. It was dark at the time but the road was illuminated by street lights. The crash occurred in a four legged intersection. The speed limit is 72km/h (45 mph) for this road. It is controlled by overhead traffic signals. Vehicle 1, a 1989 Chevrolet Spectrum 4-door sedan driven by a 41 year old male, was traveling northbound in lane one approaching the intersection at a police estimated speed of 64 km/h (40 mph), preparing to travel straight through the intersection. The driver was restrained by the available manual lap/shoulder restraint. Police indicated that the driver of Vehicle 1 was under the influence of alcohol at the time of the crash. His blood alcohol content registered at .07%. There were no other occupants in the vehic

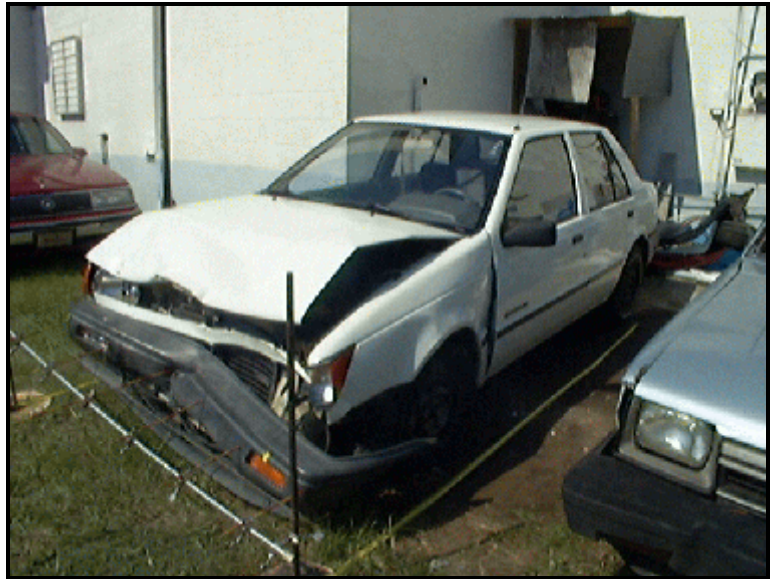
**Figure 1.** Exterior, Vehicle 1 (Chevrolet Spectrum)

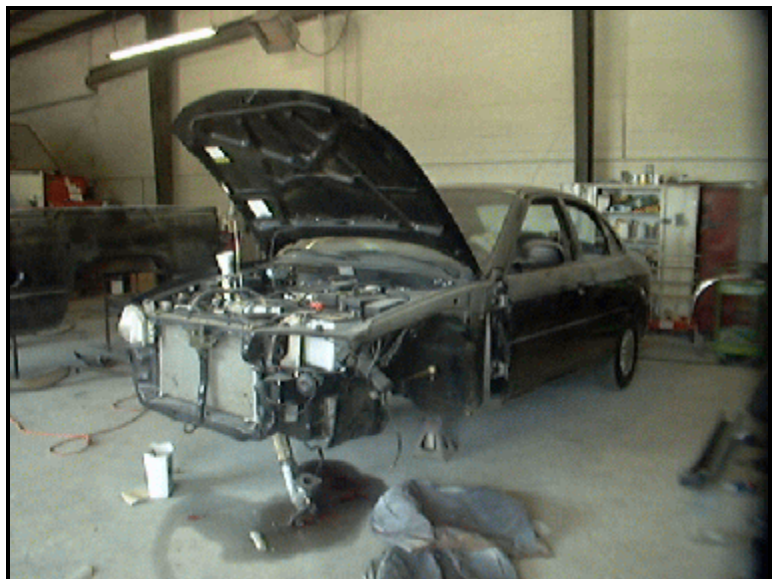
**Figure 2.** Exterior, Vehicle 2 (Mitsubishi Mirage)

Vehicle 1 entered the intersection on a solid red traffic signal. Vehicle 2 entered the intersection on a solid green traffic signal. Vehicle 2 entered the path of Vehicle 1 and was struck. The front plane of Vehicle 1 (01FDEW1)<sup>1</sup> struck the left plane of Vehicle 2 (11LFEW99) in the intersection.

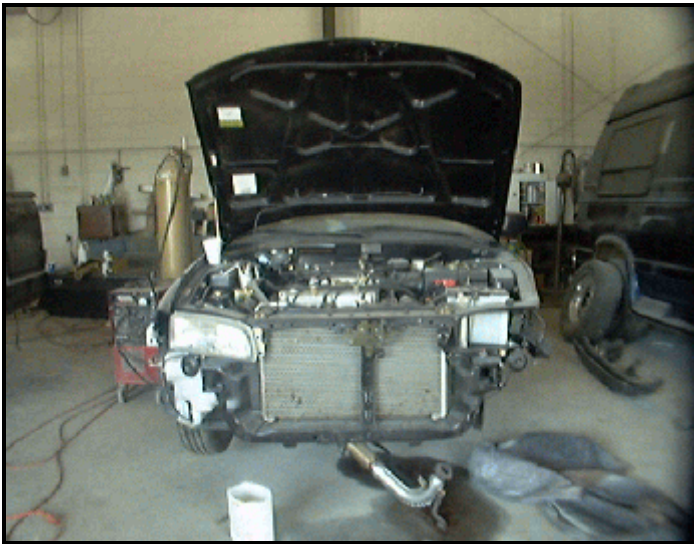
**Figure 3.** Exterior, Vehicle 2 (1998 Mitsubishi Mirage)

Vehicle 2 was under repair and stripped down at the time of inspection so crush measurements could not be taken. A CDC was ascertained from inspection of the removed damaged parts.

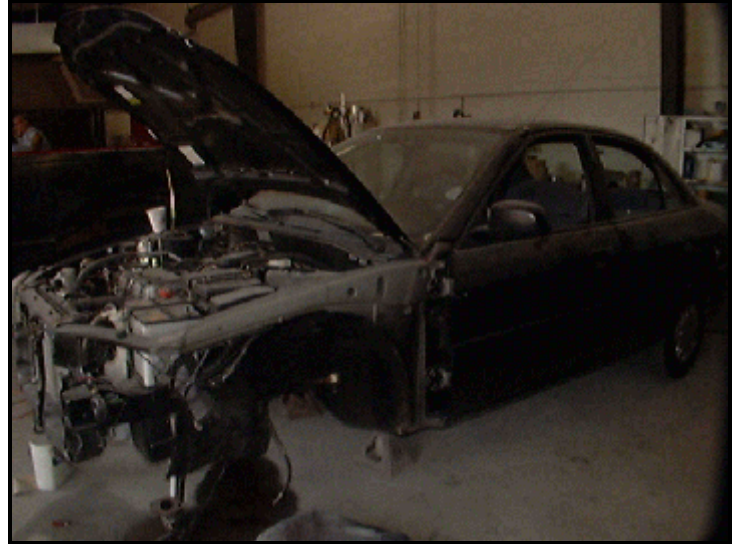
**Figure 4.** Exterior, Vehicle 2 (1998 Mitsubishi Mirage)

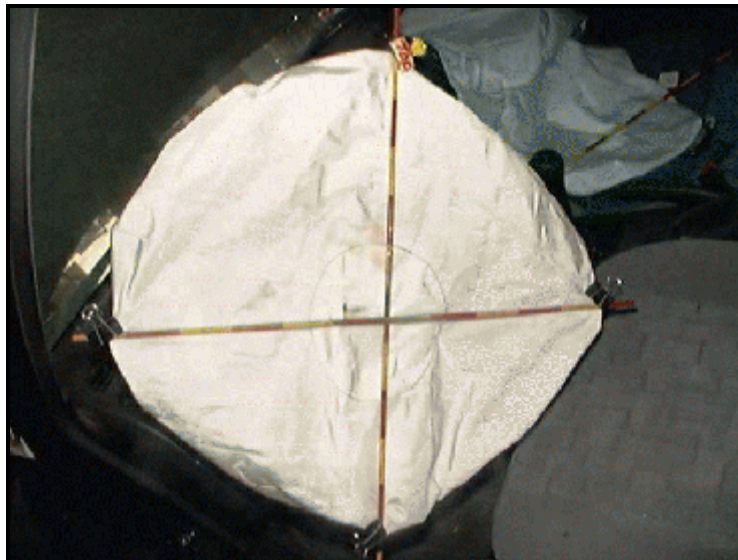
**Figure 5.** Interior, Vehicle 2, driver's side redesigned air bag

The front left air bag was housed in the steering wheel hub and was concealed by a single inverted “D” shaped cover flap. The circular air bag was equipped with two tethers and two vent ports. Two makeup transfers were found on the bag from contact with the driver's face.

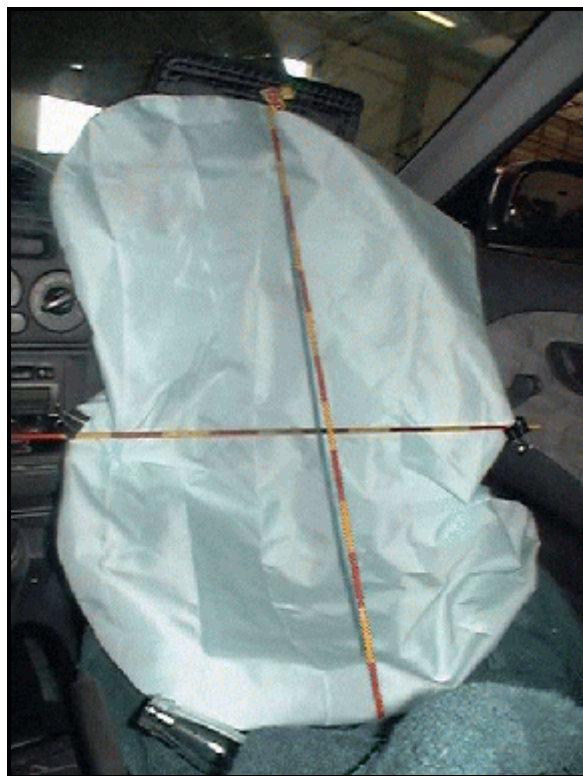
The front right air bag was housed in the mid-instrument panel position and was concealed by a single rectangular shaped cover flap. The rectangular air bag was equipped with one vent port and no tethers. A makeup transfer was found on the bag from contact with the front right passenger's face.

**Figure 6.** Interior, Vehicle 2, passenger's side redesigned air bag

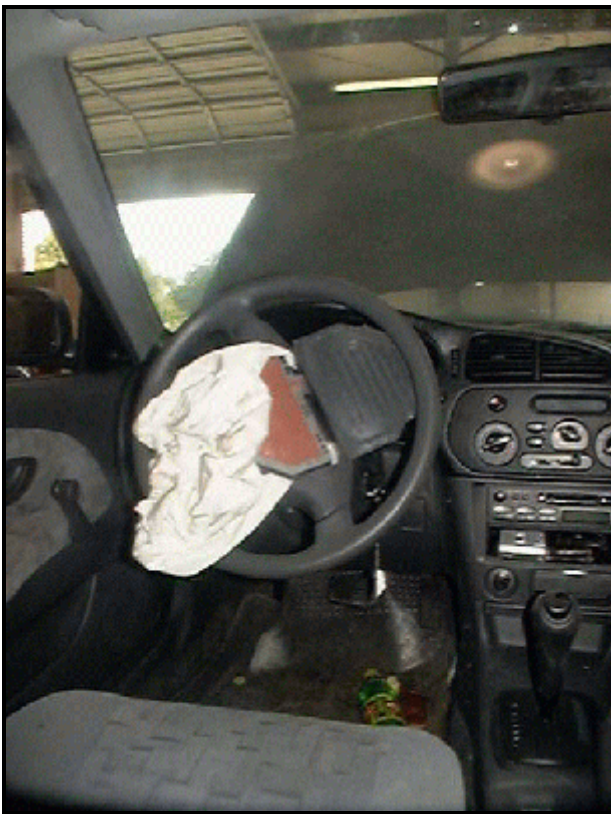
**Figure 7.** Interior, case vehicle

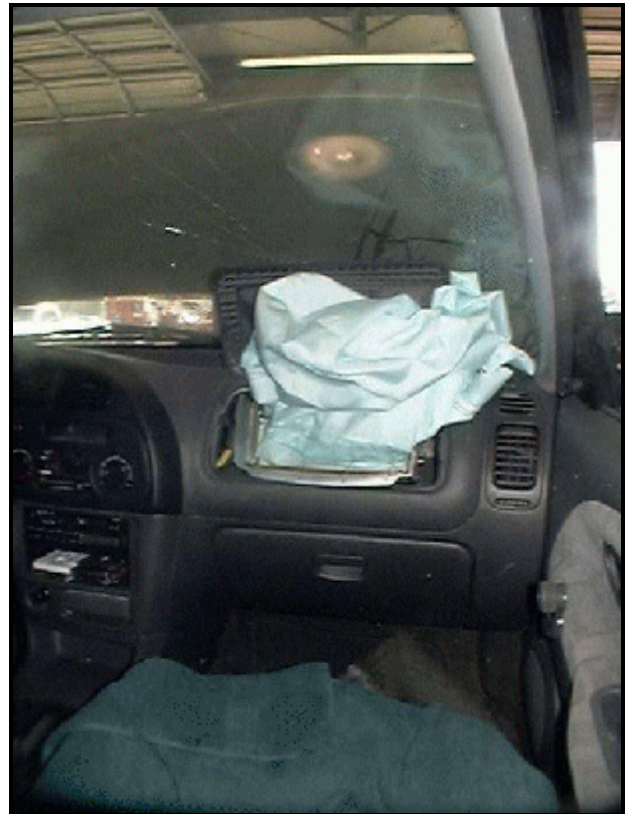
**Figure 8.** Interior, case vehicle
