Remote, Redesigned Air Bag Special Study
Dynamic Science, Inc., Case Number (1998-48-117J)
1998 Mazda B2500 Pickup Truck
Alabama
November/1998

Summary

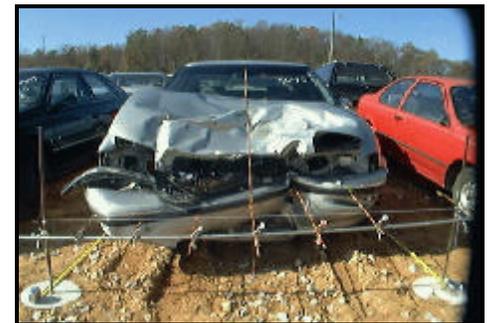
Figure 3. Frontal Damage to Vehicle 1

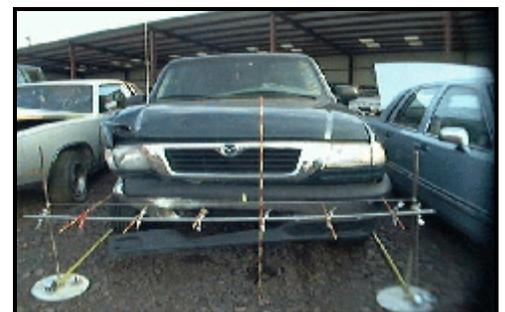
Figure 4. Front right corner Damage to Vehicle 2

The driver of Vehicle 2 stopped at the intersection and initiated a left turn directly in the path of Vehicle 1. The front bumper of Vehicle 1 (12FDEW2) impacted the front, left bumper region of Vehicle 2 (01FZEW2) in an obtuse angle head-on impact configuration. The calculated total delta V for Vehicle 1 was 21.3 km/h (13.2 mph) while Vehicle 2 (Mazda pickup) underwent a total delta V of 23.2 km/h (14.4 mph) with a longitudinal delta V of -21.8 km/h (-13.5 mph)¹ which proved to be of sufficient force to deploy the redesigned frontal air bags. The frontal air bags in Vehicle 1 also deployed as a result of the impact.

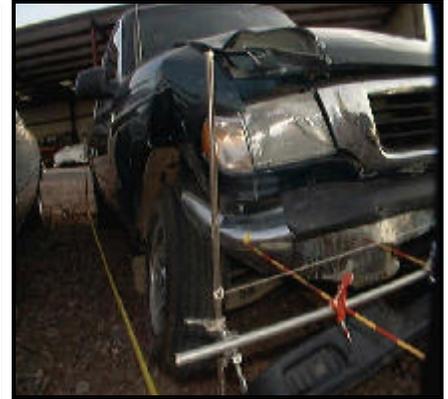
Figure 7. Close-up view showing right front bumper impact to case vehicle

Plane of Impact	Field L cm/in.	C1 cm/in.	C2 cm/in.	C3 cm/in.	C4 cm/in.	C5 cm/in.	C6 cm/in.
Front Bumper	144	4	4	6	9	12	24
	56.7	1.6	1.6	2.4	3.5	4.7	9.4

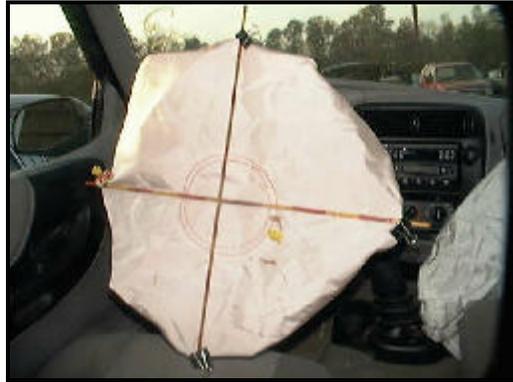
The front, left drivers air bag was housed in the steering wheel hub and was concealed by symmetrical double horizontal module cover flaps. The circular air bag was tethered two straps, and was equipped with two exhaust vent port holes. The lower instrument panel is equipped with a rigid plastic knee bolster. There was a scuff mark noted to the lower left knee bolster and there were blood fluid transfers noted to the lower right quadrant of the air bag.

Figure 12. View showing deployed drivers air bag

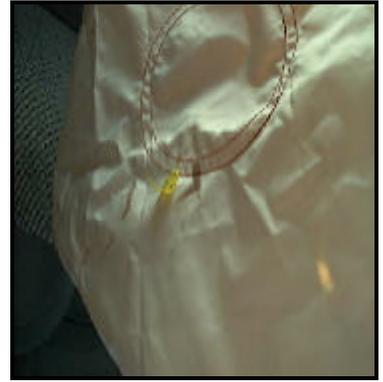
Figure 13. Close-up view showing blood stain on drivers air bag

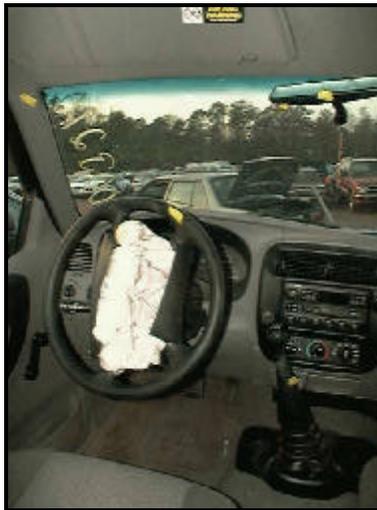
The driver responded to the 20 degree impact force by moving forward and slightly to the right. His left knee contacted the knee bolster (refer to **Figure 16**) and his right knee contacted the floor mounted transmission selector knob as he loaded the lap belt webbing which prohibited extended forward motion of his lower torso and extremities. His upper torso moved forward, loading the shoulder belt webbing at about the time of air bag deployment. As the air bag deployed, it would appear that both hands flailed upward. His right hand contacted the rearview mirror which subsequently broke the laminated windshield. His left hand contacted the upper A-pillar resulting in a reported body fluid transfer. He rebounded back into the seat back support, remaining in his respective seated position. He reportedly was uninjured.

Figure 16. Drivers seated position and contacts

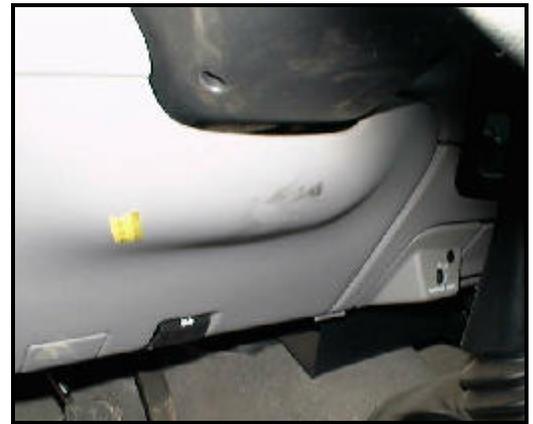
Figure 15. Drivers left knee contact to knee bolster

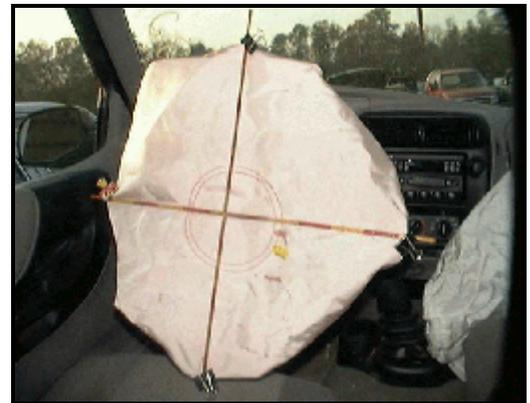
Figure 17. Driver deployed air bag and contact point

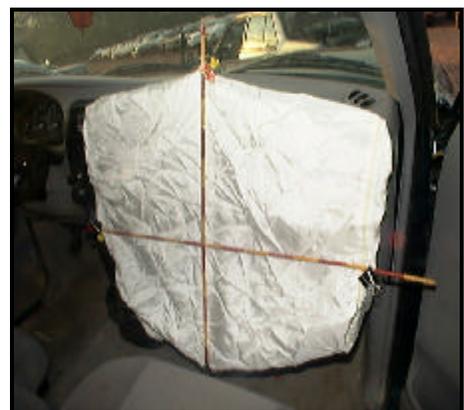
The front, right air bag was located at the mid-instrument panel level. The module cover flap is hinged at the top and is rectangular in shape. The module cover, apparently did not contact the windshield during deployment. There was no residual damage to the air bag or the single module cover flap. The air bag fabric was devoid of any detectable areas of occupant contact. The adult passenger in this seated position, reportedly was uninjured.

Figure 18. Deployed front, right passenger air bag
