Remote, Redesigned Air Bag Special Study

Dynamic Science, Inc., Case Number (1998-048-804G)

1998 Chevrolet S-10

November, 1998

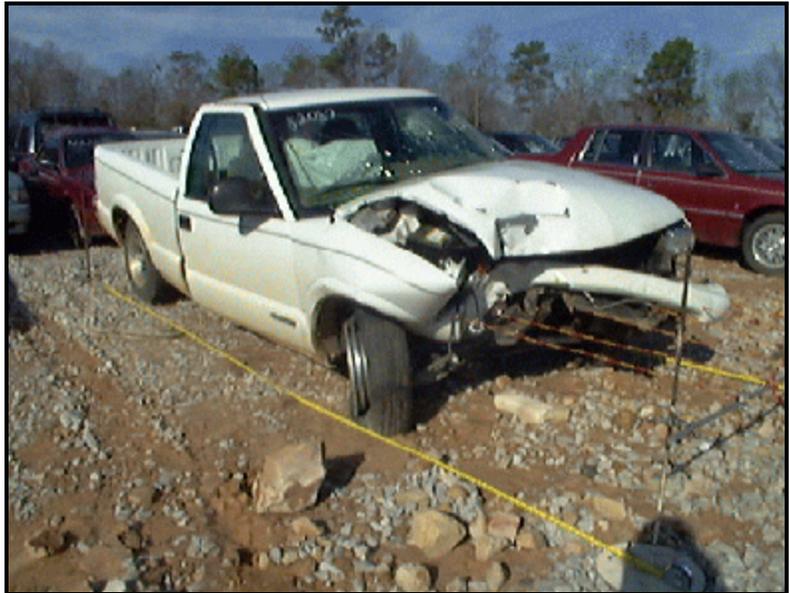
Figure 1. Exterior, Vehicle 1 (Chevrolet S-10)

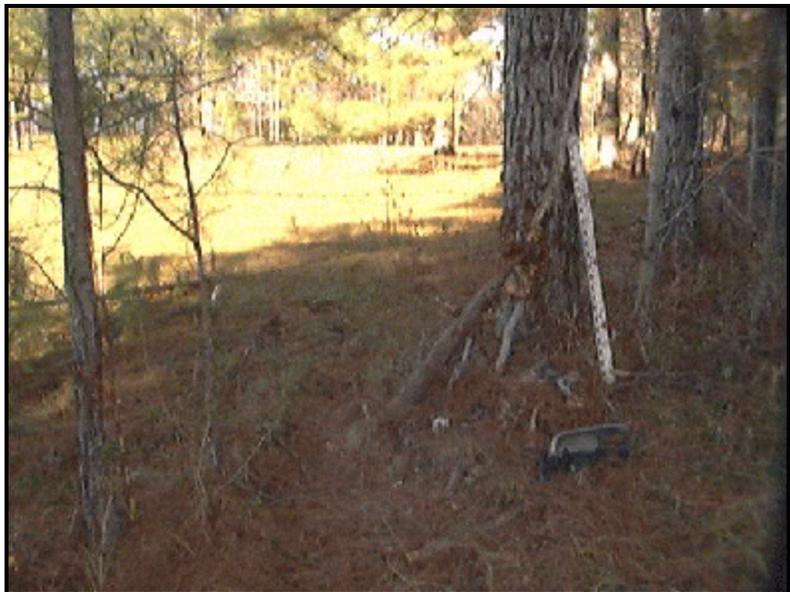
Figure 2. Crash scene, point of impacts

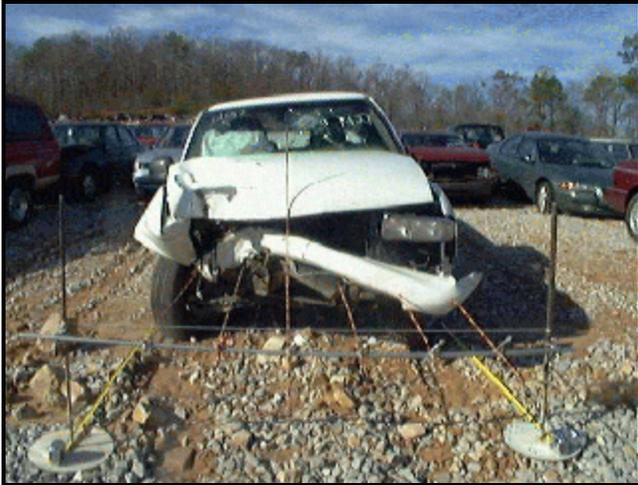
The driver of Vehicle 1 cut the curve too tight and as Vehicle 1 was coming around the curve, the right front wheel dropped off the right side of the road, entering the deposit of loose gravel on the roadside. As the driver attempted to bring the vehicle back onto the road, the wheels began to slide on some of the gravel that had accumulated in this section of the road. Vehicle 1 slid across the roadway and exited the left roadside where it struck a large tree (event 1) with the front plane (12FREW3).

A Delta V was calculated for event 1, utilizing WinSMASH, to be 48 kmph (30 mph).

Figure 3. Exterior, Case vehicle (event 1 damage)

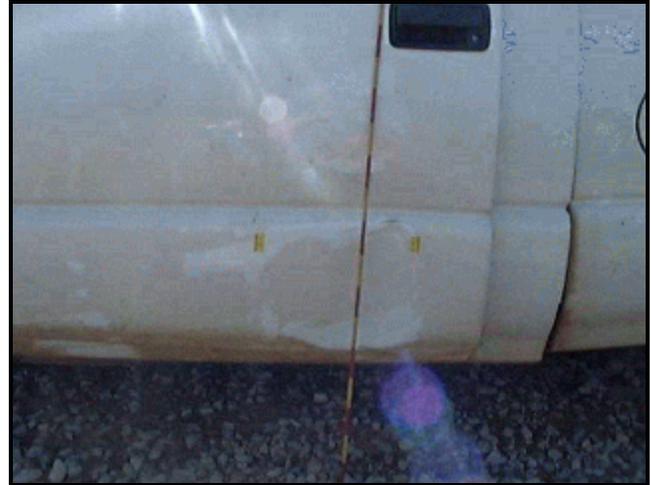
clockwise and impacted a second tree (event 2) with the left plane (12LPMS1) in a minor sideswipe configuration.

Figure 4. Exterior, Case vehicle (event 2 damage)

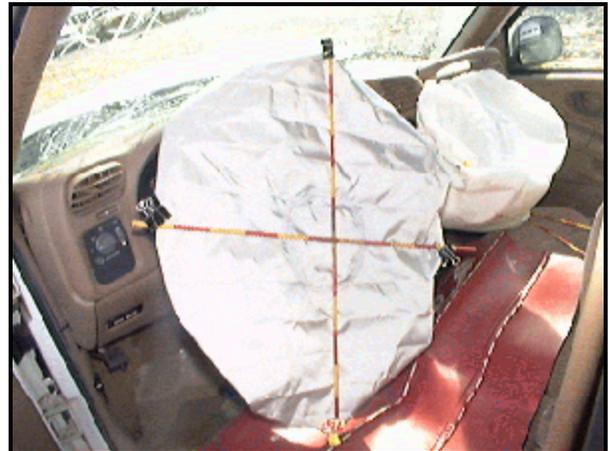
The front left air bag was housed in the steering wheel hub and was concealed by symmetrical I-configuration cover flaps. The circular air bag was equipped with two tethers and two vent ports. No contact evidence was found on the bag and the bag and cover flaps were not damaged.

Figure 5. Interior, case vehicle. Frontal air bags.

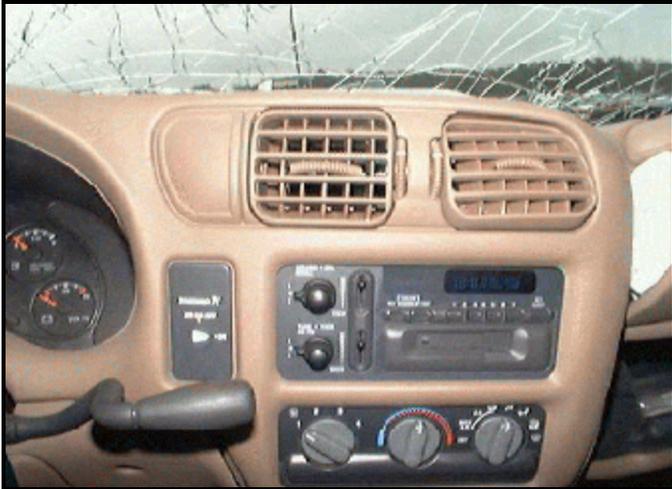
The front right air bag shut off switch was located on the center-instrument pane area. The switch is key activated and was turned to the "on" position at the time of the crash.

Figure 6. Interior, case vehicle. Air bag shut off switch.

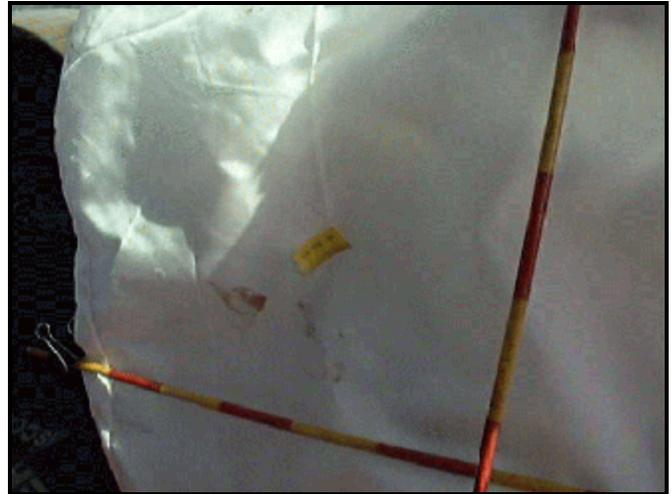
The front right air bag was housed in the mid-instrument panel position. The single air bag module cover flap was a rectangular configuration. The rectangular air bag was equipped with two vent ports and was not tethered. Contact evidence consisting of blood was found on the left side of the front of the bag as a result of contact with the driver's face. The bag and cover flap were not damaged.

Figure 7. Interior, case vehicle. Passenger air bag contact evidence (blood).

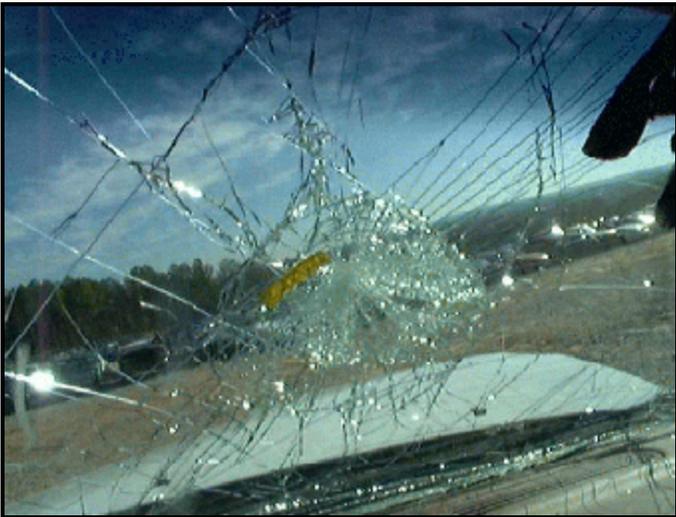
At impact, the unrestrained driver initiated a forward trajectory in response to the 10 degree principle direction of force. It appears that the driver’s torso engaged the right side of the driver side air bag. The driver’s head then struck the windshield (spider web crack) and rearview mirror (deformed/cracked) causing the forehead laceration. At some point it also appears that the driver struck the passenger side air bag (blood), but it is unclear if this was during the impact or post-impact. The driver reported that he did not lose consciousness and he was “sore all over” as a result of the crash.

Figure 8. Interior, case vehicle. Windshield contact.

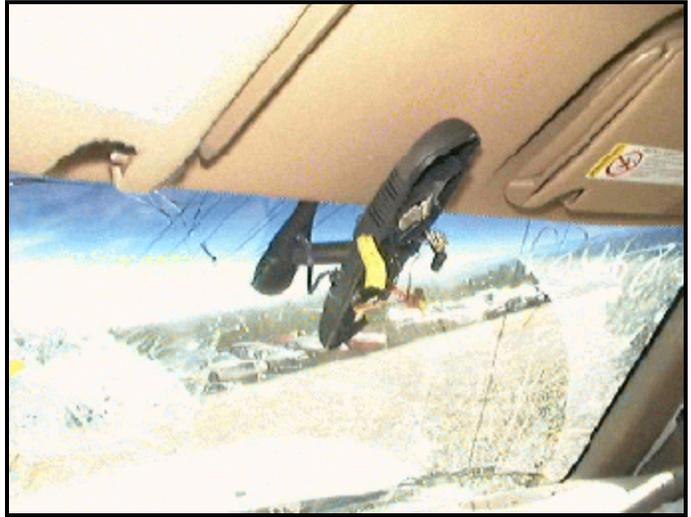
Figure 9. Interior, case vehicle. Rearview mirror contact.
