Remote, Redesigned Air Bag Special Study

Dynamic Science, Inc., Case Number ( 1998-48-093C)

1998 Jeep Grand Cherokee

October 1998

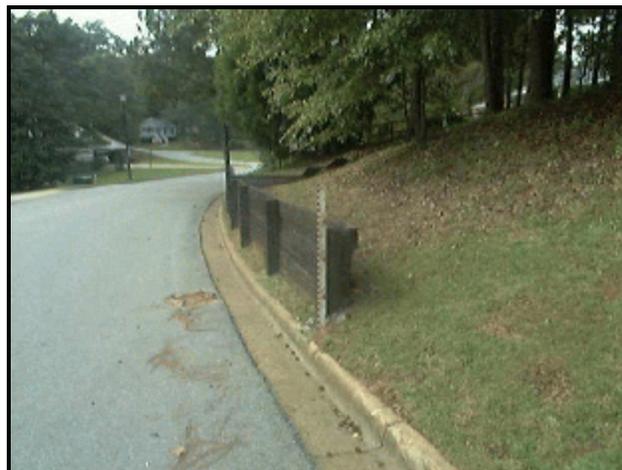
**Figure 1.** Path to object struck

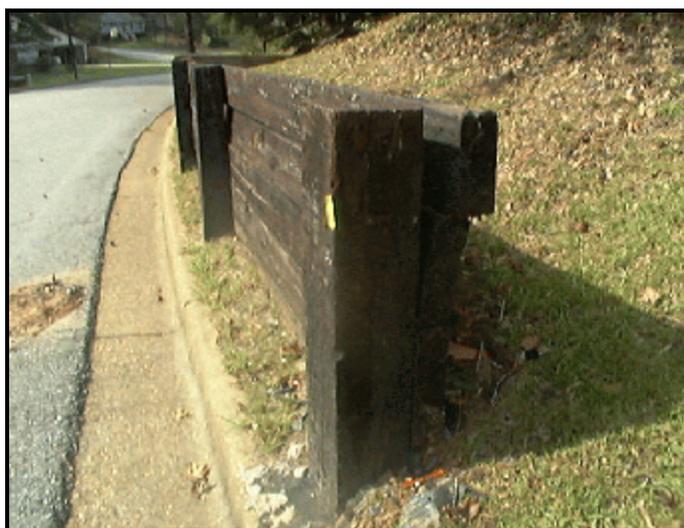
**Figure 2.** Wooden retaining wall (closeup)

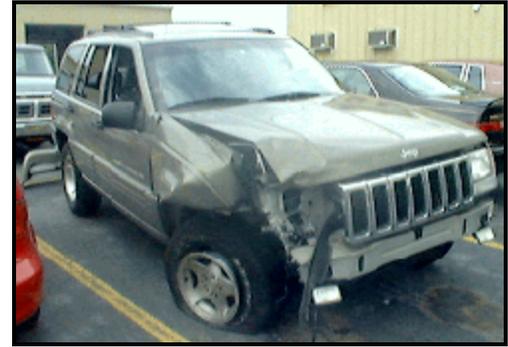
**Figure 3.** Exterior, oblique view, 1998 Jeep Cherokee

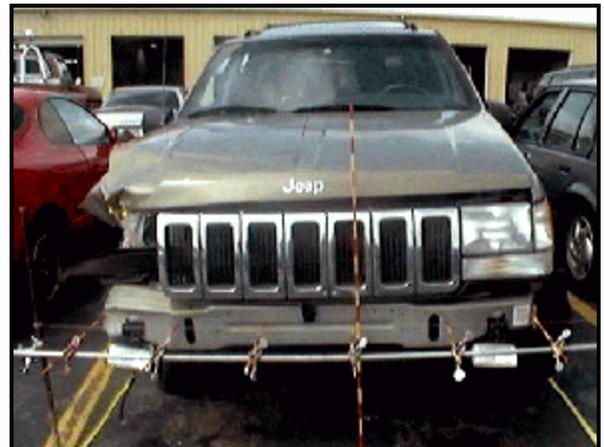
**Figure 4.** Exterior, 1998 Jeep Grand Cherokee

Plane of Impact	Field L cm/in.	C1 cm/in.	C2 cm/in.	C3 cm/in.	C4 cm/in.	C5 cm/in.	C6 cm/in.
Bumper	156	2	0	0	0	0	3
	61.4	0.8	0	0	0	0	1.2

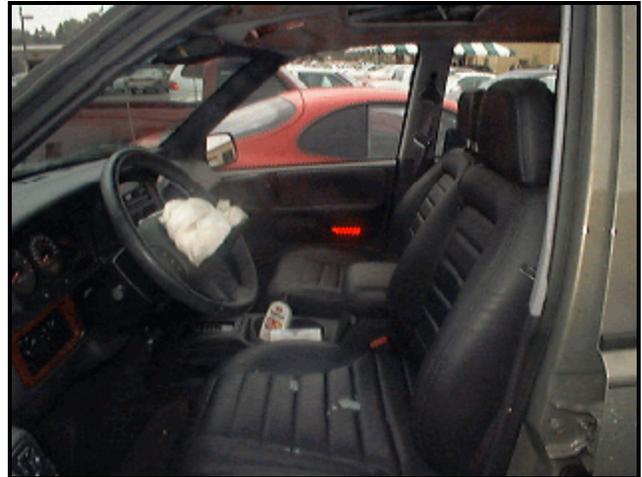
This vehicle sustained integrity loss through the left front side glass. The glass was disintegrated due to both the rollover and the interaction of the driver's left side. There were no intruding components. There were occupant contacts noted to the left interior side surface and to the center mirror.

**Figure 5.** Interior

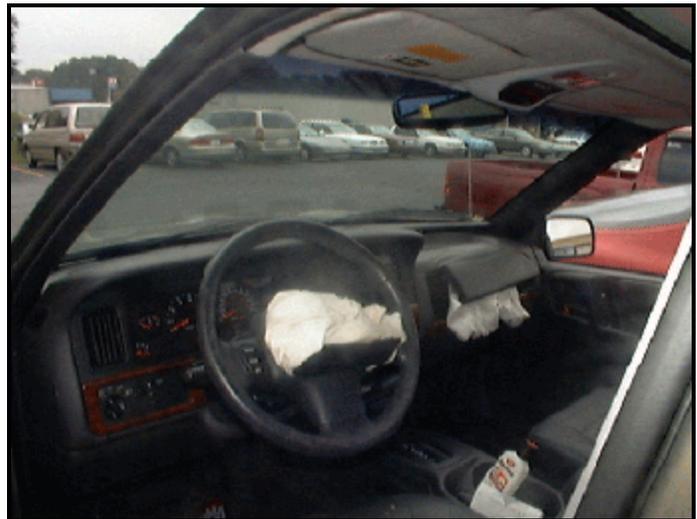
The front left air bag was housed in the steering wheel hub and was concealed by double horizontal H-configuration module cover flaps. The circular air bag was tethered by two straps and did not have any vent ports. The lower instrument panel is shrouded with a rigid plastic knee bolster. The tilt steering wheel was adjusted to the full up position at the time of the vehicle inspection.

**Figure 6.** Driver and front-passenger air bags

The front right air bag was located in the face of the instrument panel. There are horizontal module cover flaps. The untethered, unvented air bag was undamaged. There was no occupant in this seat position.

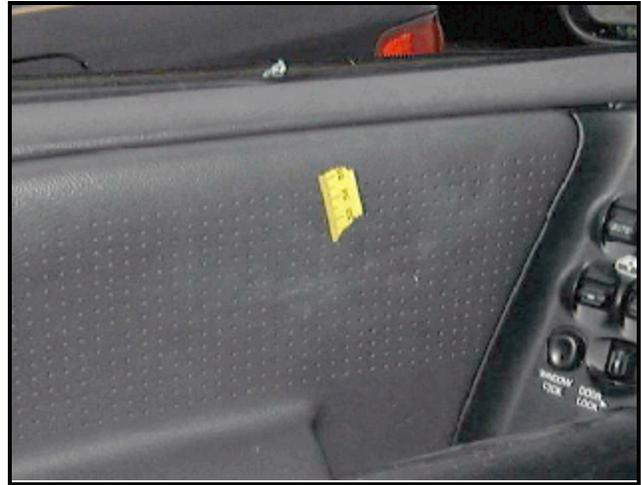
**Figure 7.** Possible door contact.

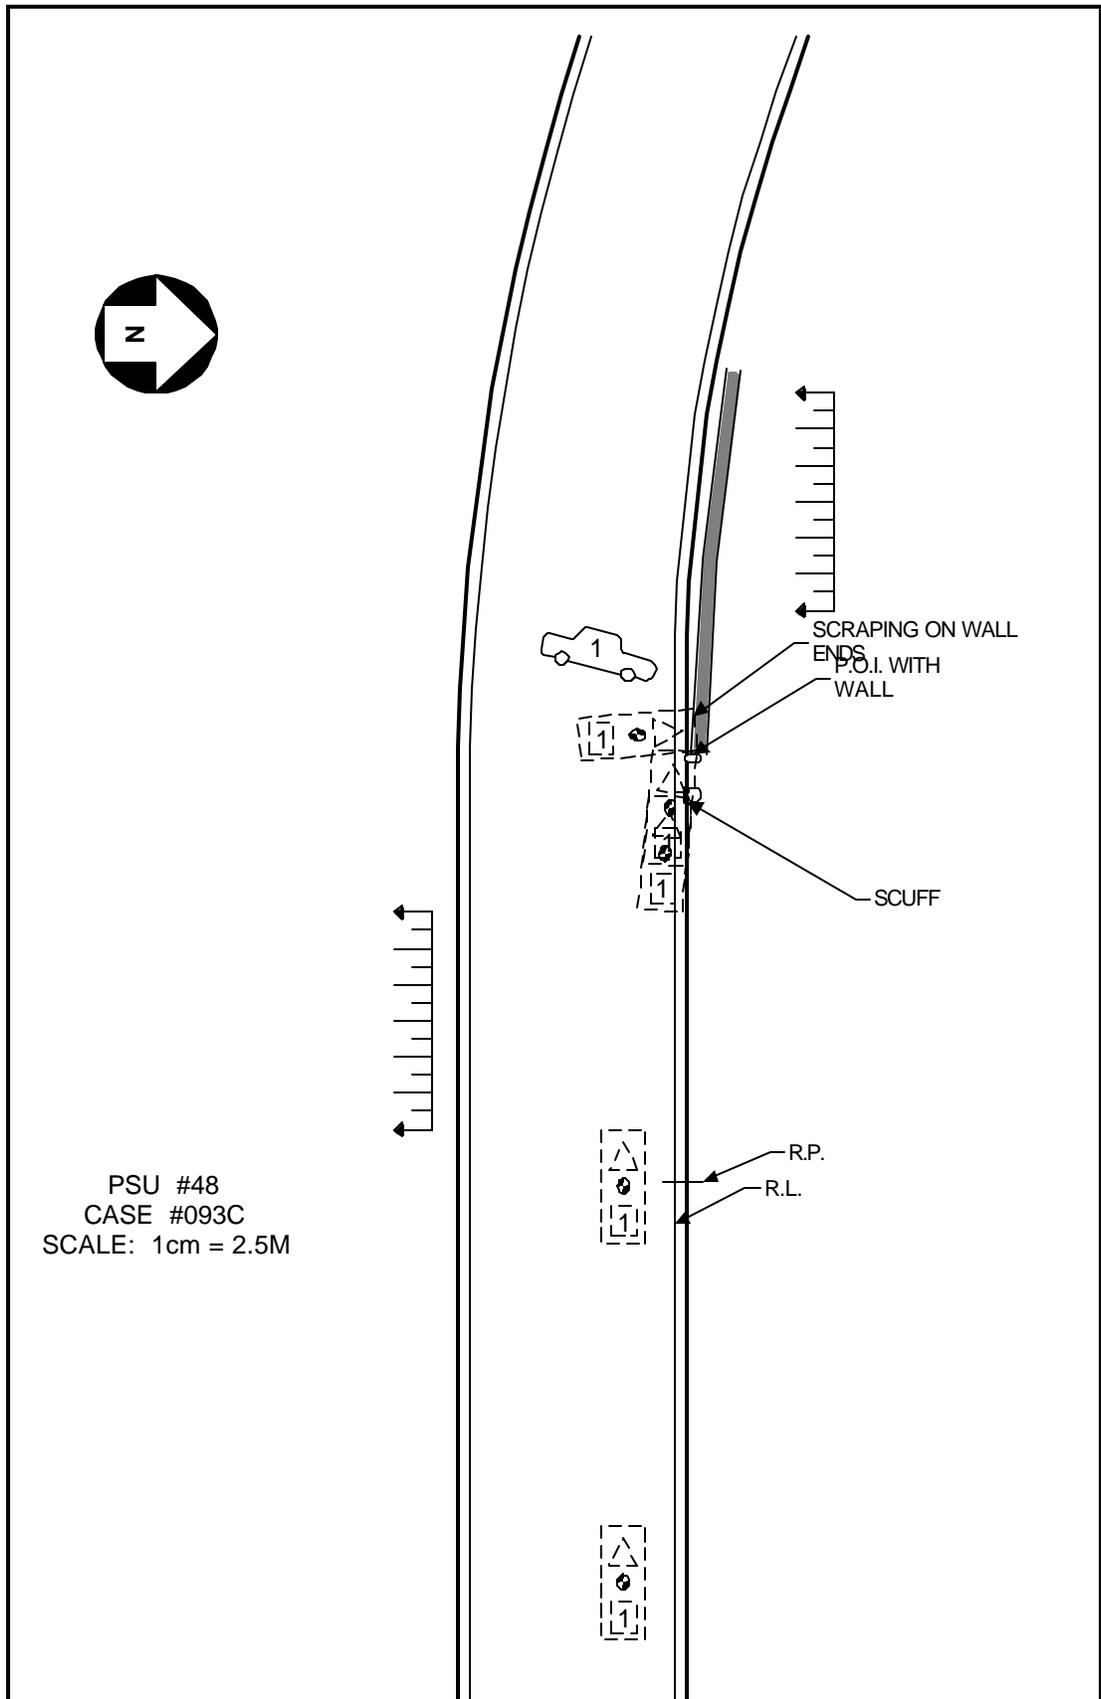
Figure 8. Scene Diagram

Vehicle 1, a 1998 Jeep Grand Cherokee driven by a properly restrained 50-year-old female (168 cm/60 in., 61 kg/134 lbs), was traveling westbound at a police reported speed of 40 km/h (25 mph). The driver of this vehicle reached over to her right to get her purse. Vehicle 1 drifted to the right, departed the roadway, and struck a wooden retaining wall (CDC = 12FREE3). The driver attempted to avoid the collision by steering to the left. Vehicle 1 sustained a longitudinal delta v of -12 km/h (-7.5 mph). The driver and passenger side front air bags deployed at this point. Vehicle 1 rotated 90E and flipped onto its left side (00LDAO2) and came to rest on the roadway.
