Remote, Redesigned Air Bag Special Study

Dynamic Science, Inc., Case Number (1998-049-153C)

1998 Chrysler Town And Country

September/1998

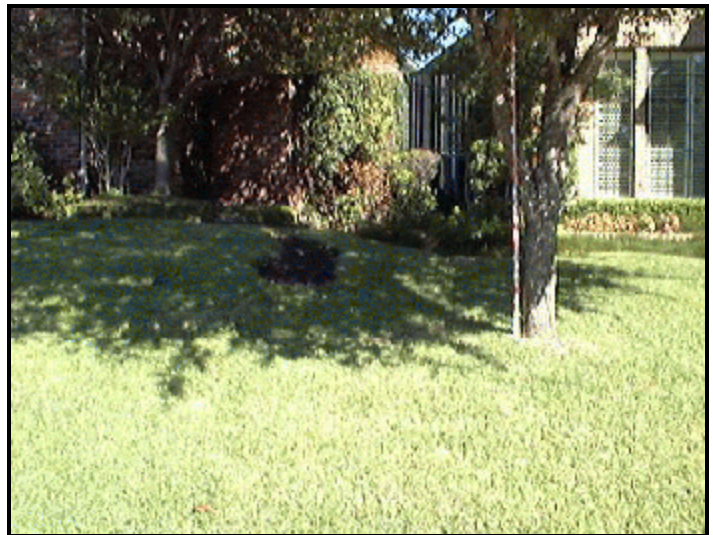
The driver reported that as they were approaching the stop sign, she believes that the accelerator pedal got stuck and she was unable to stop the vehicle at the intersection. Vehicle 1 traveled through the intersection and struck a curb, damaging the right front wheel (12FRWN3) and deflating the tire (event 1). Vehicle 1 then crossed a residential lawn where the front plane (12FREE5) struck a tree (event 2). The damage extended partially down the right side of the vehicle. Vehicle 1 then continued across the lawn where the front plane (12FREN2) struck a brick wall (event 3) and the vehicle came to final rest.

Figure 2. Approach to tree impact (event 2)

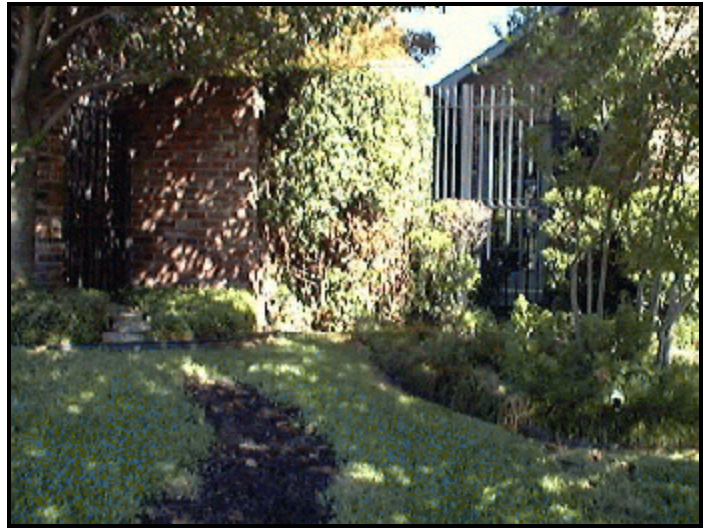
Vehicle 1 came to rest engaged with the damaged brick wall facing northwest.

Figure 3. Approach to wall impact (event 3)

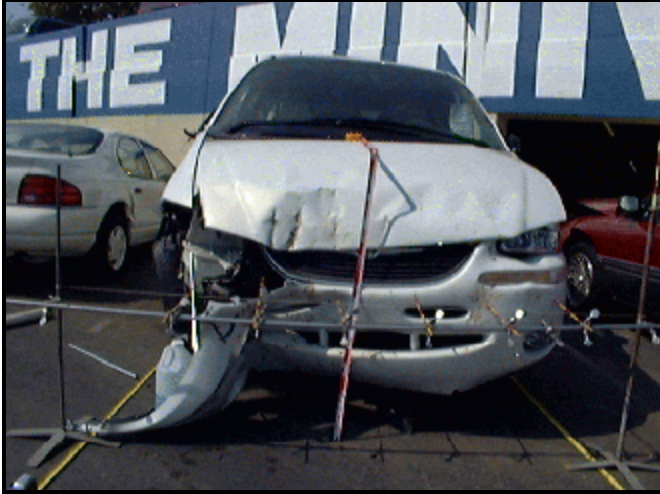
Model year, make and model	1998 Chrysler Town And Country
VIN	1C4GP64L2WB
CDC	12FREE5 (event 2), 12FREN2 (event 3)

Figure 4. Exterior, Vehicle 1 (1998 Chrysler Town & Country)

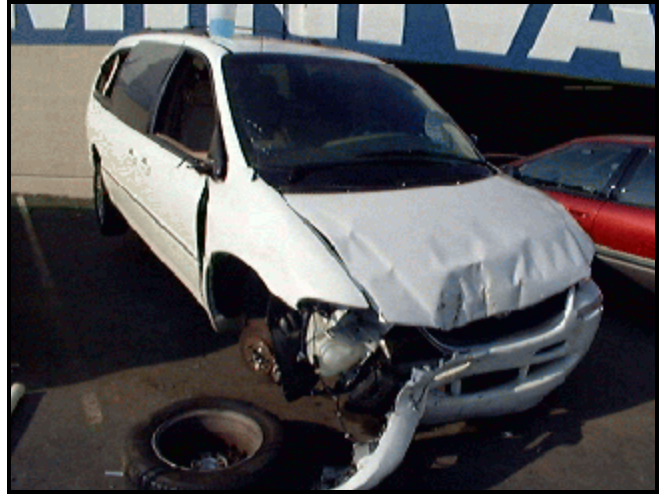
Figure 5. Exterior, Vehicle 1 (1998 Chrysler Town & Country)

Plane of Impact	Field L cm/in.	C1 cm/in.	C2 cm/in.	C3 cm/in.	C4 cm/in.	C5 cm/in.	C6 cm/in.
Bumper	134	6	5	13	29	37	31
	52.8	2.4	2	5.1	11.4	14.6	12.2

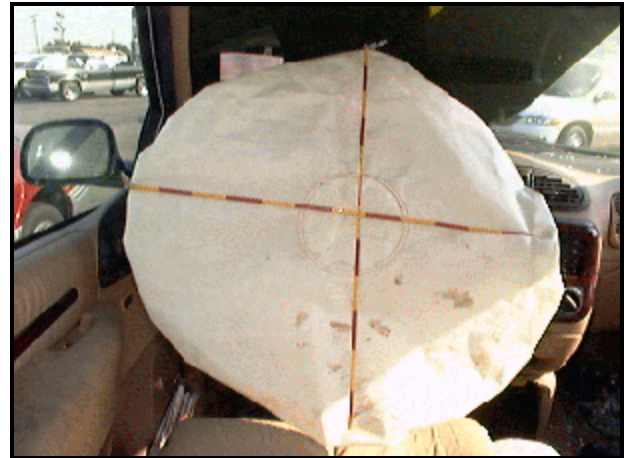
The front left air bag was housed in the steering wheel hub and was concealed by asymmetrical H-configuration cover flaps which were not damaged. The circular air bag was equipped with two tether straps and no vent ports. Contact evidence consisting of blood was found primarily on the lower-right quarter of the front of the bag. The bag was not damaged.

Figure 6. Interior, case vehicle. Driver's side air bag.

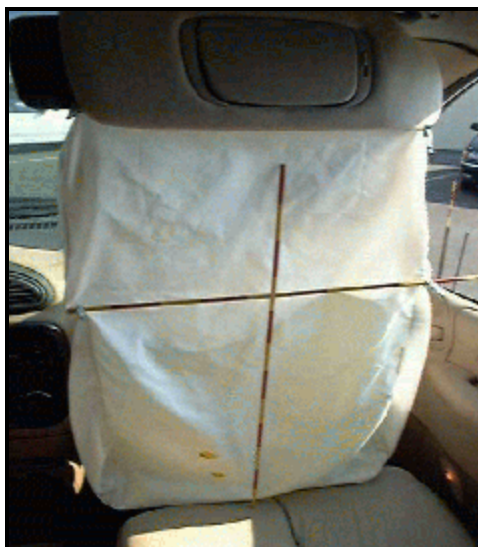
The front right air bag was housed in the mid-instrument panel position. The H-configuration rectangular cover flaps were not damaged. The rectangular air bag was not equipped with tether straps or vent ports. Contact evidence consisting of blood spots was found on the lower half of the front of the bag. Two large holes and several small holes were found on various locations of the bag. There was no air bag shut off switch present in the vehicle.

Figure 7. Passenger's side air bag

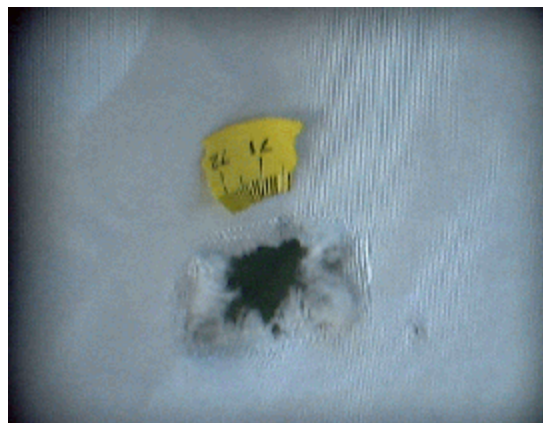
Figure 8. Passenger's side air bag damage
