Remote, Redesigned Air Bag Special Study

Dynamic Science, Inc., Case Number (1998-49-176A)

1998 Ford Mustang GT

November/1998

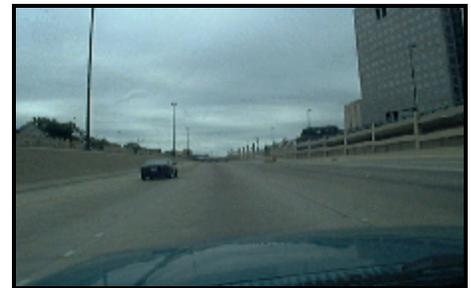
Figure 1. Area of the initial impact

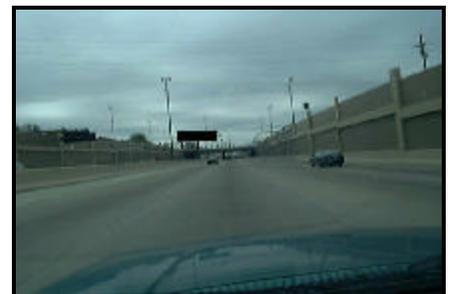
Figure 2. Area of Vehicle 1's rollover

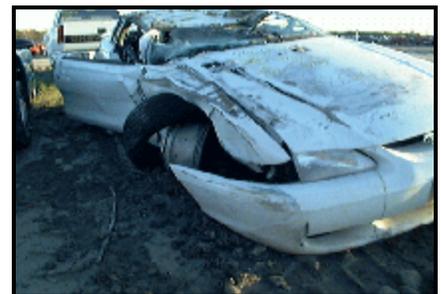
The front, right bumper corner of Vehicle 1 (12FRAS6) impacted the left, rear bumper corner of Vehicle 2. Direct contact damage to the front of Vehicle 1 was documented to be 6 cm (2.4 in.) and engaged along the right side plane, snagging the front, right wheel. The front, right tire engagement provided enough longitudinal deceleration to deploy the redesigned frontal air bags.

Figure 3. Exterior Vehicle 1 showing initial front, right impact damage

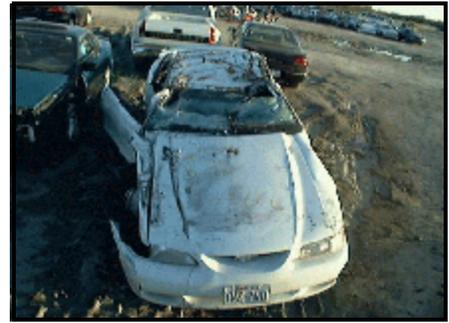
Figure 4. Overhead view showing rollover damage to Vehicle 1.

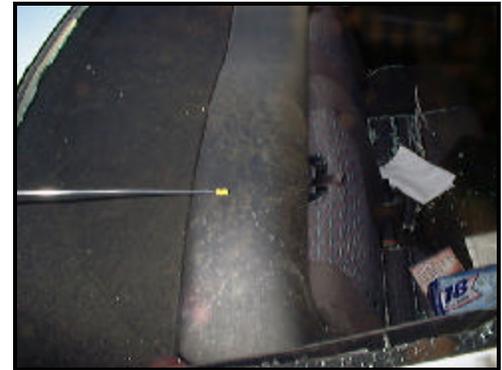
During the rollover sequence, the unrestrained driver of Vehicle 1 was thrust rearward and was partially ejected through the backlight opening. The driver's head contacted the concrete roadway surface resulting in numerous severe head injuries. Driver 1 sustained a scalp laceration which measured 10 cm (3.9 in.) in length (AIS-2). He sustained a right parietal, temporal and occipital skull fracture with the brain and dura exposed (AIS-4), a cerebral laceration (AIS-4), subdural hematoma (AIS-4), a subarachnoid hemorrhage (AIS-3) and a cerebral contusion (AIS-3) all noted to the right side. Driver 1 was fatally injured and had succumbed to his injuries at the crash scene. It was later determined that he had a blood alcohol level of .31%. The driver of Vehicle 2 sustained a cervical strain (AIS-1) and a left shoulder abrasion (AIS-1) from the shoulder belt webbing.

Figure 5. View showing area of driver 1's partial ejection.

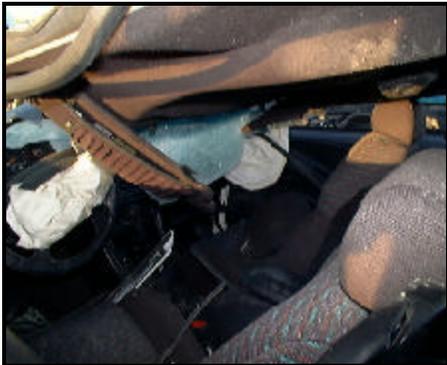
This vehicle is equipped with front bucket seats that have the folding seat back feature. The driver’s seat was adjusted between the middle and rearmost track position. The front, left seat back was also deformed rearward and rotated slightly clockwise due to occupant (driver) loading. The front seats are equipped with adjustable head restraints which were not damaged during the impact.

Figure 6. Front, Left view showing interior of case vehicle

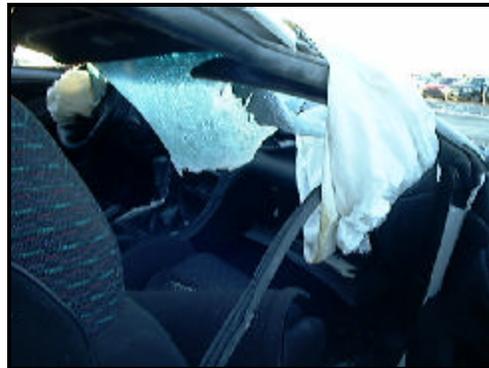
Figure 7. Front, right showing case vehicle interior

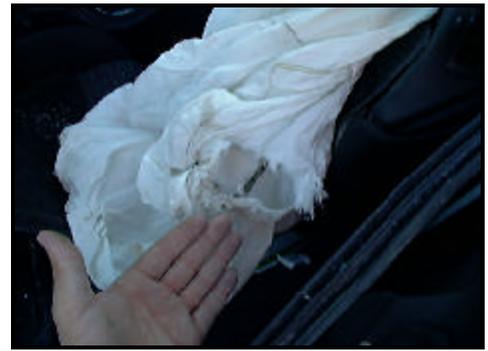
Figure 8. View showing hole in passenger air bag

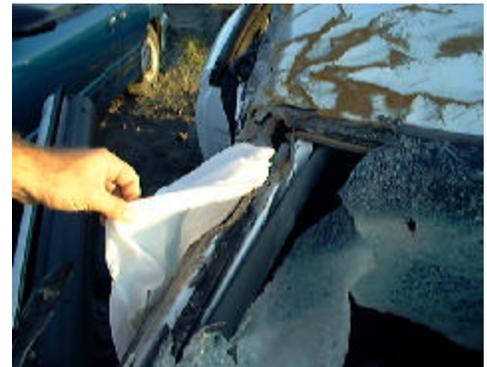
The front, right passenger air bag is located on the instrument panel (top mount). The module deployment door is rectangular in shape and constructed with molded-in tear seam that separates and hinges out of the way during the deployment. The air bag module consists of an inflator unit, air bag, reaction housing with mounting brackets and the trim cover module door. The air bag is constructed of ripstop nylon and inflates to a total volume of 8 cubic feet. There was considerable damage to the air bag due to contact with the concrete roadway surface. The air bag was pinned between the pavement and the right A-pillar as the vehicle slid on its roof panel.

Figure 9. Passenger air bag melted to the right A-Pillar

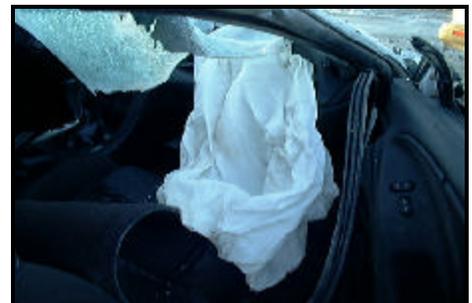
Figure 10. View showing deployed passenger (front, right) air bag
