Remote, Redesigned Air Bag Special Study

Dynamic Science, Inc., Case Number (1998-49-193E)

1998 Dodge Neon

November 22, 1998

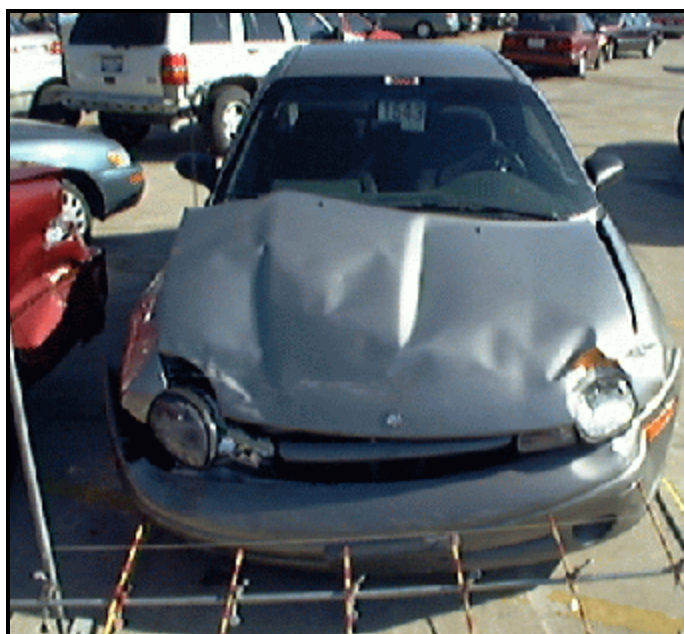
Figure 1. Exterior, Vehicle 1

As Vehicle 2 entered the intersection it was struck in the right side (02RYEW3) by the front of Vehicle 1 (11FDEW1). Vehicle 1 sustained a longitudinal delta v of -16 km/h (-9.9 mph). Both the driver and passenger side air bags deployed at this point. Vehicle 2 sustained a lateral delta v of -10 km/h (-6.2 mph). Vehicle 1 was pushed in a clockwise rotation and came to rest in the intersection 90E from the original path of travel. Vehicle 1 was redirected to the left and came to rest near the median in the southern leg of the intersection.

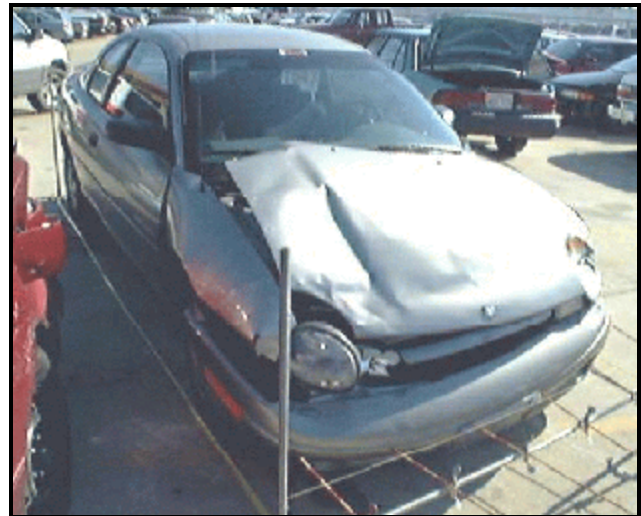
Figure 2. Exterior, case vehicle

| CDC | 11FDEW1 |

Table 3. Crush Measurements

| Plane of Impact | Field L cm/in. | C1 cm/in. | C2 cm/in. | C3 cm/in. | C4 cm/in. | C5 cm/in. | C6 cm/in. |
| Bumper | 136 | 10 | 9 | 11 | 12 | 12 | 15 |
| | 53.5 | 3.9 | 3.5 | 4.3 | 4.7 | 4.7 | 5.9 |

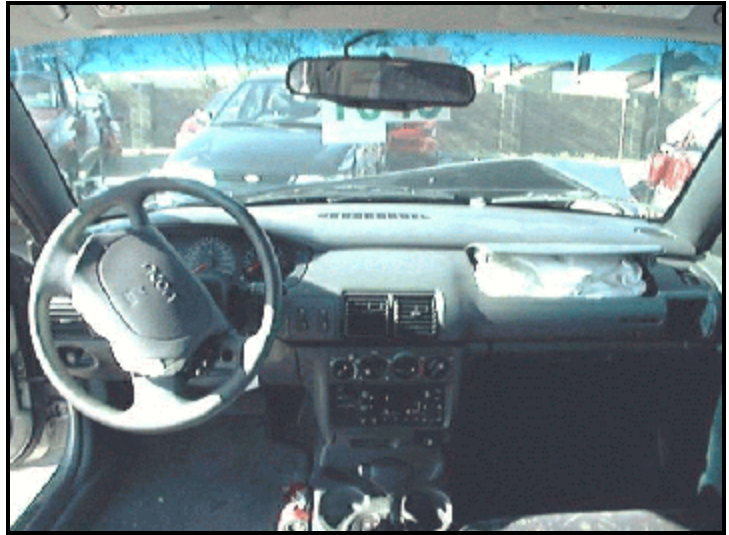
Figure 3. Vehicle interior, front view

The case vehicle was equipped with bucket seats with folding backs in the front left and the front right seating positions. The front left seat was adjusted to the rear most track position. Both front seats were equipped with adjustable head restraints which were not damaged. The rear of the vehicle was equipped with bench seats with folding backs. The vehicle was equipped with a tilt column—which was found in the full up position at the time of inspection. There was no steering wheel rim deformation.

The Dodge Neon was equipped with “Next Generation” driver and front-passenger air bags. The front left air bag was housed in the steering wheel hub and was concealed by a single module cover. The circular air bag was tethered by two tether straps and contained two vent ports. There was a scuff located on the left side of the face of the air bag module cover.

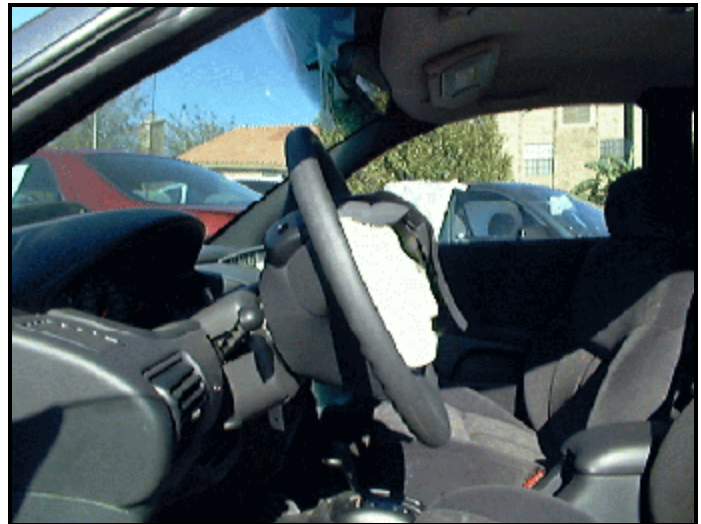
Figure 4. Vehicle interior, side view

This vehicle did not sustain any intrusion or any integrity loss.
