Remote, Redesigned Air Bag Special Study

Dynamic Science, Inc., Case Number ( 1998-49-803E)

1998. Ford, Contour Four-Door Sedan

July/1998

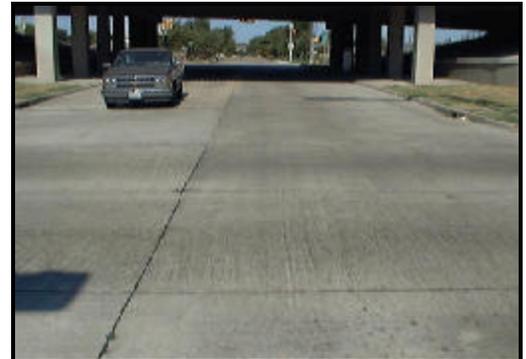
**Figure 1.** View showing Vehicle 1's travel lane and approximate point of impact

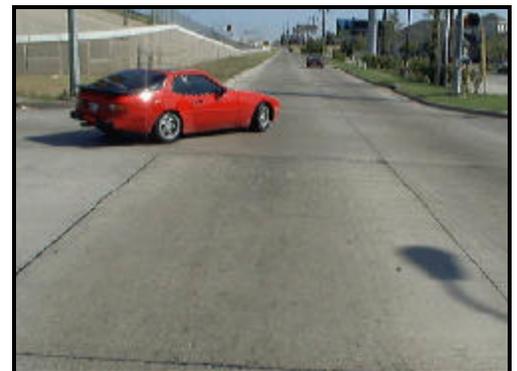
**Figure 2.** Pre-impact trajectory of Vehicle 2 and approximate point of impact

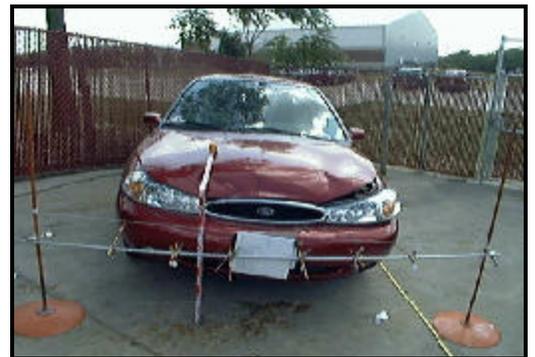
The full frontal plane of Vehicle 2/case vehicle (12FDEW1) impacted the left quarter-panel of Vehicle 1 in an "L"-type impact configuration. The total delta V for Vehicle 1 was calculated at 11.2 km/h (7 mph). The total delta V for Vehicle 2 (1998 Contour) was 14.4 km/h (8.9 mph) and the longitudinal delta V was 14.2 km/h (-8.8 mph)<sup>1</sup>. These results are slightly below or at the threshold level required for air bag deployment. Vehicle 1 rotated counterclockwise approximately 164 degrees before coming to rest facing in an easterly direction. Vehicle 2 also rotated counterclockwise and came to rest facing west.

**Figure 3.** Frontal Deformation (Vehicle 2) 1998 Ford Contour

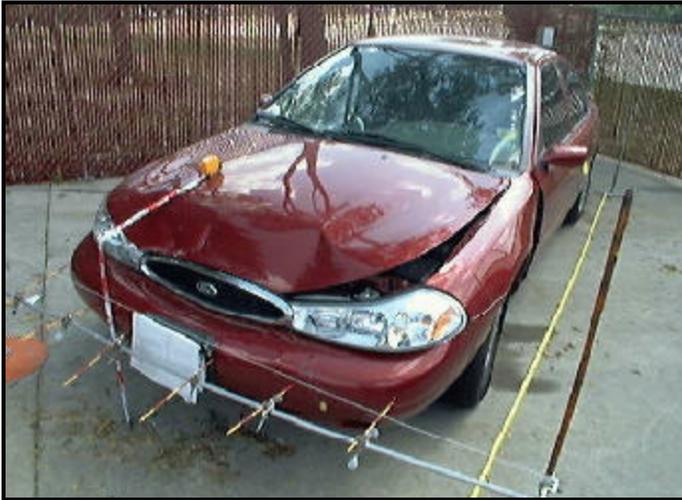
**Figure 5. Frontal Deformation to Ford Contour**

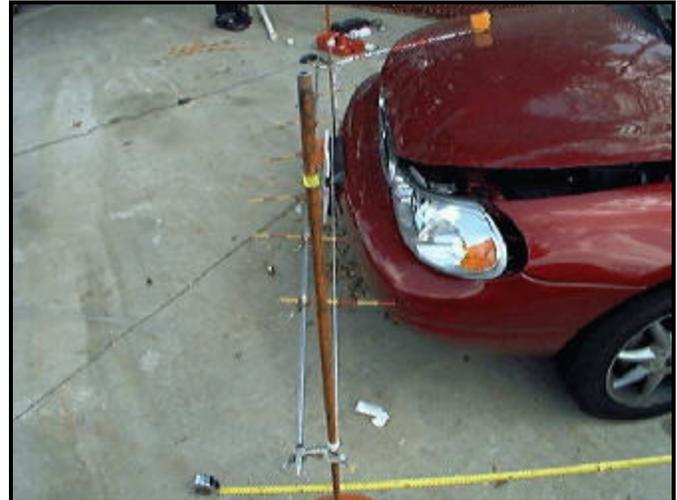
**Figure 6. Perpendicular view showing frontal damage to Vehicle1 (Ford Contour)**

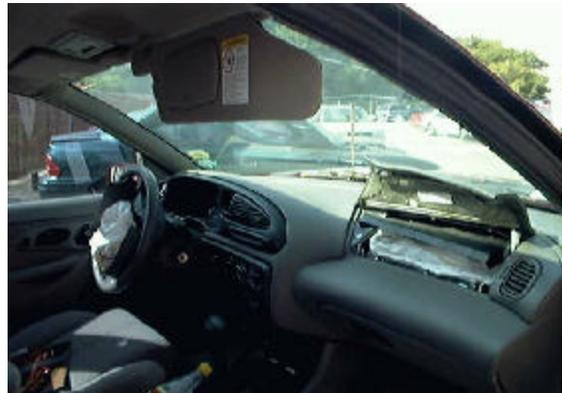
Damage to the interior of the 1998 Ford Contour consisted only of windshield glazing damage due to the passenger side air bag module flap cover contacting the windshield during deployment. There were no intruding components and the interior was devoid of any discernable occupant contacts.

**Figure 7.** Interior of Case Vehicle

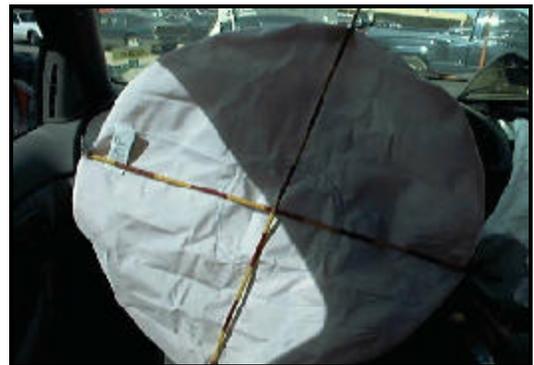
The front left air bag was housed in the steering wheel hub and was concealed by symmetrical double horizontal module cover flaps. The circular air bag was tethered by reportedly four straps and was equipped with two vent port holes. The lower instrument panel is shrouded with a rigid plastic knee bolster. There were no discernable areas of occupant contact to the air bag fabric. The air bag was undamaged and the air bag module flap covers separated at their designated tear points.

**Figure 8.** Deployed Drivers Air Bag

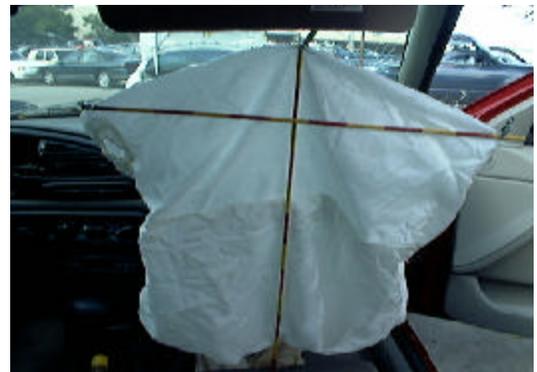
The front right air bag was located on the instrument panel, top surface plane. The module cover flap is an asymmetric shape that contours the instrument panel. It is primarily a rectangular shape. The module cover flap opened at its designated tear points and broke the laminated windshield glazing upon deployment. The untethered air bag was undamaged and was equipped with one vent port hole. There was no occupant positioned in front of this air bag.

**Figure 9.** Deployed Front Passenger Air Bag

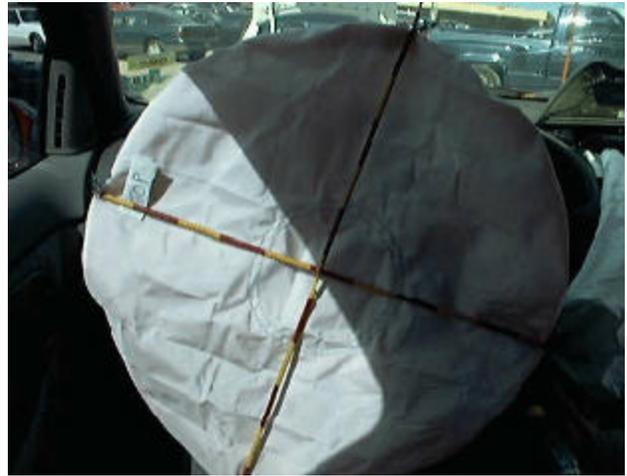
**Figure 11.** Deployed Drivers air bag
