Remote, Redesigned Air Bag Special Study

Dynamic Science, Inc., Case Number (1998-049-805E)

1998 Buick Regal

Summary

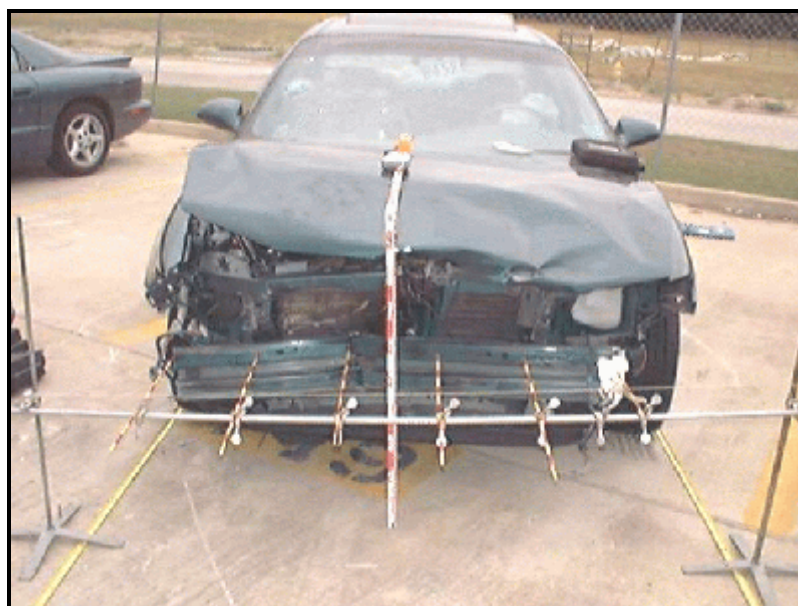
Figure 2. Front view of Vehicle 1 (1998 Buick Regal)

As Vehicle 2 reached the intersection, Vehicle 1 pulled out from the stop sign to begin a left turn to go north. The right front of Vehicle 2 (12FREE9) struck the front of Vehicle 1 (11FDEW2).

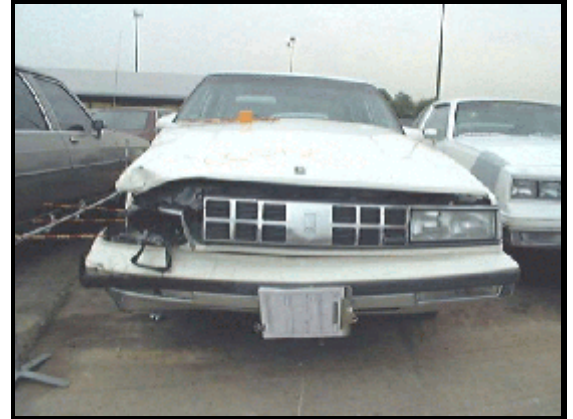
Figure 3. Front view of Vehicle 2 (1989 Oldsmobile 98)

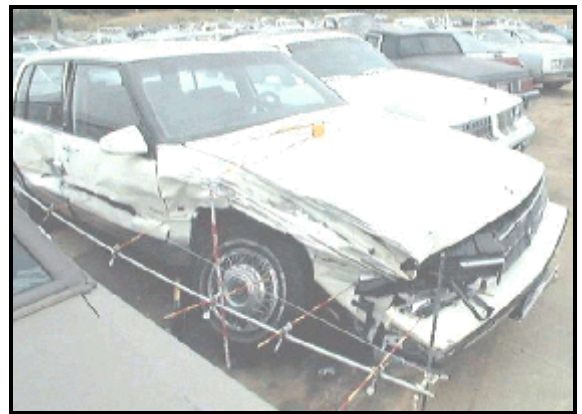
Figure 4. Front right view of Vehicle 2

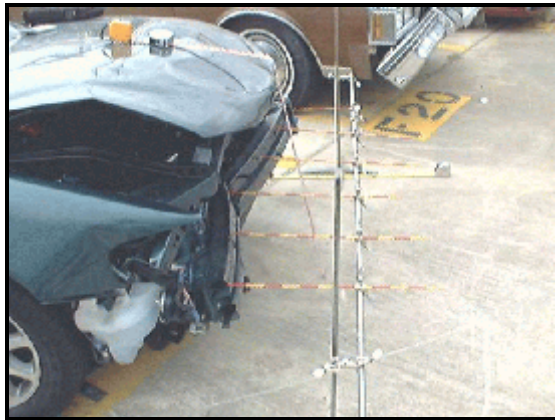
Figure 5. Front right view of Vehicle 1

Plane of Impact	Field L cm/in.	C1 cm/in.	C2 cm/in.	C3 cm/in.	C4 cm/in.	C5 cm/in.	C6 cm/in.
Bumper	144	10	18	29	37	24	22
	56.7	3.9	7.1	11.4	14.6	9.4	8.7

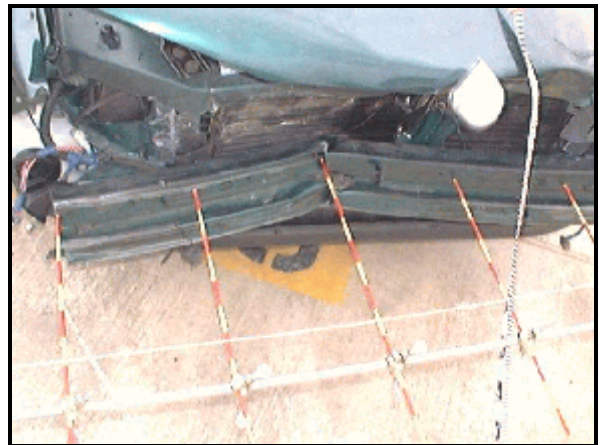
Figure 6. Close up of front right bumper, Vehicle 1

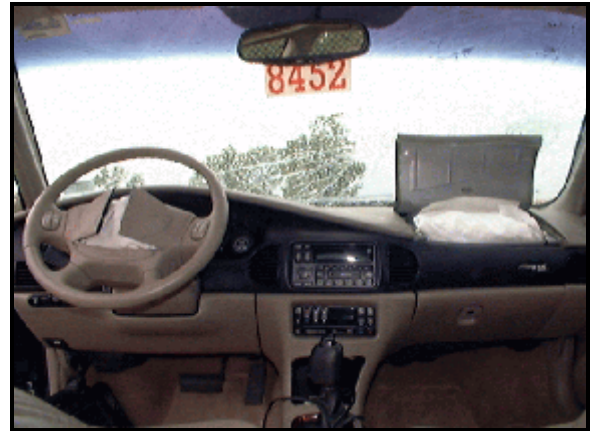
The interior of the Buick Regal did sustain any appreciable damage. There was no integrity loss nor was there any intrusion.

Figure 7. Front view of vehicle interior

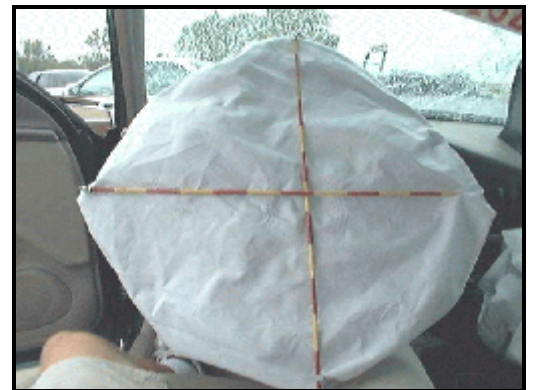
The front left air bag was housed in the steering wheel hub and was concealed by I configuration cover flaps that were not damaged in the crash. The circular air bag was equipped with two tether straps and two vent ports. No contact evidence was found on the air bag and the bag was not damaged.

Figure 8. Driver's frontal air bag

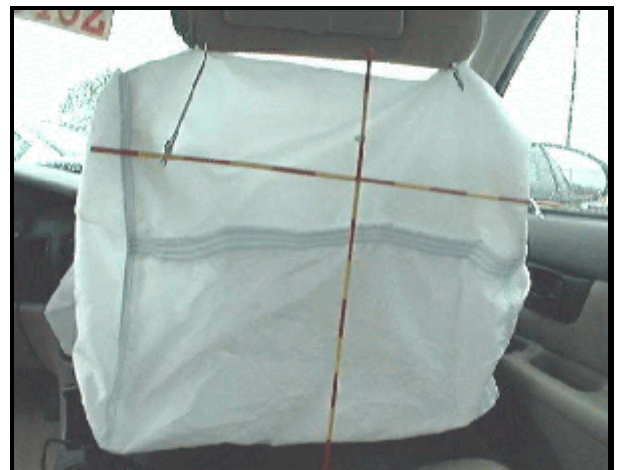
The front right air bag was housed in the top-instrument panel position and was concealed by a single rectangular cover flap which was not damaged in the crash. The rectangular air bag was equipped with one tether and no vent ports. No contact evidence was found on the bag.

Figure 9. Passenger frontal air bag
