Remote, Redesigned Air Bag Special Study

Dynamic Science, Inc., Case Number (1998-073-090G)

1998 Chevrolet Lumina

1. Report No. 1998-073-090G	2. Government Accession No.	3. Recipient Catalog No.	
4. Title and Subtitle		5. Report Date July 19, 1999	
		6. Performing Organization Report No.

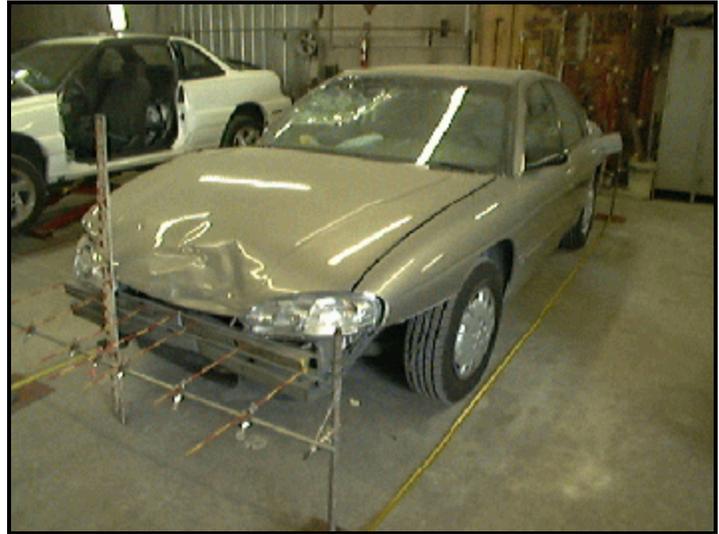
Figure 1. Exterior, Vehicle 2 (Chevrolet Lumina)

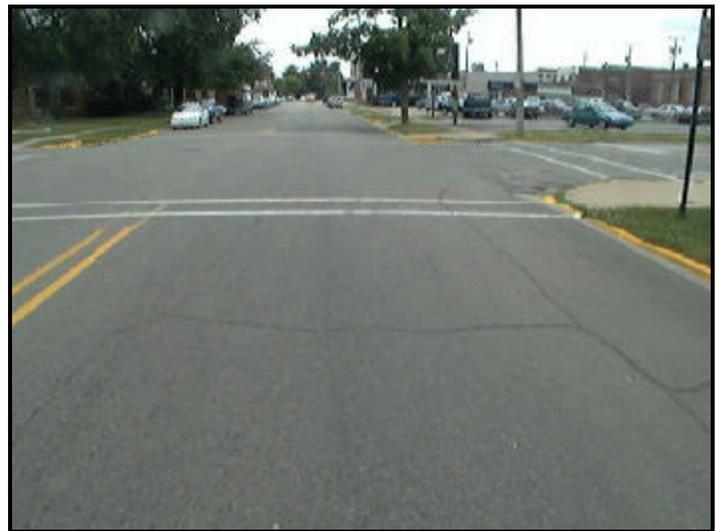
Figure 2. Crash scene. Vehicle 2 approach path.

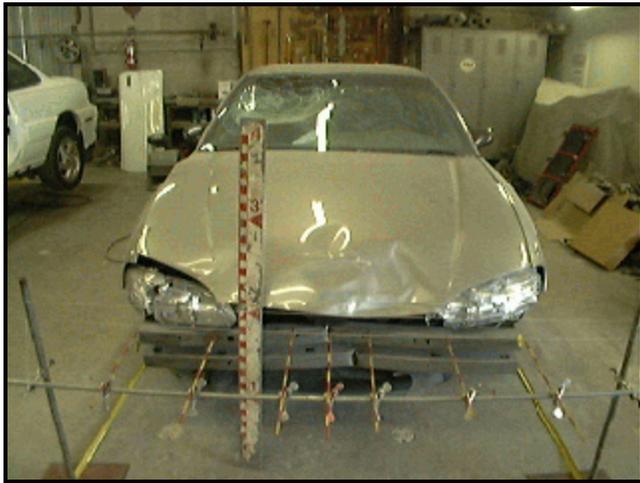
Figure 3. Exterior, Vehicle 2 (Chevrolet Lumina)

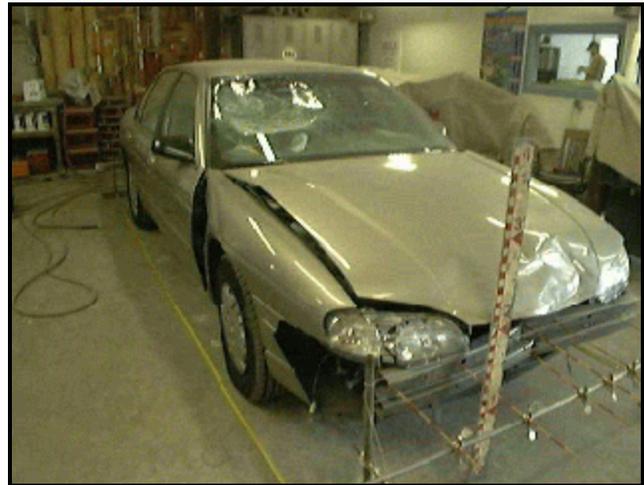
Figure 4. Exterior, Vehicle 2 (Chevrolet Lumina)

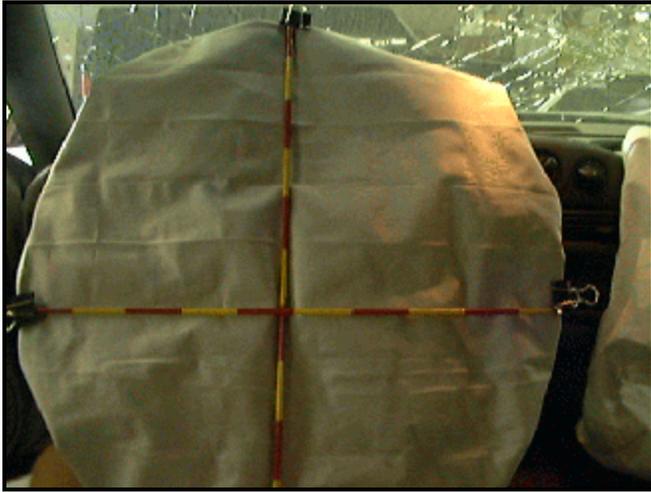
The front left air bag was housed in the steering wheel hub and was concealed by symmetrical I-configuration cover flaps which were not damaged in the crash. The circular air bag was equipped with two vent ports and two tether straps. The bag showed some signs of contact with the driver's face. The bag was not damaged.

Figure 5. Interior, case vehicle. Driver's side air bag.

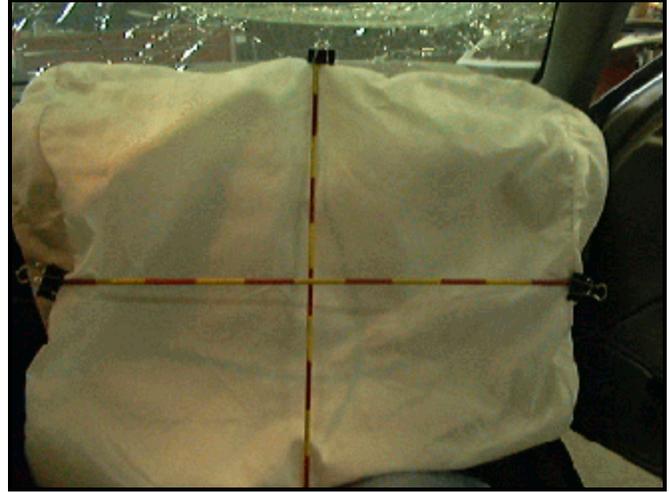
The front right air bag was housed in the top-instrument panel position and was concealed by a single rectangular cover flap which was not damaged in the crash. The rectangular air bag was equipped with two vent ports and no tether straps. The air bag was not damaged.

Figure 6. Interior, case vehicle. Passenger's side air bag.

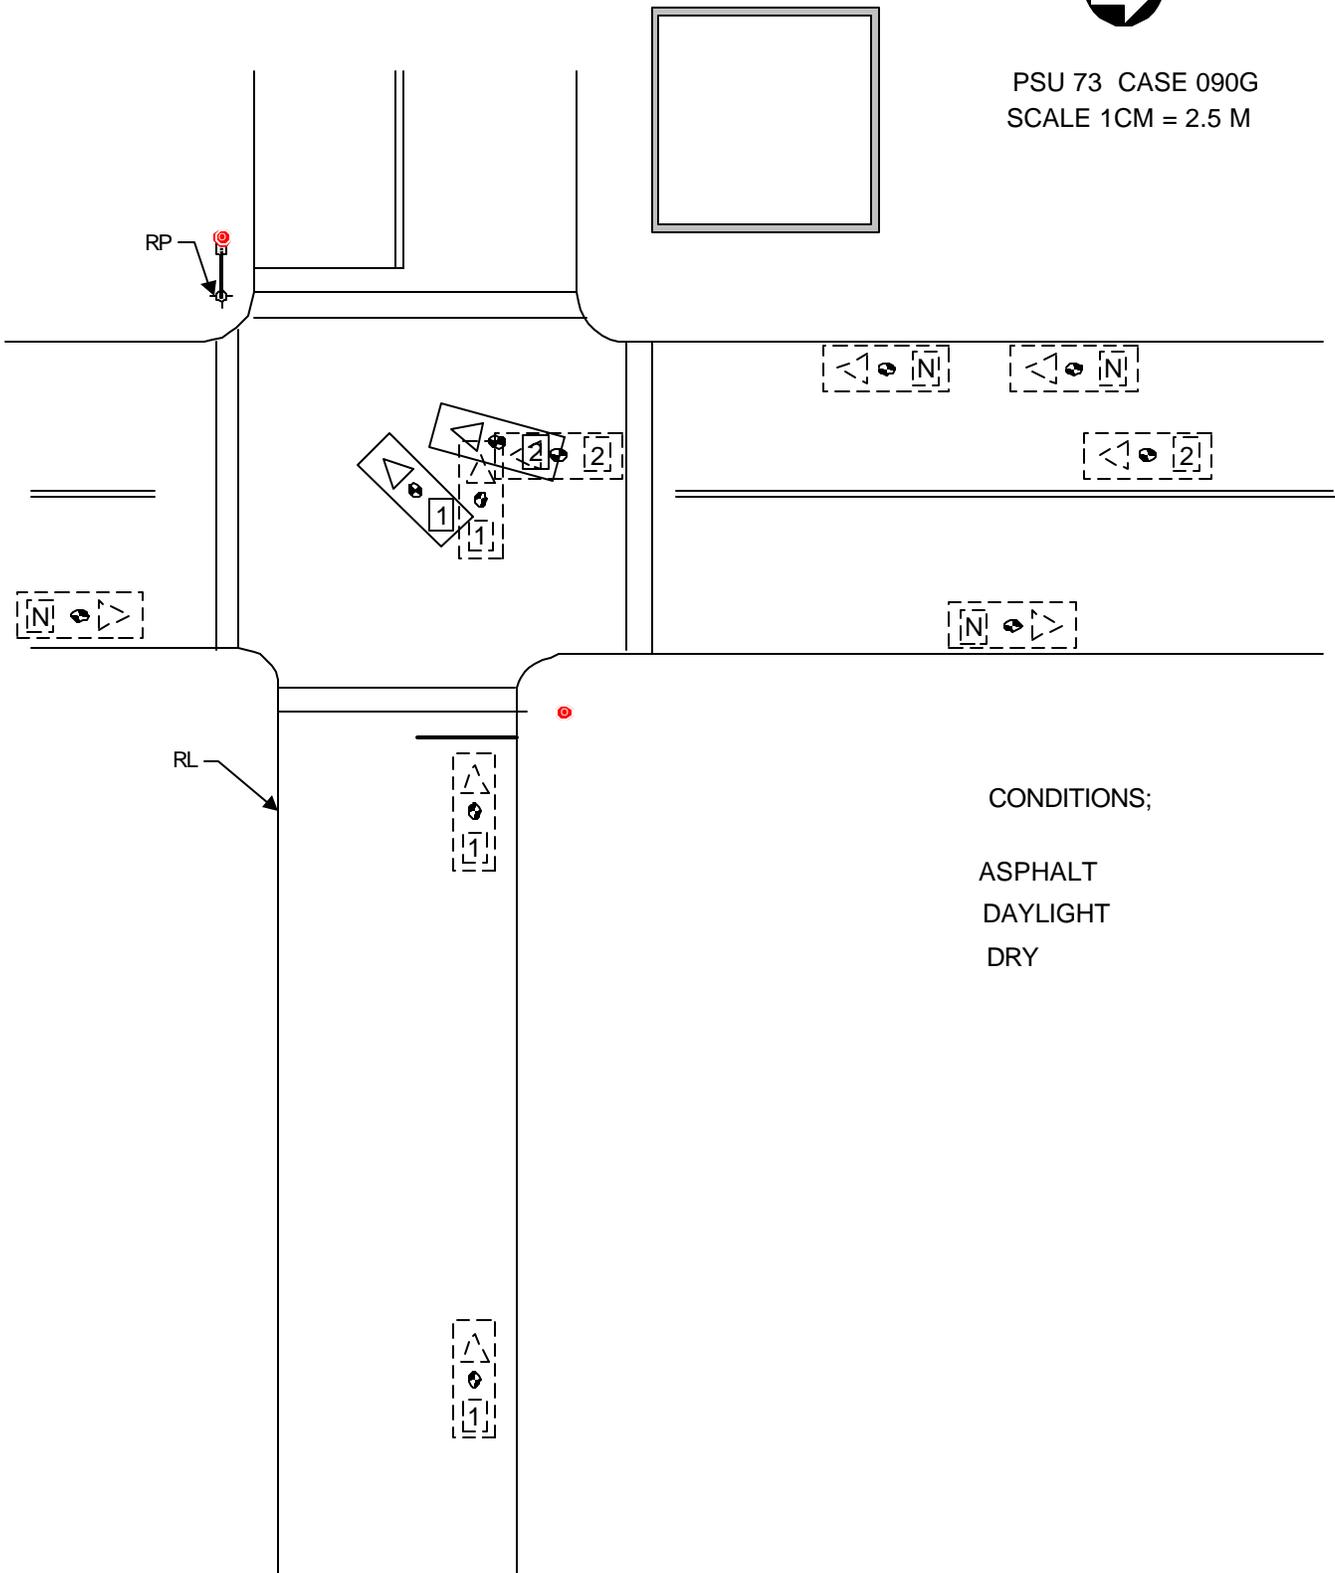
Scene Diagram

PSU 73 CASE 090G  
SCALE 1CM = 2.5 M

ASPHALT  
DAYLIGHT  
DRY
