Remote, Redesigned Air Bag Special Study

Dynamic Science, Inc., Case Number (1998-073-106A)

1998 Lincoln Continental

August/1998

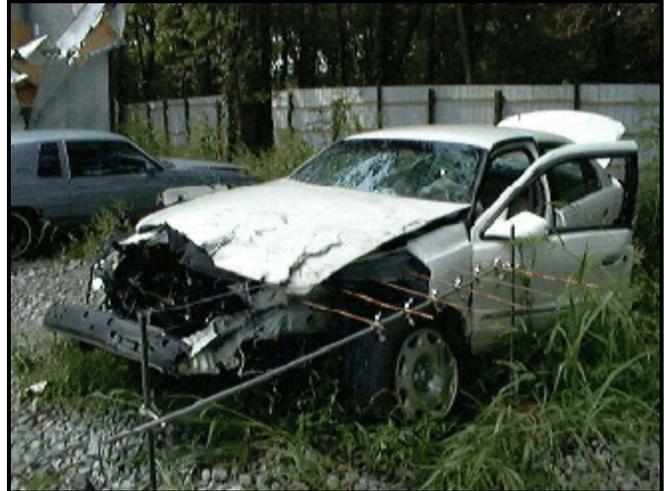
Vehicle 1 pulled out into the path of Vehicle 2 and was struck. The front plane of Vehicle 2 (12FDEW3) struck the front plane of Vehicle 1 (70FYEW99) in the eastbound lane. The two vehicles then sideslapped with the right plane of Vehicle 2 (03R99999) striking the left plane of Vehicle 1 (09LBEW2) in the westbound lane.

Figure 1. Exterior, Vehicle 1 (Lincoln Continental)

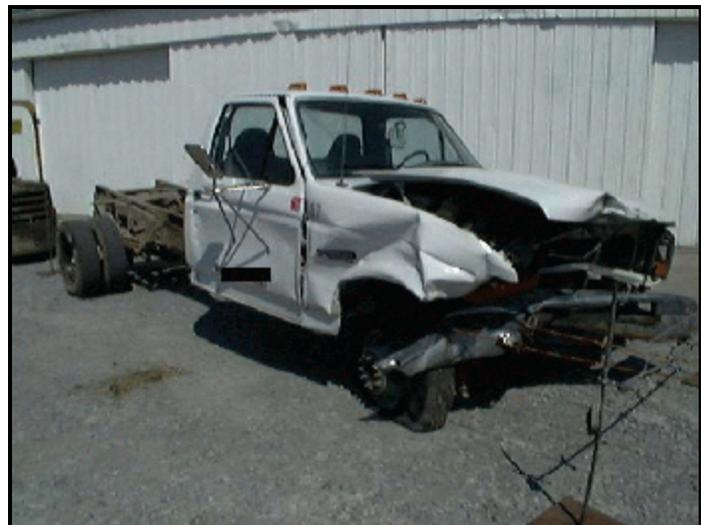
Figure 2. Exterior, Vehicle 2 (Ford F-series)

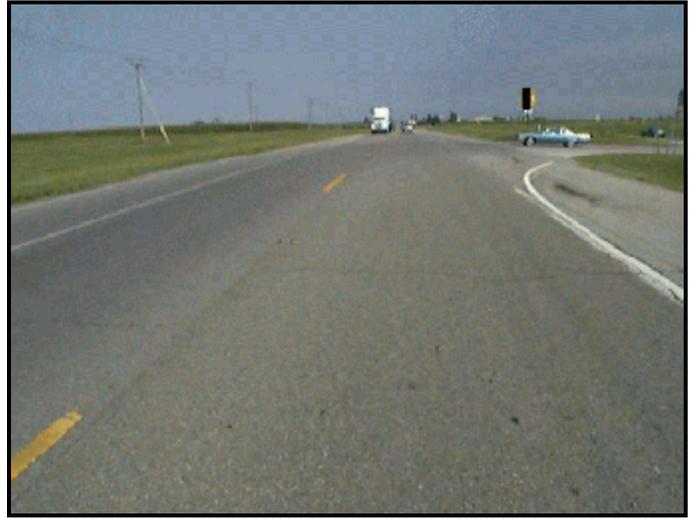
Figure 3. Crash scene, Vehicle 2 approach path.

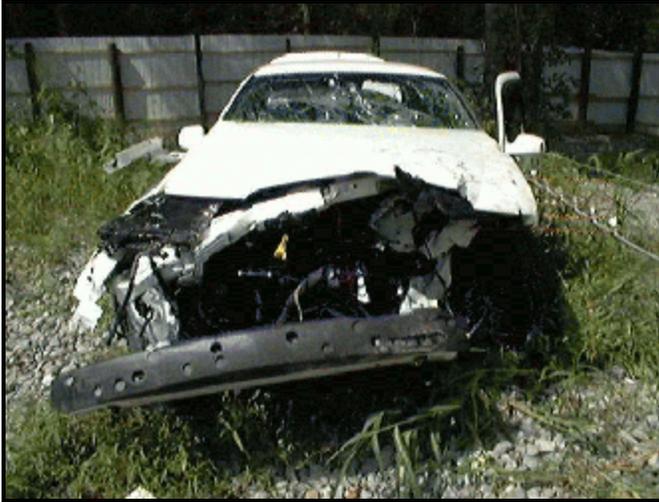
Model year, make and model	1998 Lincoln Continental
VIN	1LNFM97VXWY
CDC	70FYEW99
PDOF	290 degrees

Figure 4. Exterior, Vehicle 1 (1998 Lincoln Continental)

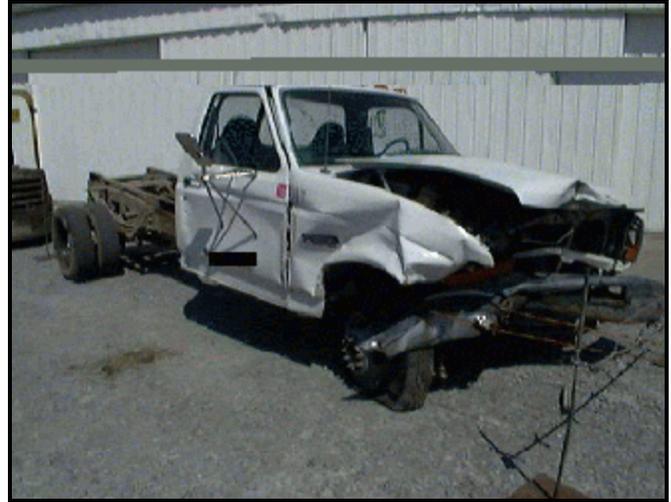
Figure 5. Exterior, Vehicle 2 (1997 Ford F series)

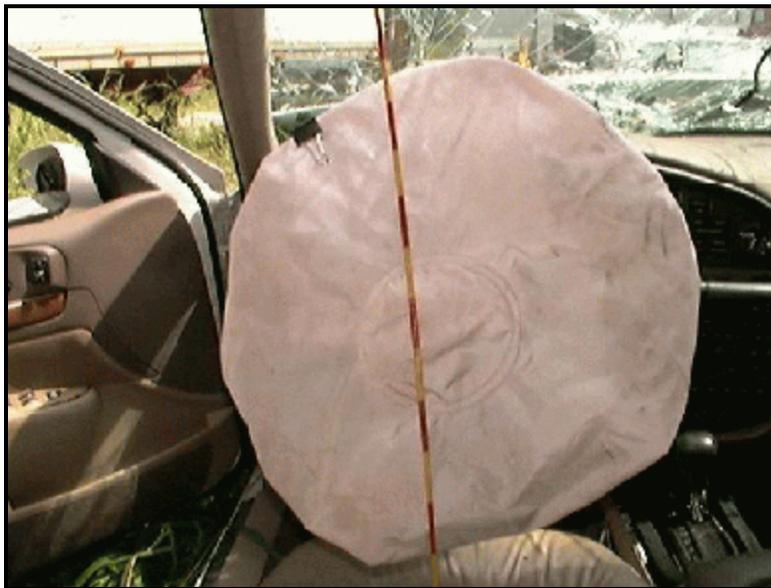
The front left air bag was housed in the steering wheel hub and was concealed by a single D-shaped cover flap which was not damaged. The circular air bag was equipped with 2 tethers and no vent ports. The bag showed scuffing from contact with the cover flap, but no evidence of occupant contact. The bag was not damaged in the crash.

Figure 6. Interior, case vehicle. Driver's side air bag.

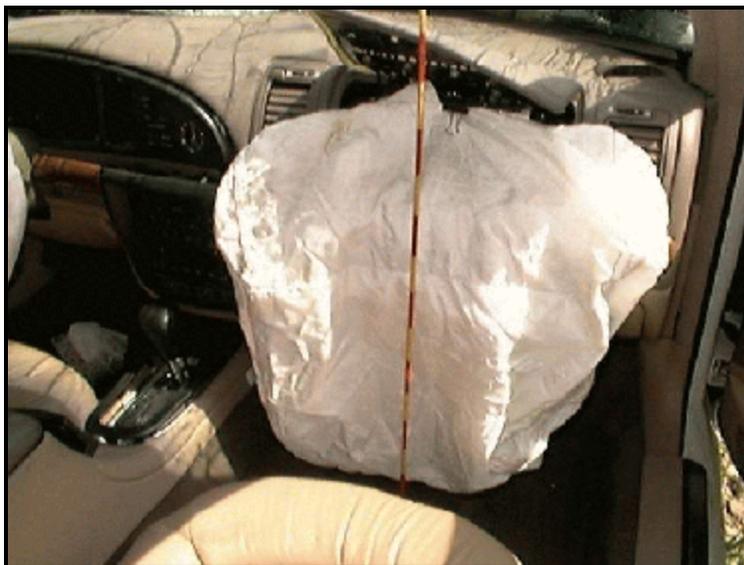
The front right air bag was housed in the top-instrument panel position. The single air bag module cover flap was in the shape of an inverted “D” and was not damaged. The rectangular air bag was equipped with 1 tether and 2 vent ports. The bag showed several areas of burns which fused the bag together at the top and created several holes. The bag showed no evidence of occupant contact.

Figure 7. Interior, case vehicle. Passenger's side air bag.

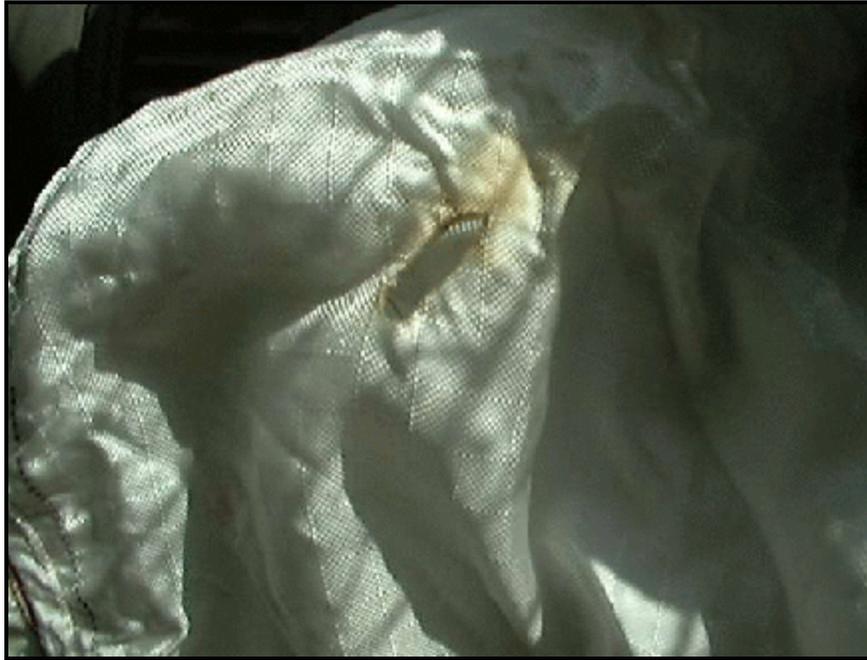
Figure 8. Interior, case vehicle. Passenger's side air bag (burn hole).

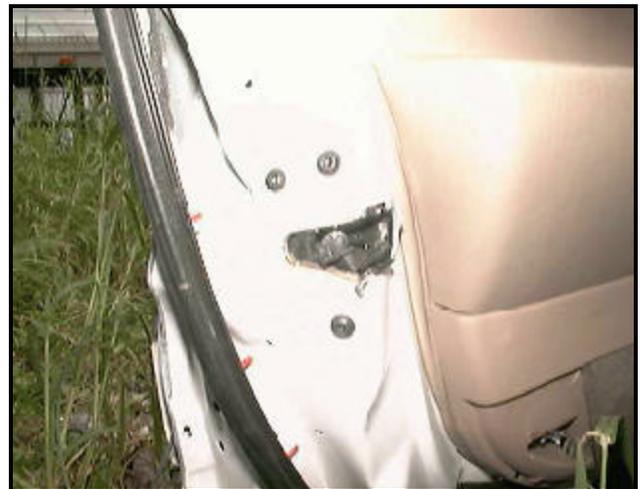
The driver of Vehicle 1 was fully ejected through the left front door which came open during the crash due to latch/striker failure. All three occupants of the case vehicle sustained serious injuries and were transported to a trauma center where the driver died the following day. The front right passenger of Vehicle 1 was hospitalized, while the back right passenger was treated and released. The driver of Vehicle 2 sustained minor injuries in the crash and was transported to a trauma center where he was treated and released.

Figure 9. Latch/striker failure, left front door.

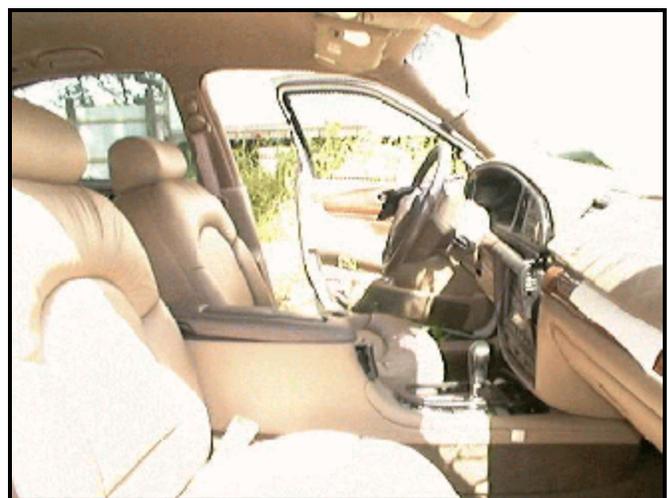
Figure 10. Interior, case vehicle. Area of ejection.
