Remote, Redesigned Air Bag Special Study

Dynamic Science, Inc., Case Number (1998-073-132C)

1998 Plymouth Breeze

October/1998

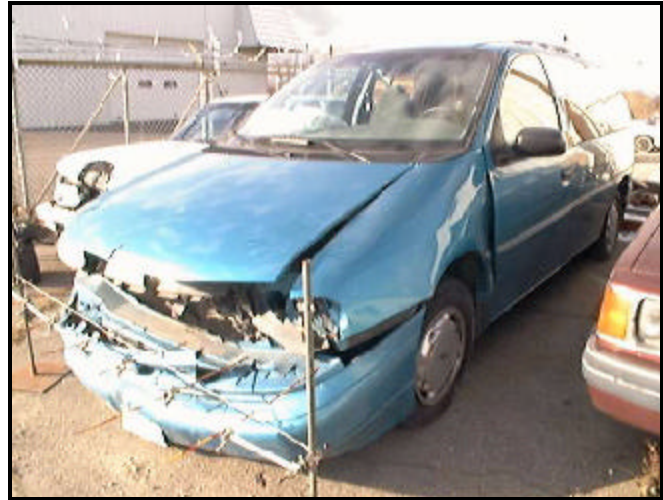
Figure 1. Exterior, Vehicle 1 (Ford Windstar)

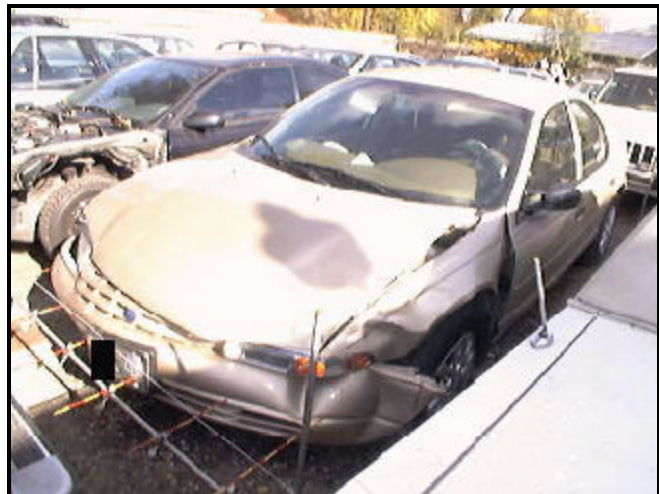
Figure 2. Exterior, Vehicle 2 (Plymouth Breeze)

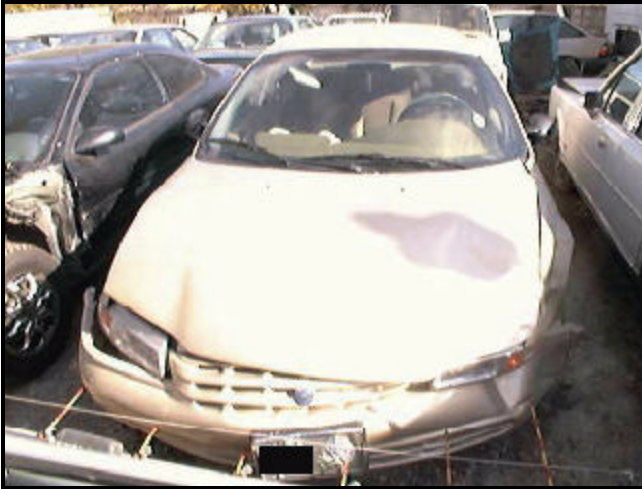
Figure 4. Exterior, Vehicle 2 (1998 Plymouth Breeze)

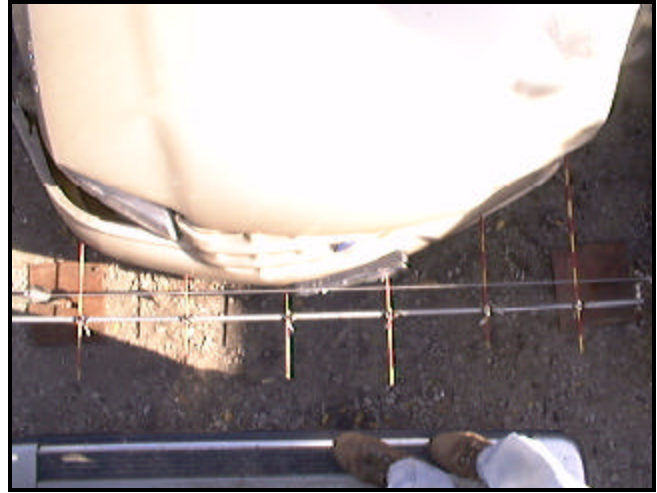
Figure 5. C' Measurements, Vehicle 2 (Plymouth Breeze)

Plane of Impact	Field L cm/in.	C1 cm/in.	C2 cm/in.	C3 cm/in.	C4 cm/in.	C5 cm/in.	C6 cm/in.
Bumper	145	32	21	12	7	2	2
	57.1	12.6	8.3	4.7	2.8	0.8	0.8

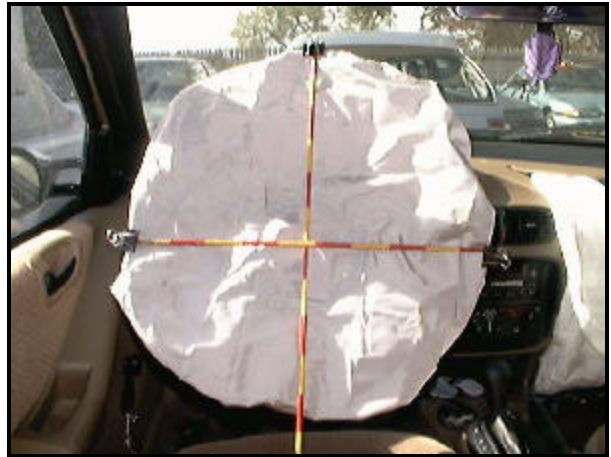
The front left air bag was housed in the steering wheel hub and was concealed by asymmetrical H-configuration cover flaps which were not damaged. The circular air bag was equipped with four tether straps and one vent port. No contact evidence was found on the air bag and the bag was not damaged.

Figure 6. Interior, case vehicle. Driver's air bag.

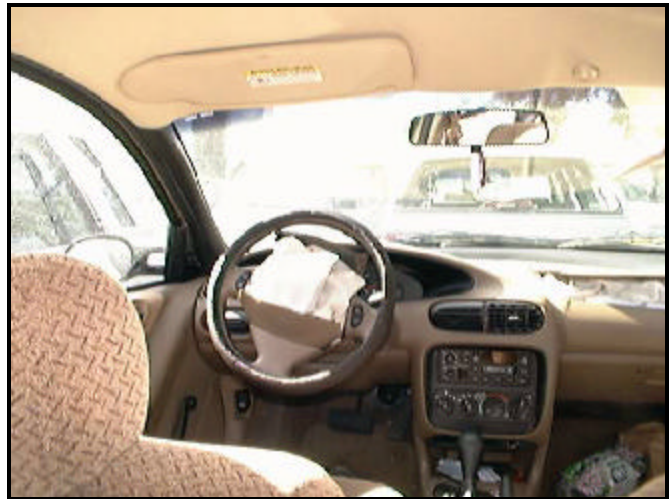
Figure 7. Interior, case vehicle. Case occupant seating position.

At impact, the case occupant reacted to the 350 degree principle direction of force by moving forward and slightly left, loading the manual lap/shoulder restraint. As the restraints locked, further frontal movement of the occupant was prevented. The case occupant's right leg experienced heavy loading against the floor and foot controls-causing the fibula and tibia fractures. The occupant's chest loaded the shoulder belt webbing-causing the chest contusion. No evidence of occupant contact was found on the air bag, but it is presumed that she contacted the bag somewhat in this moderate frontal impact. This may have contributed to the chest contusion. The case occupant was transported from the scene to a trauma center where she was hospitalized for two days.
