Remote, Redesigned Air Bag Special Study

Dynamic Science, Inc., Case Number (1998-073-802E)

1998 Ford Escort 2-door coupe

Indiana

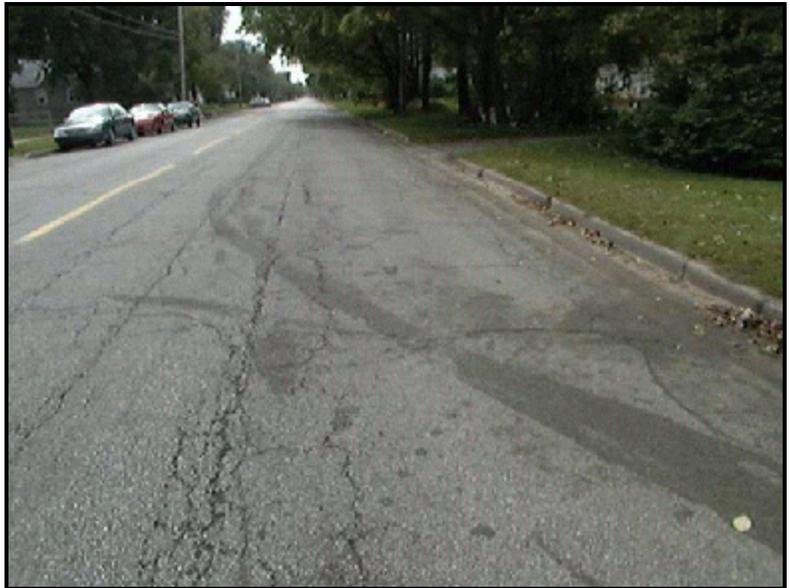
Figure 3. Crash scene, point of impact.

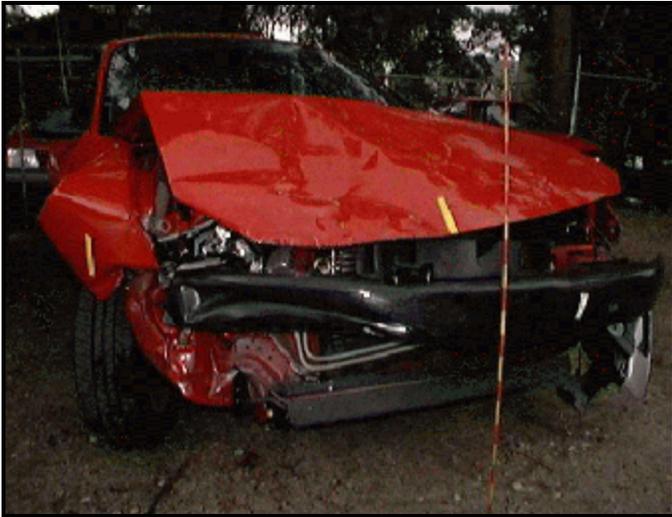
Figure 4. Exterior, Vehicle 1, direct damage

Plane of Impact	Field L cm/in.	C1 cm/in.	C2 cm/in.	C3 cm/in.	C4 cm/in.	C5 cm/in.	C6 cm/in.
Bumper	135	7	5	9	16	26	39
	53.1	2.8	2	3.5	6.3	10.2	15.4

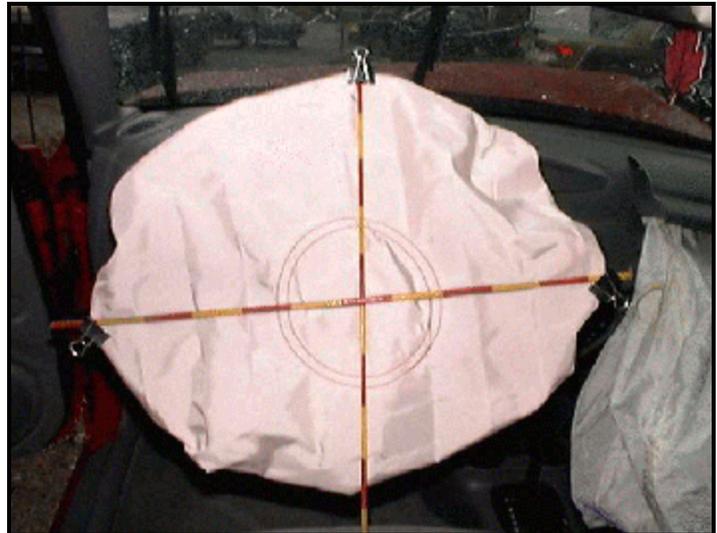
The front left air bag was housed in the steering wheel hub and was concealed by asymmetrical H-configuration cover flaps. The circular air bag was equipped with two tethers and two vent ports. No contact evidence was found on the bag and it was not damaged.

Figure 6. Interior, case vehicle. Driver's side air bag.

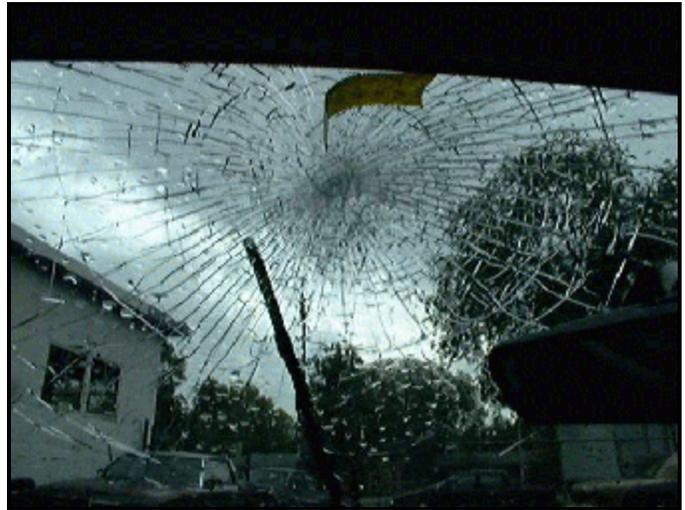
At impact, the case occupant reacted to the 360 degree principle direction of force by moving forward. It appears that the driver's head struck the windshield and her knees struck the left instrument panel. A large spider web crack with embedded hair was found on the windshield (see Figure 7) and scuff marks were found on the instrument panel (see Figures 8 and 9). The driver reported that she was not injured and not treated but it is unclear if that is correct. The police accident report stated that the case occupant was transported to a hospital with non-incapacitating injuries of an unknown nature and severity.

Figure 7. Interior, case vehicle. Head contact.

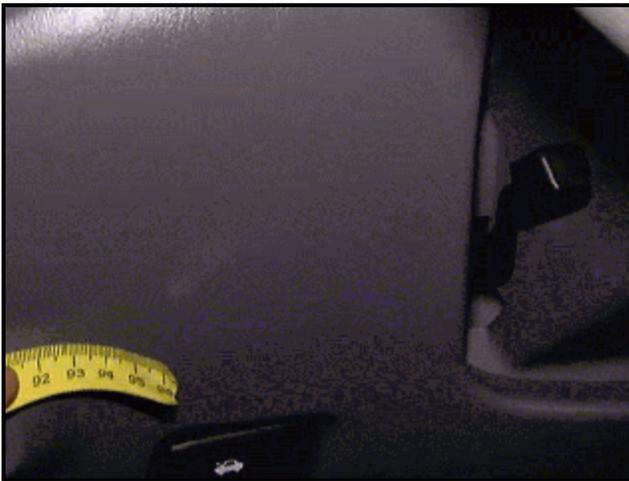
Figure 8. Interior, case vehicle. Left knee contact.

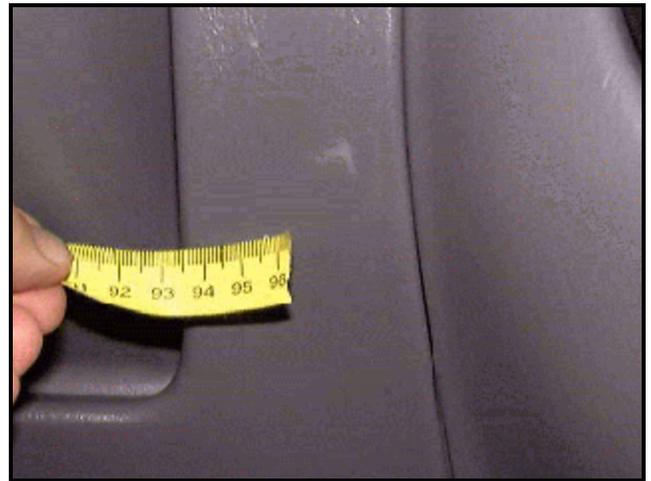
Figure 9. Interior, case vehicle. Right knee contact.
