Remote, Redesigned Air Bag Special Study

Dynamic Science, Inc., Case Number (1998-73-803G)

1998 Pontiac Grand Prix

October 23, 1998

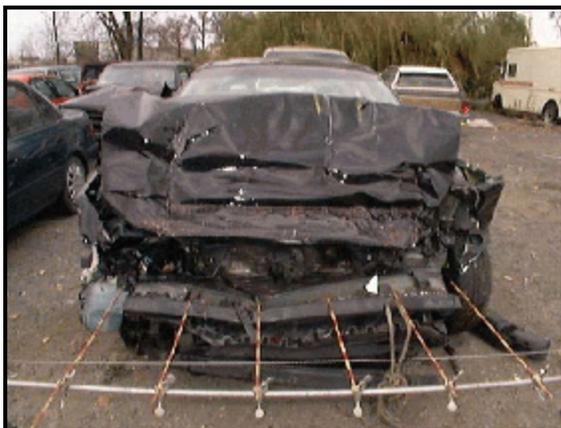
Figure 2. Exterior, Vehicle 1 (front)

The driver of Vehicle 1 looked down momentarily and was not aware of Vehicle 2 until it was too late. The driver did not take any avoidance maneuvers. The front of Vehicle 1 (12FDEW3) struck the rear of Vehicle 2. While this was essentially a fully distributed impact, but there was some offset to the left.

Plane of Impact	Field L cm/in.	C1 cm/in.	C2 cm/in.	C3 cm/in.	C4 cm/in.	C5 cm/in.	C6 cm/in.
Bumper	130	49	51	53	50	47	43
	51.2	19.3	20.1	20.9	19.7	18.5	16.9

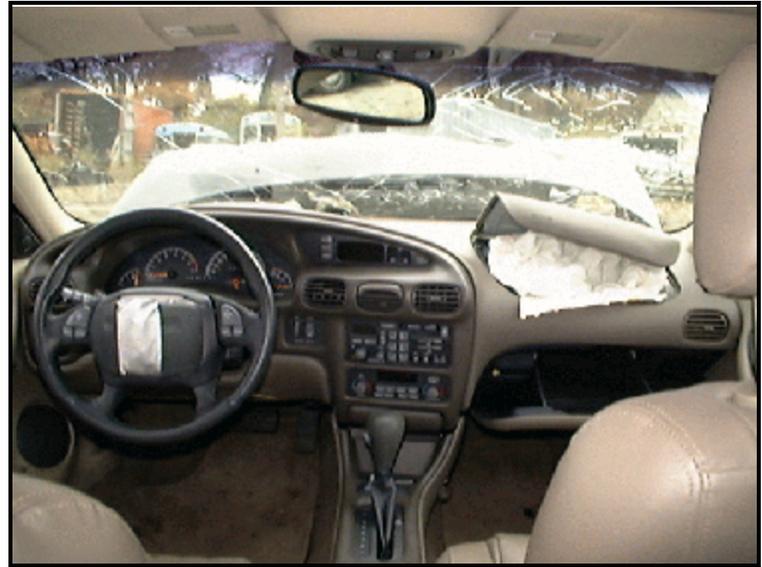
Figure 4. Interior, Vehicle 1 (overview)

The interior of the Grand Prix sustained minor damage from various occupant contacts. There was a scuff to the left instrument panel and movement of the center mirror. Both air bags had deployed. There was a small amount of instrument panel intrusion that extended uniformly in a rearward direction.

Intruded Component	Location of Intrusion	Intruded Value cm/in.		Dominant Crush Direction
Right instrument panel	Front seat right	3	1.2	Longitudinal
Center instrument panel	Front seat middle	2	0.8	Longitudinal
Left instrument panel	Front seat left	1	0.4	Longitudinal

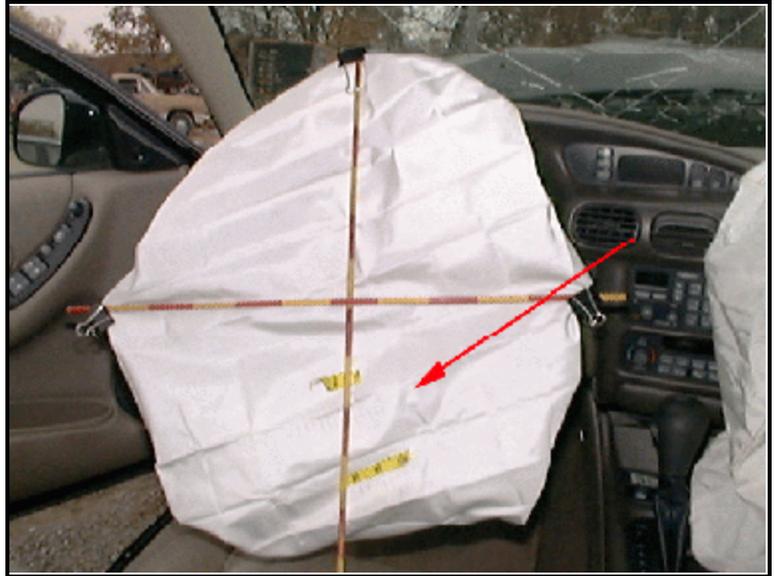
Figure 5. Driver's side air bag

The front left air bag was housed in the steering wheel hub and was concealed by symmetrical I-configuration cover flaps. The air bag had nine horizontal folds and six vertical folds. The circular air bag was equipped with two vent ports and was not damaged in the crash. It was not equipped with any tethers. There was some smudges found at the bottom of the air bag face which likely came from the inside of the module cover flap.

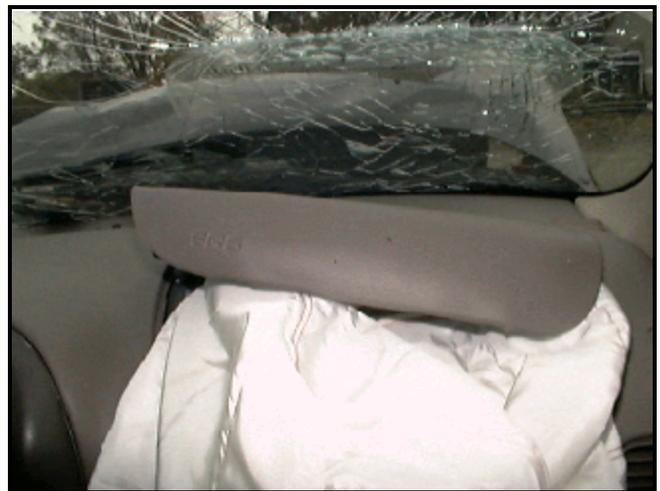
Figure 7. Passenger side air bag

The front right air bag was housed in the mid-instrument panel position. The single air bag module cover flap was in the shape of an inverted “D”. The rectangular air bag showed no evidence of occupant contact and was not damaged in the crash. Blood was found on left edge for the air bag face.

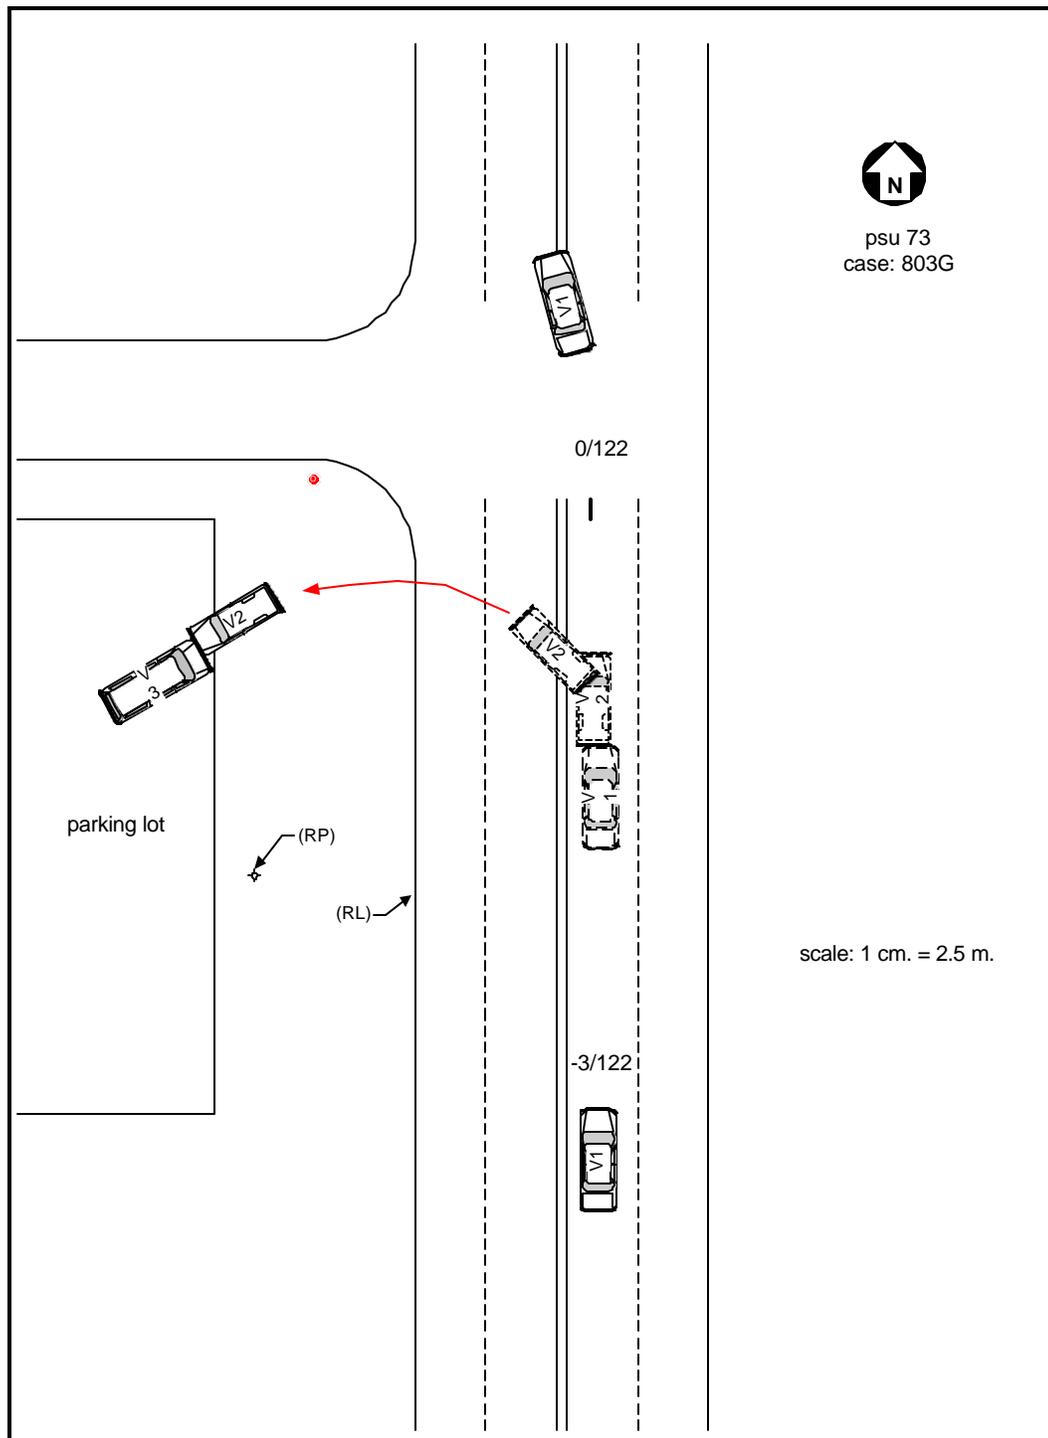
Scene Diagram²

²Final rest for V1 added. POI moved further south to account for police-reported final rest position.
