Remote, Redesigned Air Bag Special Study

Dynamic Science, Inc., Case Number (1998-73-804F)

1998 Dodge Dakota Pick-up Truck

October/1998

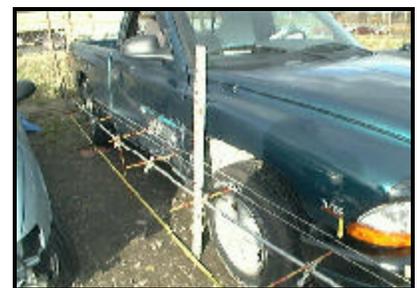
Figure 3. View showing initial right side impact to Vehicle 1

As Vehicle 1 entered the intersection, the front bumper of Vehicle 2 impacted the right side of Vehicle 1 (01RYEW3) in an “L”-type impact configuration. The calculated delta V was 9.1 km/h (5.7 mph) for Vehicle 1 with a longitudinal delta V of -7.9 km/h (-4.9 mph)¹ which was not of sufficient force to deploy the redesigned frontal air bags. The 1 o’clock impact force deflected Vehicle 1 to the left towards the northwest intersection quadrant. Vehicle 1 rotated approximately 27 degrees in a counterclockwise rotation before its frontal plane (12FDEW1) impacted the front, left bumper area of Vehicle 3 (11FYEW1).

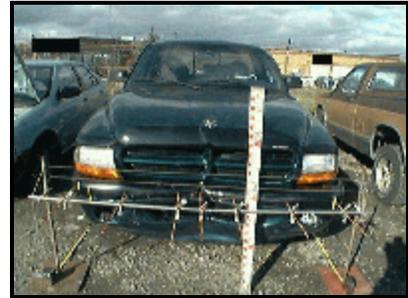
Figure 4. Secondary frontal impact to Vehicle 1

Vehicle 3 was stationary (stopped) at the time of the second impact. The calculated delta V for Vehicle 1 was 11.2 km/h (7 mph) with a longitudinal delta V of -11.2 km/h (-7 mph)². The second frontal impact deployed the frontal air bags, however, the longitudinal delta V was on the lower end of the threshold necessary for air bag deployment. Nether the driver or the front, right seated occupant of Vehicle 1 (Dodge Dakota) were injured. The driver of Vehicle 2 was transported to a local hospital with complaint of pain to her neck. The driver of Vehicle 3 was also uninjured in the crash.

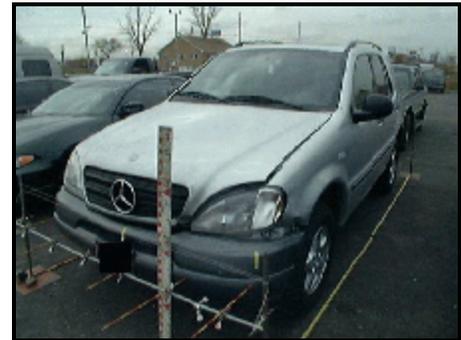
Figure 5. View showing frontal damage to Vehicle 3

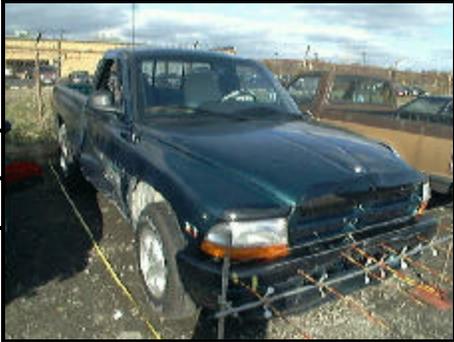
Figure 6. Three-quarter view showing initial right side impact and primary frontal impact

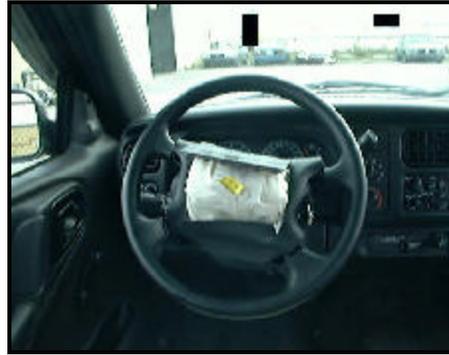
The interior of the Dodge Dakota sustained minor damage due to occupant contacts and two separate impacts. The laminated windshield and tempered left front side window were undamaged. The right front side window glazing disintegrated due to the initial right side impact. The right front door panel intruded 5cm (2 in.) laterally. The driver’s left knee contacted the knee bolster as evidenced by a permanent residual scuff mark. There were scuff marks noted to both the driver’s and passenger’s frontal air bags.

Figure 7. Front, left view showing interior of case vehicle

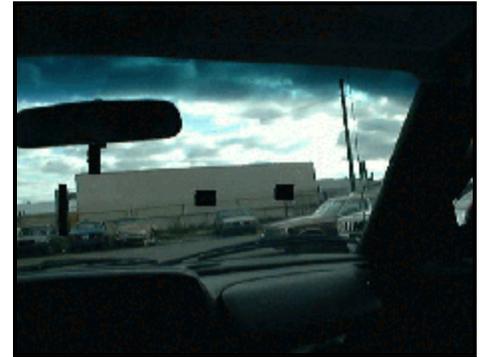
Figure 8. Front, right view showing case vehicle interior

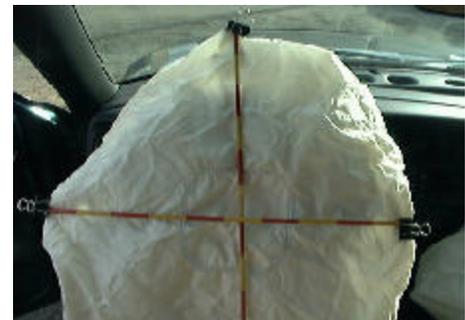
Figure 9. View showing deployed drivers air bag

The front, left drivers air bag was housed in the steering wheel hub and was concealed by symmetrical double horizontal module cover flaps. The circular air bag was tethered by two straps and not equipped with exhaust vent port holes. The lower instrument panel is equipped with a rigid plastic knee bolster.

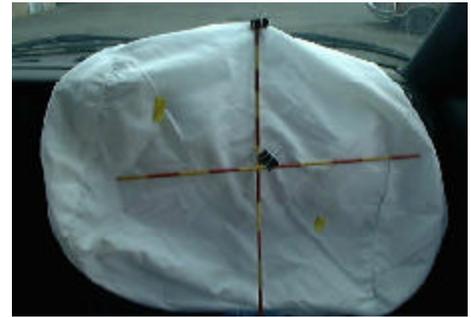
The front, right air bag was located in the instrument panel (top-mount level). The module cover flap door is rectangular in design and opens at predetermined break-out lines as the door pivots outward. There was no residual damage to the air bag and the module door opened at its designed tear points. The passenger air bag is equipped with a disarm switch or (PADS-Passenger Airbag Disarm Switch). The PADS switch is actuated with the ignition key in the switch key cylinder.

Figure 10. View showing deployed passenger (front, right) air bag

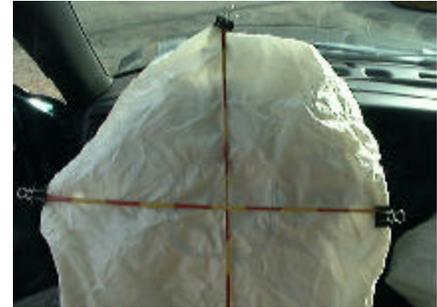
Figure 11. Deployed drivers air bag

Driver 1 responded to the initial right side 30 degree impact force by moving forward and slightly to his right. The applied lap and shoulder belt secured the driver in his respective seated position. As the case vehicle was deflected to the left the driver rebounded back into his seatback support. He responded to the second impact to the frontal plane by moving directly forward. Again, the seatbelt retractor was activated which prohibited extended forward motion of his upper and lower torso. He probably made contact with the deploying air bag as evidenced by a documented scuff mark to the air bag nylon fabric. Driver 1 was uninjured in the crash.

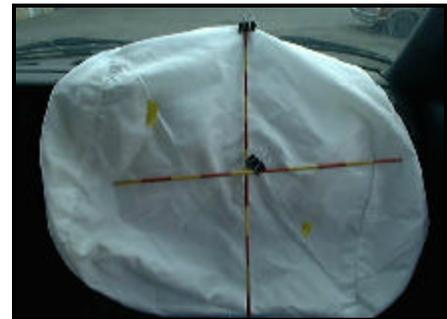
Figure 12. Deployed passenger air bag with occupant contacts highlighted

The front right seated passenger responded to the initial 1 o'clock direction of force by moving forward and slightly to his right. He may have contacted the padded right door panel, however, no occupant contacts were noted. The lap and shoulder belt maintained the occupant in his respective seated position. He responded to the second impact to the frontal plane by moving directly forward. He loaded the applied lap and shoulder belt webbing which prohibited extended forward motion of his upper and lower torso. His hands probably flailed forward contacting the air bag fabric. His face pitched downward contacting the deploying air bag, as evidenced by a documented scuff mark.
