Remote, Redesigned Air Bag Special Study

Dynamic Science, Inc., Case Number (1998-74-801E)

1998 Honda Accord

Nebraska

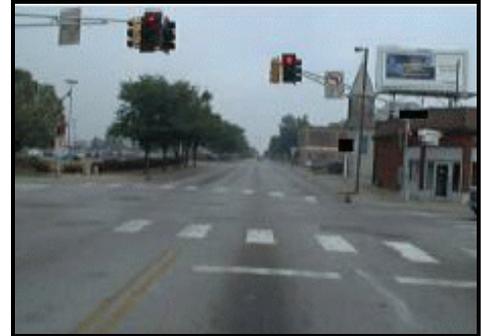
Figure 1. Pre-impact trajectory of Vehicle 1 showing point of impact in foreground

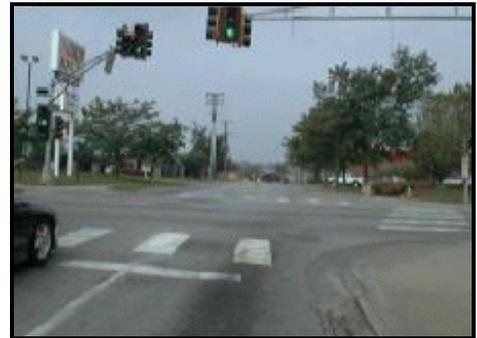
Figure 2. Pre-impact trajectory of Vehicle 2 and area of impact

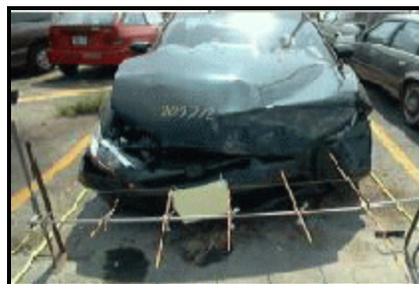
Figure 3. Front view of Vehicle 2 (Honda)

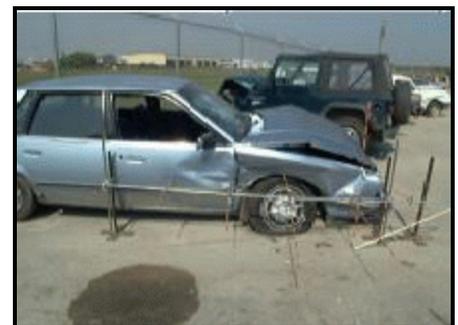
Figure 4. View showing right fender damage to Vehicle 1 (Impact #1)

As Vehicle 1 & 2 entered the intersection, the frontal plane of Vehicle 2 (71FDEW2) impacted the right fender area of Vehicle 1(02RYEW3) at a right angle “L”-type impact configuration. Vehicle 2 (Honda) rotated in a rapid clockwise direction while Vehicle 1 was deflected to the left. The left rear door panel of Vehicle 2 side slapped (09LZEW2) the right quarter-panel of Vehicle 1 (03RBEW2). As the involved vehicles separated, the front of Vehicle 1(12FDEW1) subsequently impacted the front of Vehicle 3, which was stopped at the intersection. Upon the initial front to side impact, the redesigned air bags in Vehicle 2 deployed.

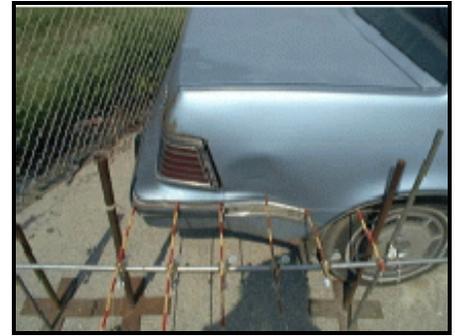
The calculated delta V was 15.7 km/h (9.8 mph) with a longitudinal delta V of -12 km/h (7.5 mph) which is at the low end of the threshold necessary for deployment¹. The secondary sideslap impact to Vehicle 2 (1998 Honda) generated a calculated delta V of 5.2 km/h (3.2 mph)². The delta V for Vehicle 1's initial right fender impact was calculated at 15.1 km/h (9.4 mph) while the secondary right quarter-panel impact generated a calculated delta V of 5.0 km/h (3.1 mph).

Figure 5. Secondary Sideslap damage to right quarter panel of Vehicle 1 (1982 Pontiac 6000)

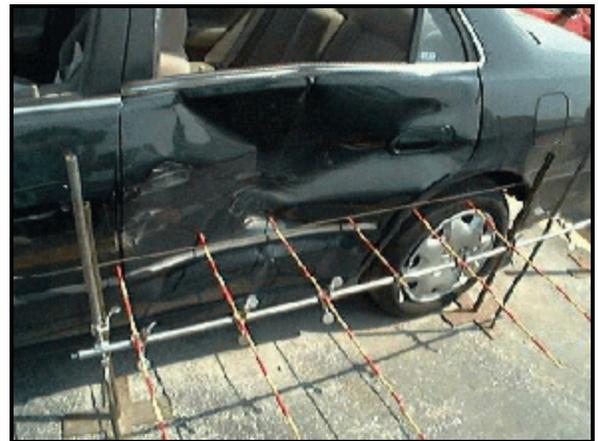
Figure 6. Secondary sideslap damage to the left rear door of Vehicle 2

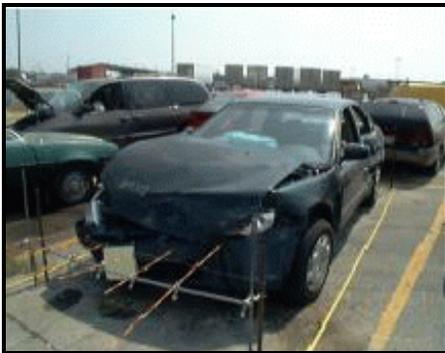
Figure 7. View showing frontal deformation to Vehicle 2 (1998 Honda Accord)

Plane of Impact	Field L cm/in.	C1 cm/in.	C2 cm/in.	C3 cm/in.	C4 cm/in.	C5 cm/in.	C6 cm/in.
Front Bumper	143	19	13	12	10	8	20
	56.3	7.5	5.1	4.7	3.9	3.1	7.9

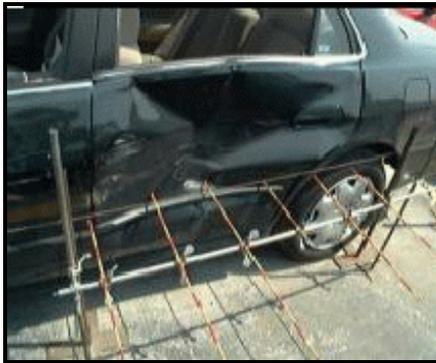
Figure 8. View showing sideslap damage to Vehicle 2's left rear door

Plane of Impact	Field L cm/in.	C1 cm/in.	C2 cm/in.	C3 cm/in.	C4 cm/in.	C5 cm/in.	C6 cm/in.
Left Side	108	2	0	4	10	8	0
	42.5	.8	0	1.6	3.9	3.1	0

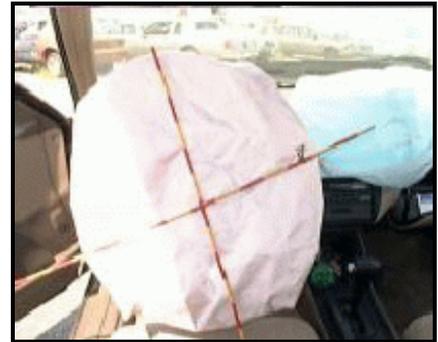
The driver's air bag is housed in the steering wheel hub and encases the nylon airbag unit. The double, horizontal, module cover flaps are asymmetric in design and opened at their designated tear points. The circular air bag is 62 cm (24.4 in.) in diameter and is equipped with two tether straps and two exhaust vent port holes. The vent ports are located at the 11 and 1 o'clock positions respectively. The rigid plastic knee bolster was undamaged and did not reveal any detectable occupant contacts.

Figure 9. Deployed driver's air bag

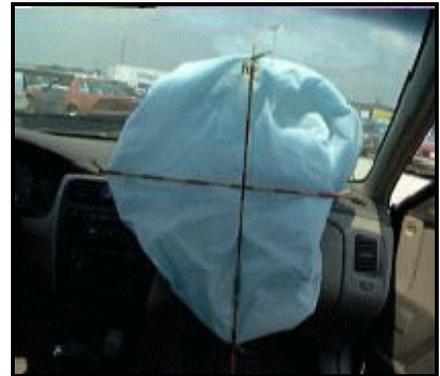
The front, right passenger air bag is located on the instrument panel (top mount). The module deployment door is rectangular in shape and is equipped with double horizontal cover flaps that are symmetrical in design (23 cm wide x 4.7cm in height). Upon deployment, the encased, folded air bag did not fully deploy. Some of the folds located in the right upper quadrant of the module remained folded. Approximately 3/4 of the air bag capacity was filled upon deployment. The non-tethered air bag was undamaged and was equipped with two vent port holes which are at the 10 and 2 o'clock positions.

Figure 11. Deployed passenger air bag

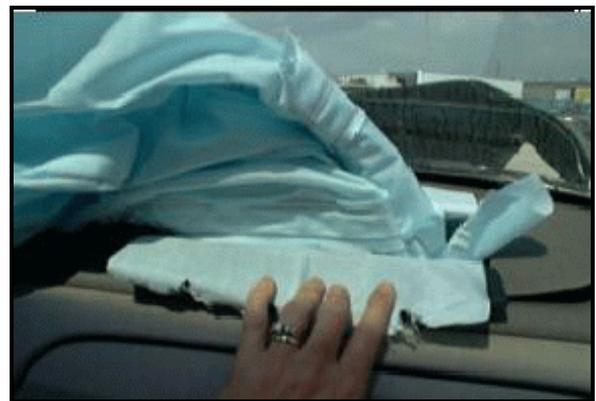
Figure 11. Close-up view showing folds in passenger air bag that did not fill with air bag gases

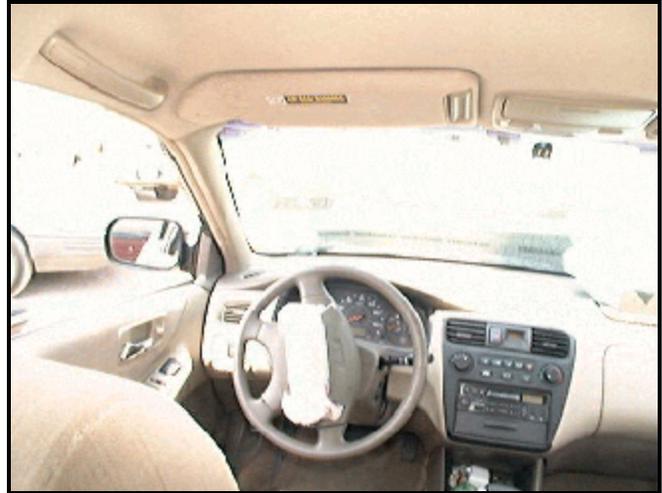
Figure 12. Driver's seated position

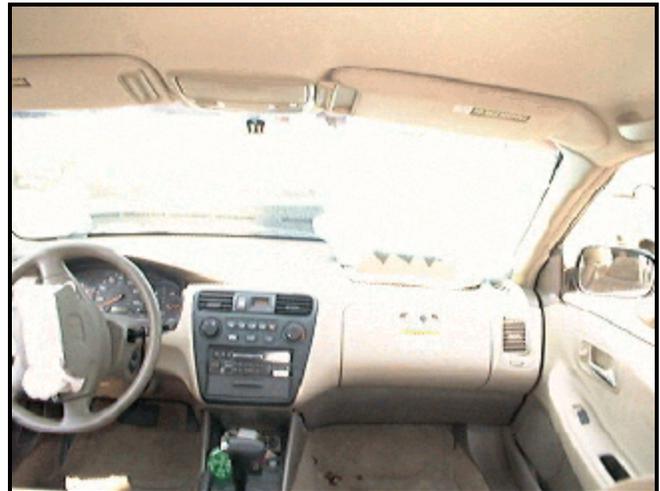
Figure 13. Passenger's seated position
