Remote, Redesigned Air Bag Special Study

Dynamic Science, Inc., Case Number (1998-075-801E)

1998 Chevrolet Cavalier, Two-Door Coupe

Technical Report Documentation Page

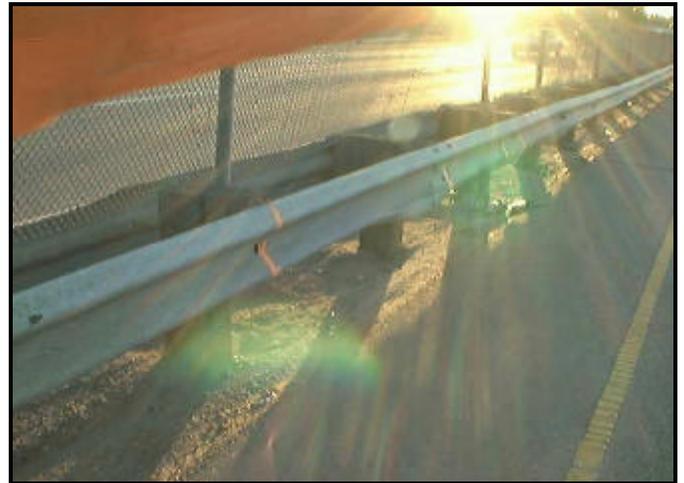
Figure 1. Primary Point of Impact

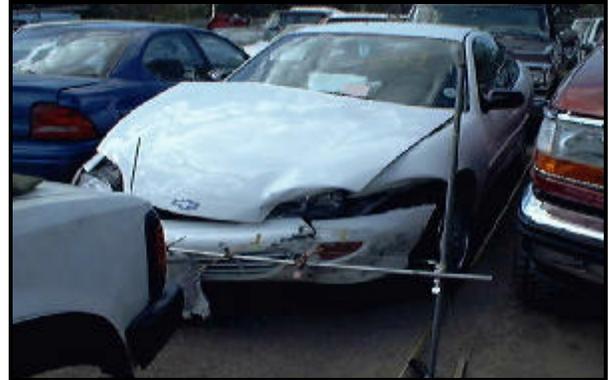
The longitudinal delta V of 14.4 km/h (8.9 mph) was at the borderline threshold necessary for air bag deployment. The initial guardrail impact deflected Vehicle 1 in a clockwise direction as the left quarter-panel impacted the guardrail in a secondary separate impact (09LBEW1). Vehicle 1 sustained a lateral delta V of 5 km/h (3.1 mph) as a result of this impact.

Figure 2. Frontal Deformation to Vehicle 1

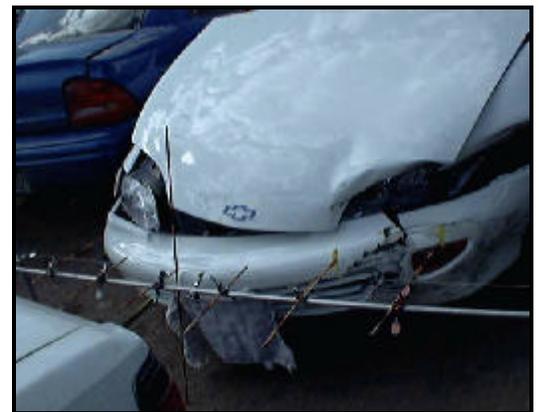
Figure 3. Close-up View of Frontal Damage to Vehicle 1

Plane of Impact	Field L cm/in.	C1 cm/in.	C2 cm/in.	C3 cm/in.	C4 cm/in.	C5 cm/in.	C6 cm/in.
Front Bumper	131	8	7	3	1	0	0
	51.6	3.1	2.8	1.2	0.4	0	0

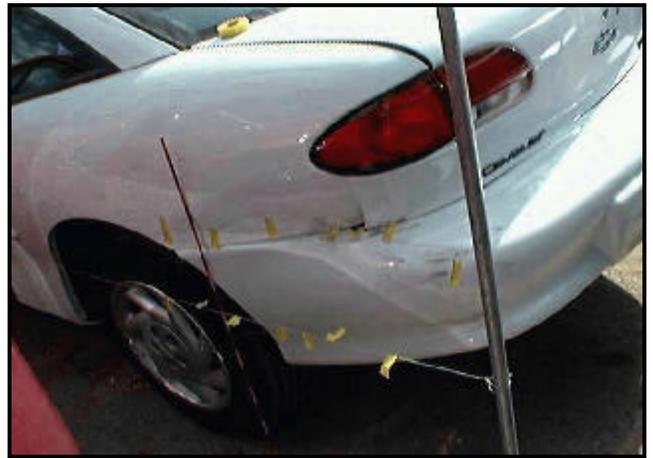
Figure 4. Secondary Impact with Guardrail

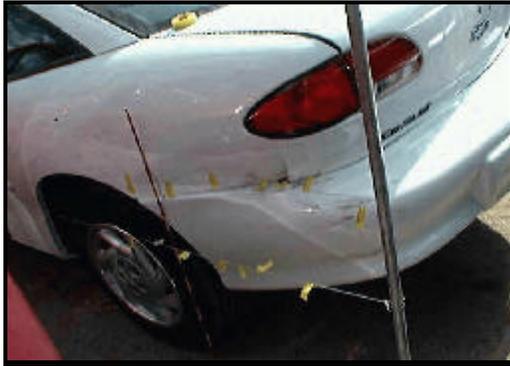
Figure 5. Secondary Impact to Left Quarter-Panel and Bumper

Plane of Impact	Field L cm/in.	C1 cm/in.	C2 cm/in.	C3 cm/in.	C4 cm/in.	C5 cm/in.	C6 cm/in.
Left Side	55	4	7	8	7	4	1
	21.7	1.6	2.8	3.1	2.8	1.6	.4

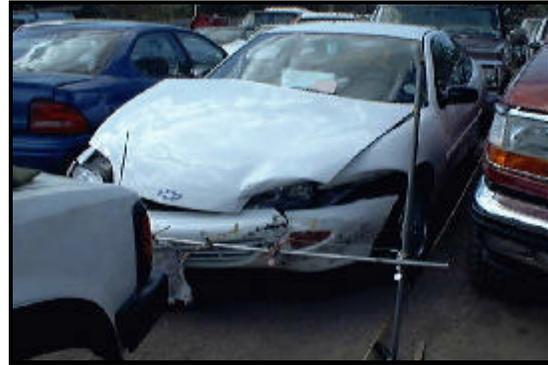
Figure 6. Frontal Primary Impact Vehicle 1 (1998 Chevrolet Cavalier)

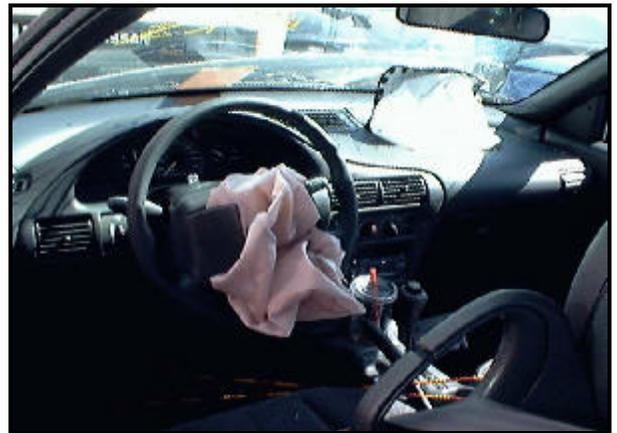
Damage to the interior of the 1998 Chevrolet Cavalier was isolated to windshield glazing damage. The damage to the windshield was due to the passenger side air bag module flap contacting the windshield during deployment. There were no intruding components and no discernible areas of occupant contact.

Figure 7. Interior of Case Vehicle

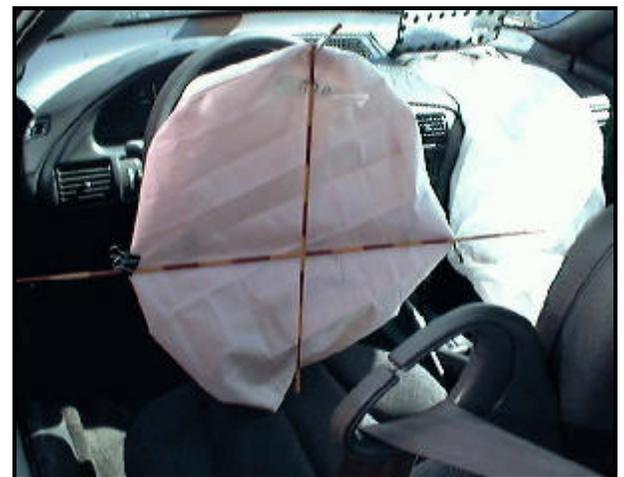
The front left air bag was housed in the steering wheel hub and was concealed by symmetrical double vertical module cover flaps. The circular air bag was an untethered design equipped with two vent port holes. The lower instrument panel is equipped with a rigid plastic knee bolster. There was no discernible contact damage to the knee bolster, air bag, or module cover flaps.

Figure 8. View Showing Deployed Air Bag

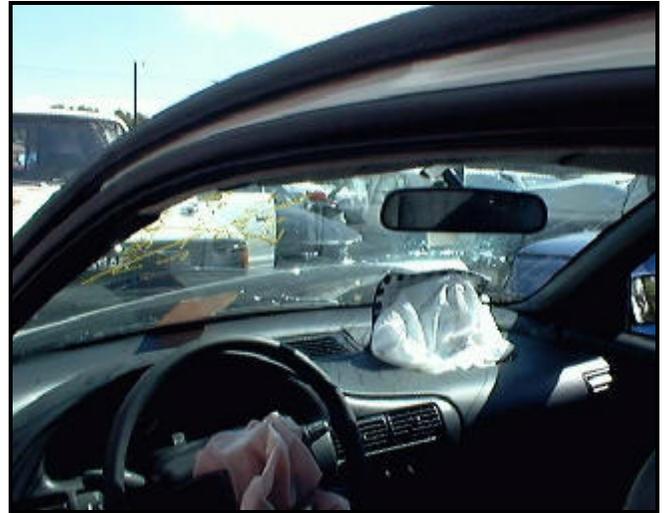
The front right air bag was located on the instrument panel, top surface plane. The module flap cover is rectangular in design and broke the laminated windshield glazing upon deployment. The air bag was not equipped with either tethers or vent port holes. There were no indications of damage or contact to either the air bag or the module cover.

Figure 9. Interior, case vehicle/ windshield and upper instrument panel

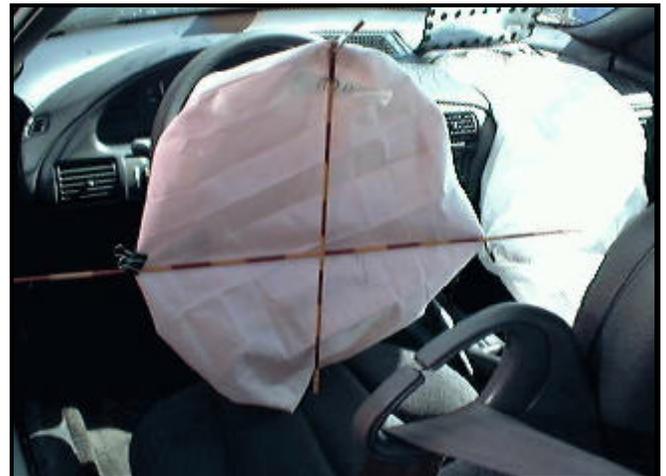
The driver responded to the 350 degree principle Direction of Force by moving forward. She loaded the lap belt webbing which prohibited further forward motion of her lower torso. Her upper torso/chest pitched forward, loading the shoulder restraint webbing. Upon air bag deployment, her head pitched slightly downward making contact with the air bag. As the air bag achieved the maximum inflation level, her head pivoted rearward resulting in a cervical neck strain/ whiplash injury (AIS-1).

Figure 10. View showing deployed air bag/injury causing mechanism
