Remote, Redesigned Air Bag Special Study

Dynamic Science, Inc., Case Number (1998-76-098D)

1998 Nissan Frontier

December/1998

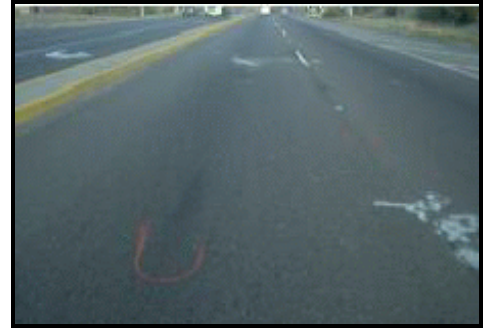
Figure 2. View showing pre-impact skidding from Vehicle 2

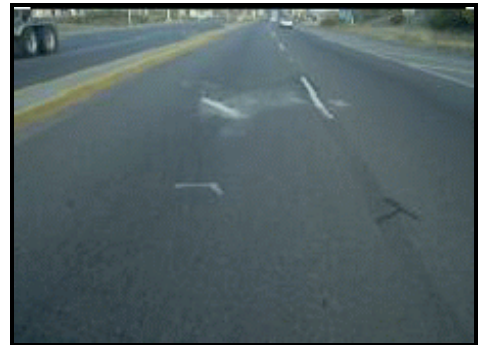
Figure 3. Point of impact and final rest of Vehicle 2

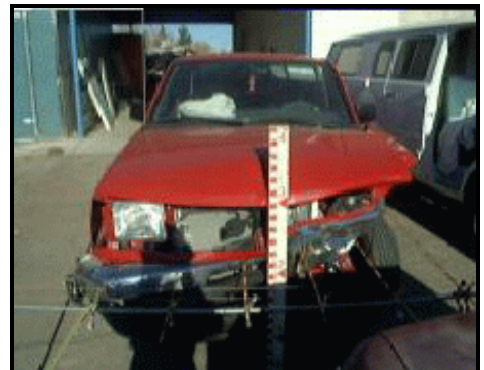
Figure 4. Frontal deformation to Vehicle 2 (1998 Nissan Frontier)

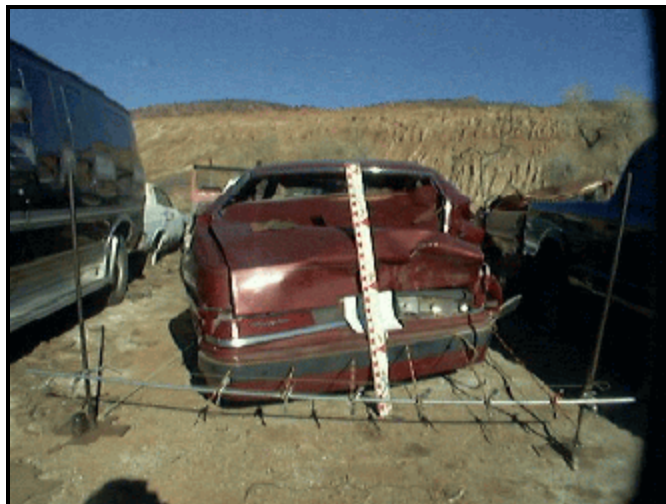
Figure 5. View showing damaged rear plane to Vehicle 1 (1986 Ford Thunderbird)

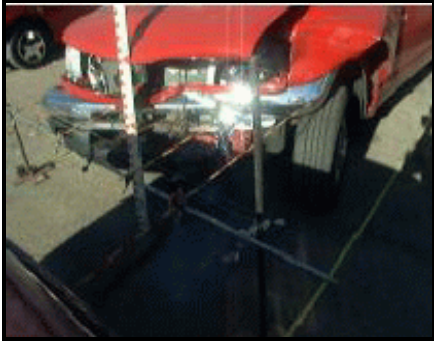
Figure 6. View showing frontal deformation to Vehicle 2

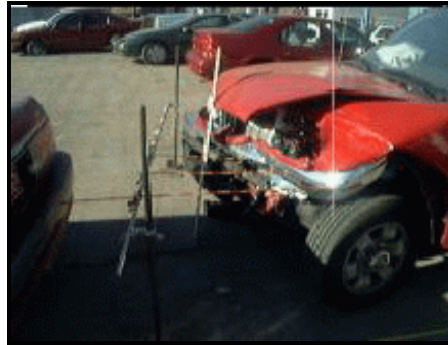
Figure 7. Perpendicular view showing frontal crush to Vehicle 2

Plane of Impact	Field L cm/in.	C1 cm/in.	C2 cm/in.	C3 cm/in.	C4 cm/in.	C5 cm/in.	C6 cm/in.
Front Bumper	140	61	49	35	18	2	0
	55.1	24	19.3	13.8	7.1	0.8	0

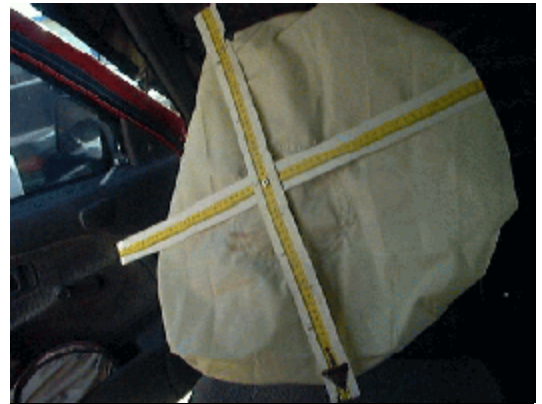
The interior of the Nissan Frontier King Cab Pickup was void of interior deformation due to intrusion or occupant contacts. There was a slight lipstick transfer noted to the driver's air bag (nylon fabric surface). The vehicle maintained its integrity as the vehicle glazing was undamaged and the doors remained closed and operational. The case vehicle is equipped with front bucket seats with folding backs and two second row seats that face inward, laterally mounted. The front seat backs are equipped with adjustable head restraints that were undamaged. Both front seats were adjusted to the middle track position.

Figure 8. View showing deployed driver's air bag and lipstick transfer

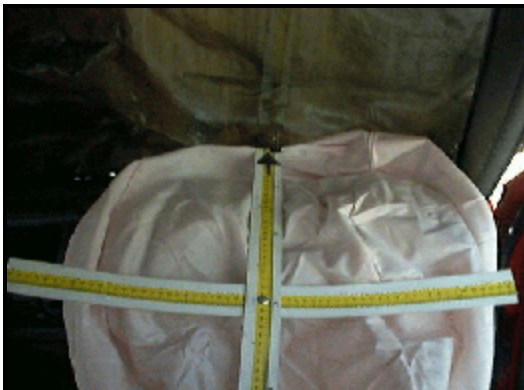
The front, right passenger air bag is located on the instrument panel (top mount). The module deployment door is rectangular in shape and opened at the designated molded seam tear points. The non-tethered air bag was undamaged and was equipped with two exhaust vent port holes.

Figure 9. View showing deployed passenger air bag (upper half)

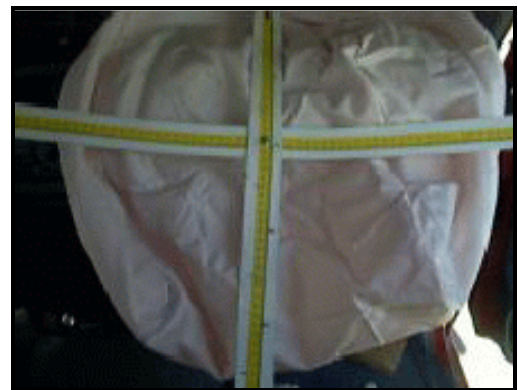
Figure 10. View showing deployed passenger air bag (lower half)

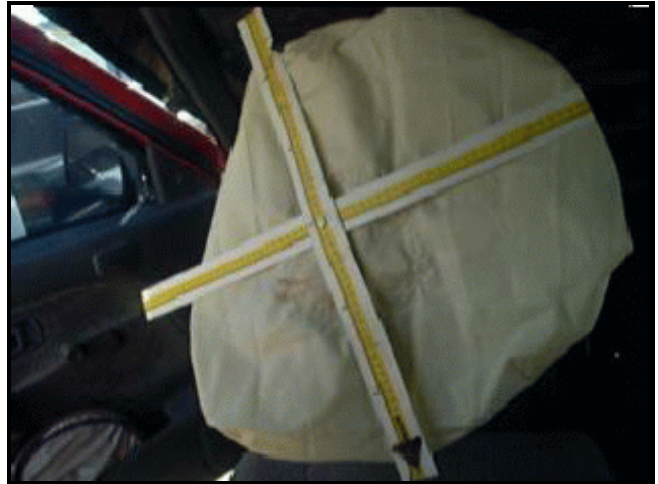
The driver's air bag is housed in the steering wheel hub and encases the nylon air bag unit. The double symmetric, horizontal module cover flaps opened at their designated tear points and were undamaged. The circular air bag is tethered by two straps and two exhaust vent port holes are present. The lower instrument panel is shrouded by a rigid plastic knee bolster. The knee bolster did not reveal any detectable areas of occupant contact. There was an obvious lipstick transfer to the upper, right quadrant of the nylon air bag fabric.

Figure 11. View showing deployed driver's air bag with lipstick transfer to upper right quadrant
