Remote, Redesigned Air Bag Special Study

Dynamic Science, Inc., Case Number (1998-081-802G)

1998 Honda CR-V

Summary

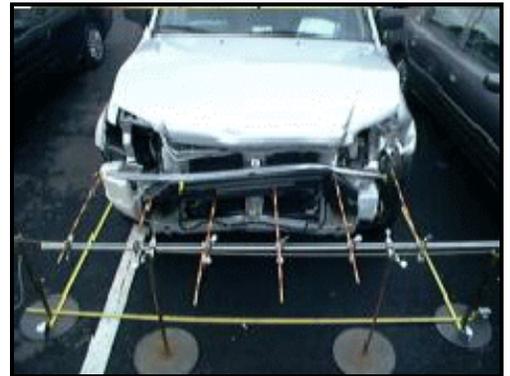
Figure 2. Frontal deformation to Vehicle 1

The front, left two thirds of Vehicle 1's bumper (12FYEW2) impacted the rear plane of Vehicle 2 (Ford Mustang). The frontal impact was of sufficient force to deploy the 2nd generation air bags in Vehicle 1. The calculated Delta V for Vehicle 1 (Honda CR-V) was 26.6 km/h (16.5 mph) with a longitudinal Delta V of -26.6 km/h (-16.5 mph)¹. The Delta V for Vehicle 2 (Mustang) was computed at 30.5 km/h (19 mph).

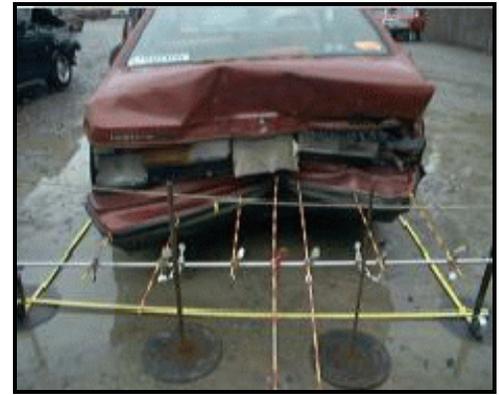
Figure 3. Rear deformation to Vehicle 2

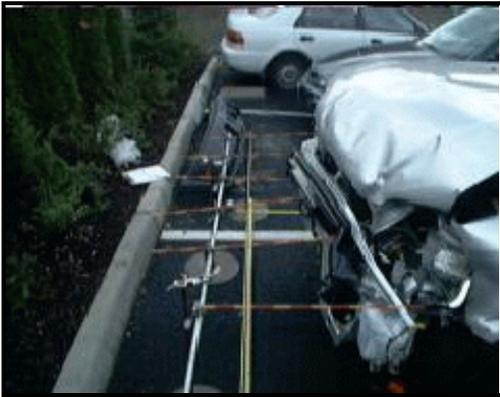
Figure 4. Perpendicular view of Vehicle 1 showing level of crush

Plane of Impact	Field L cm/in.	C1 cm/in.	C2 cm/in.	C3 cm/in.	C4 cm/in.	C5 cm/in.	C6 cm/in.
Front Bumper	143	25	19	20	16	9	0
	56.3	9.8	7.5	7.9	6.3	3.5	0

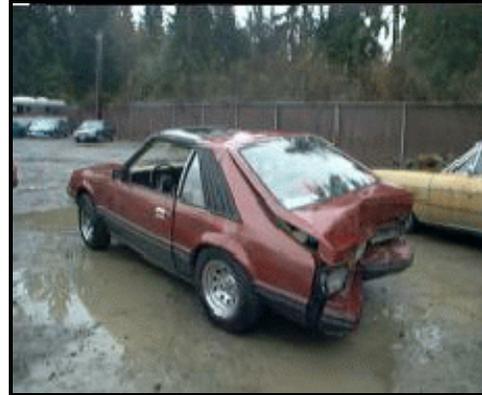
Figure 5. Three-quarter view showing rear damage to Vehicle 2

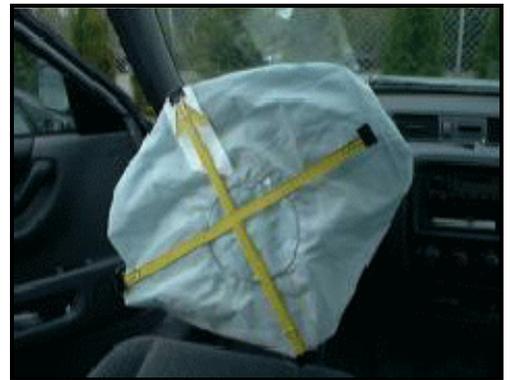
The driver's air bag is housed in the steering wheel hub and encases the nylon air bag unit. The double, horizontal module cover flaps are asymmetric in design and opened at their designated tear points. The circular air bag is 62 cm (24.4 in.) in diameter and is equipped with two tether straps and two exhaust vent port holes. The vent ports are located at the 11 and 1 o'clock positions. The rigid plastic knee bolster was undamaged and maintained its original form.

Figure 6. View showing deployed driver's air bag

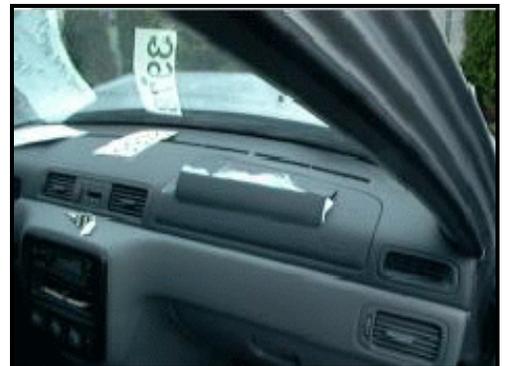
The front, right passenger air bag is located on the instrument panel (top mounted). The module deployment door is rectangular in shape and is equipped with double horizontal cover flaps that are symmetrical in design (23 cm wide x 4.7 cm in height). The non-tethered air bag deployed and was undamaged and void of any occupant contact evidence. The passenger air bag is equipped with two vent port hole which are at the 10 and 2 o'clock positions respectively.

Figure 7. View showing opened passenger air bag module cover flaps

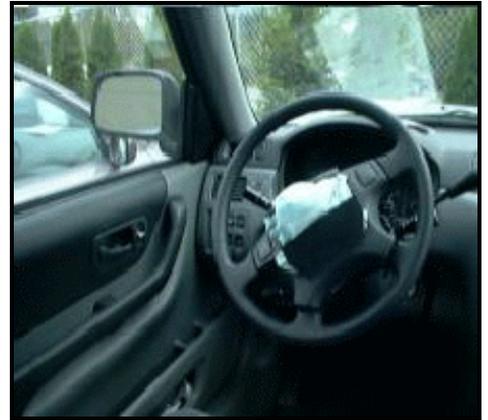
Figure 8. Interior view showing driver's seated position

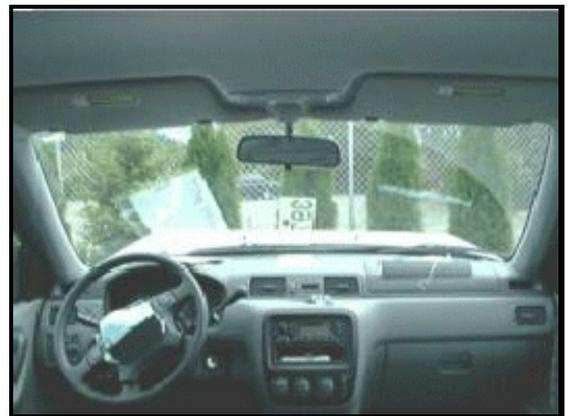
Figure 9. Interior view of Vehicle 1 showing the left and front right seated positions
