Remote, Redesigned Air Bag Special Study  
Dynamic Science, Inc., Case Number (1998-081-804G)  
1998 Toyota Camry  
Washington  
November/1998

**Summary**

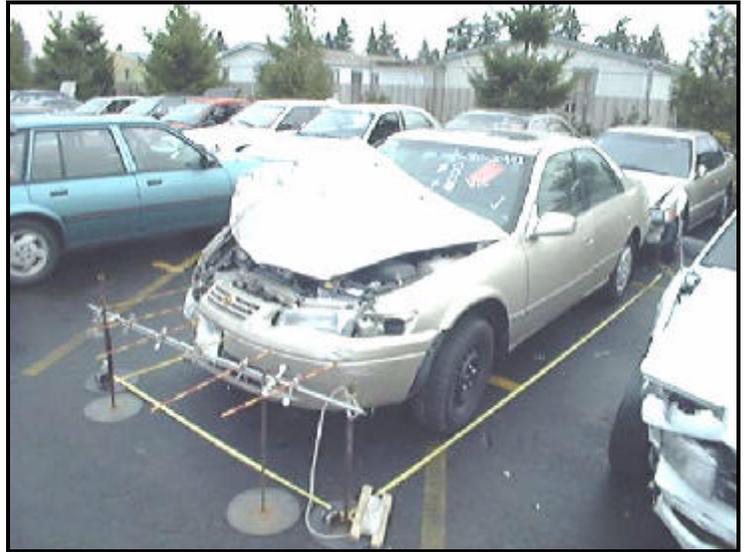
**Figure 1.** Exterior, case vehicle (1998 Toyota Camry).

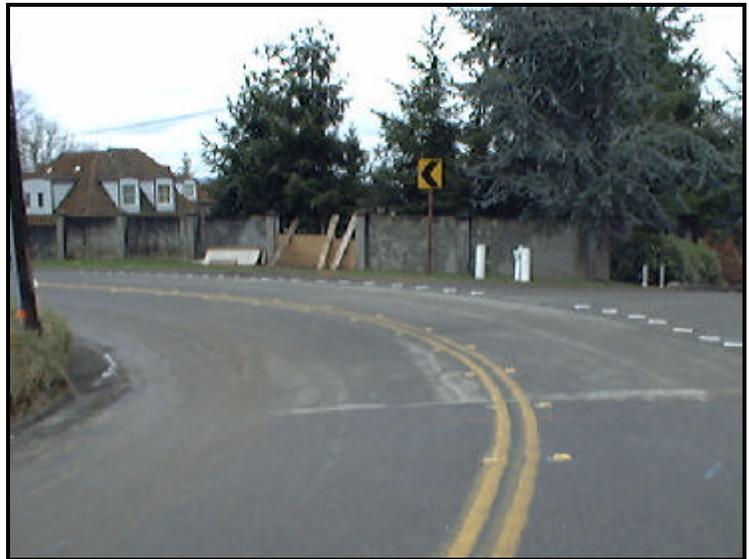
**Figure 2.** Crash scene. Case vehicle approach path.

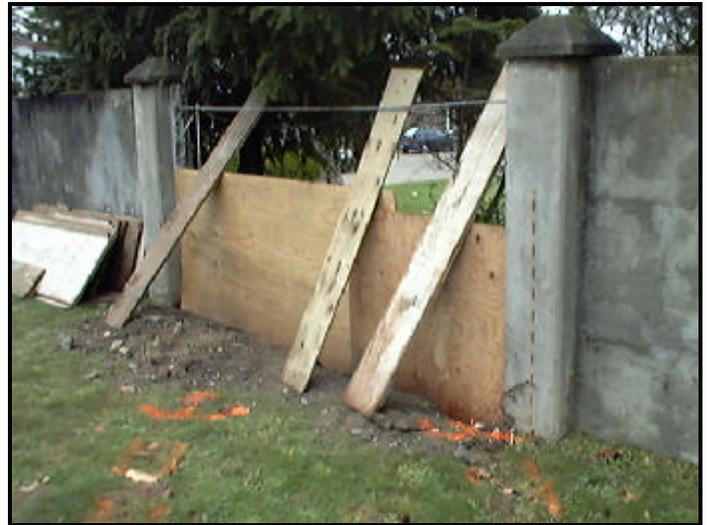
The driver of the case vehicle attempted to negotiate the curve in the roadway at an unsafe speed and the vehicle departed the right roadside where the front plane (12FDEW1) struck a concrete wall (event 1). Vehicle 1 then continued through the wall and came to rest after striking a tree (event 2) with its front plane (12FR999). Vehicle 1 came to rest up against the struck tree facing northwest.

**Figure 3.** Crash scene. Point of impact with wall (event 1).

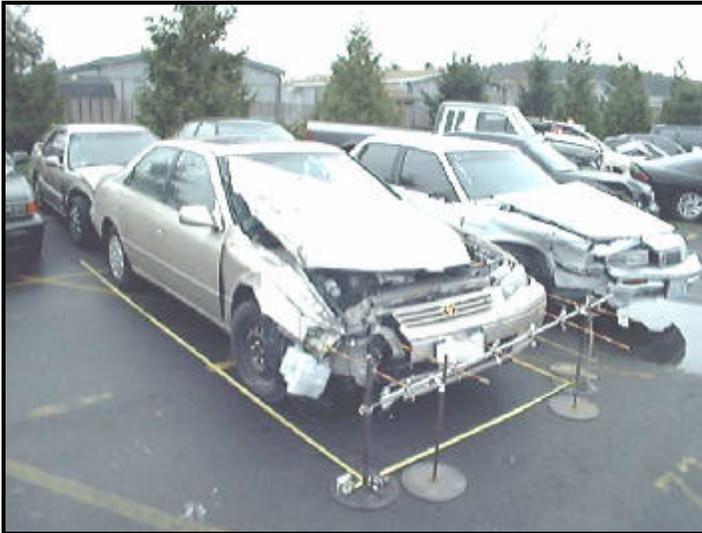
**Figure 4.** Exterior, case vehicle (1998 Toyota Camry).

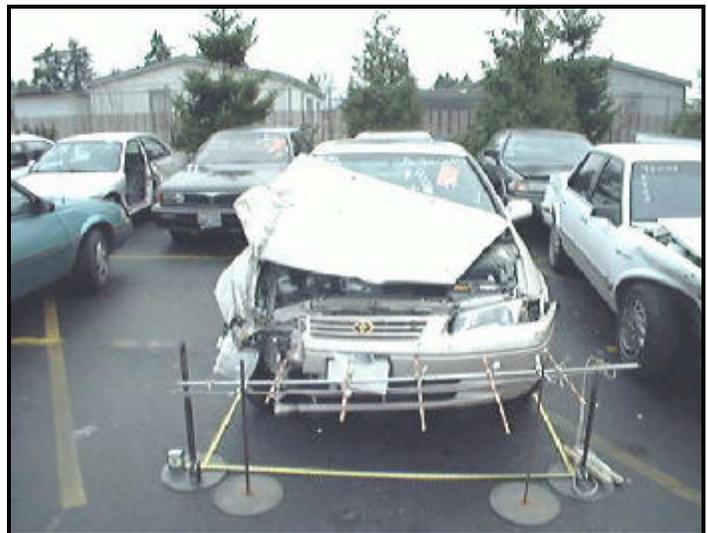
**Figure 5.** Exterior, case vehicle (1998 Toyota Camry).

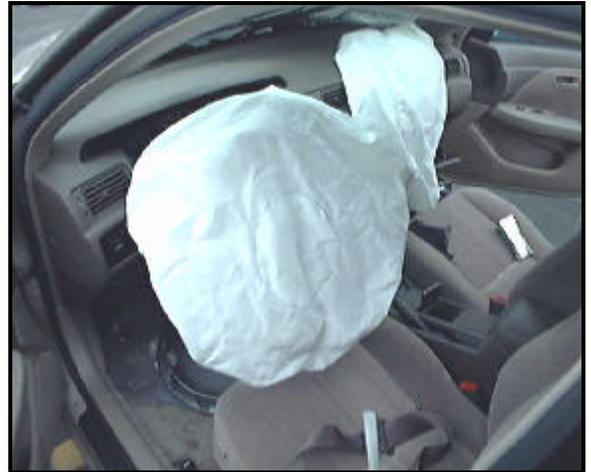
The front left air bag was housed in the steering wheel hub and was concealed by H-configuration cover flaps which were not damaged in the crash. The circular air bag was equipped with two vent ports and an unknown number of tether straps. No contact evidence was found on the air bag and the bag was not damaged.

The front right air bag was housed in the top-instrument panel position and was concealed by a single rectangular cover flap which was not damaged in the crash. The rectangular air bag was not equipped with vent ports or tether straps. No contact evidence was found on the air bag and the bag was not damaged.

**Figure 6.** Interior, case vehicle. Supplemental restraint system (frontal air bags).

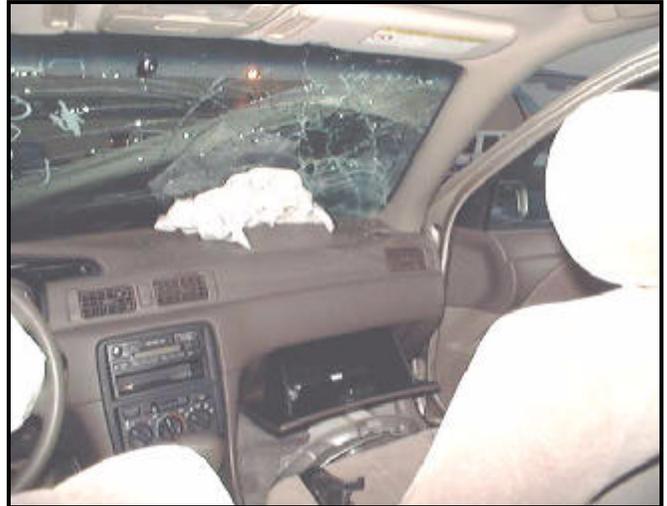
**Figure 7.** Interior, case vehicle. Front right seating position.
