Remote, Redesigned Air Bag Special Study

Dynamic Science, Inc., Case Number (1998-082-802E)

1998 Toyota Tercel

July/1998

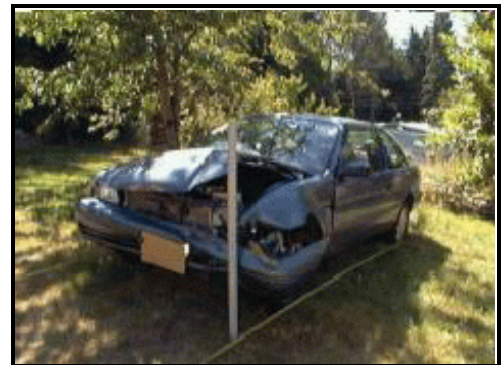
Figure 1. Vehicle 1 (frontal damage)

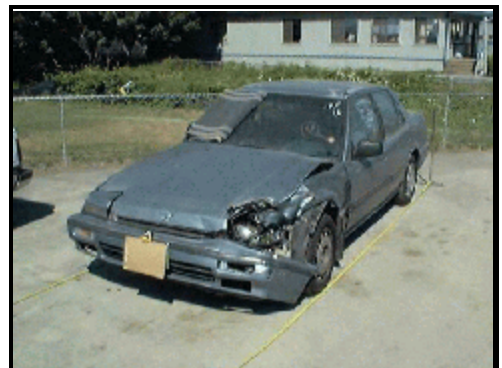
Figure 2. Vehicle 2 (frontal damage)

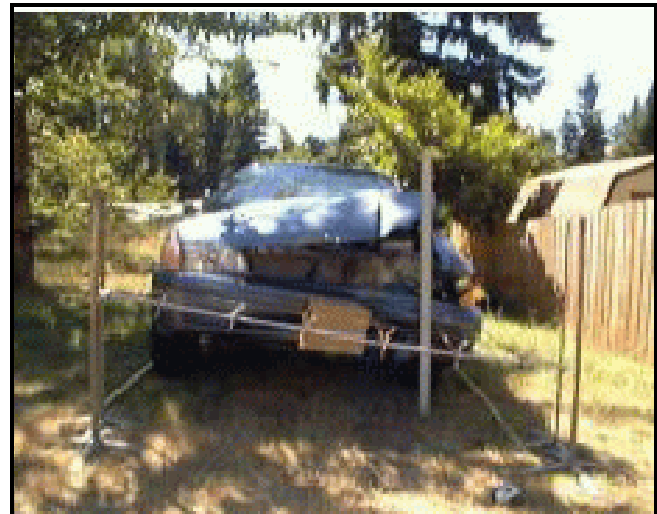
Plane of Impact	Field L cm/in.	C1 cm/in.	C2 cm/in.	C3 cm/in.	C4 cm/in.	C5 cm/in.	C6 cm/in.
Front Bumper	147	34	32	34	20	7	0
	57.9	13.4	12.6	13.4	7.9	2.8	0

Figure 3. Exterior damage to Vehicle 1 (1998 Toyota Tercel)

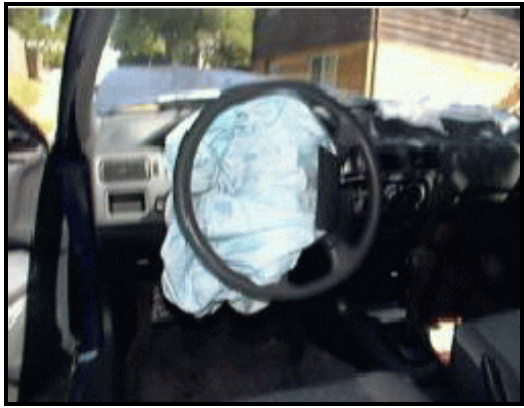
Figure 4. Front, left view showing interior of case vehicle

The interior of the Toyota Tercel was void of interior damage due to occupant contacts. The laminated windshield, side window glazing and backlight were undamaged. The occupant compartment maintained its integrity and there were no intruding components due to the frontal impact. There was a large scuff mark documented to the driver's air bag which was located right of the air bag center point.

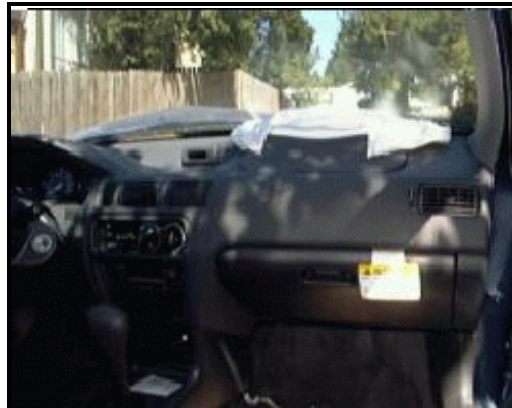
Figure 5. Front, right view showing case vehicle interior

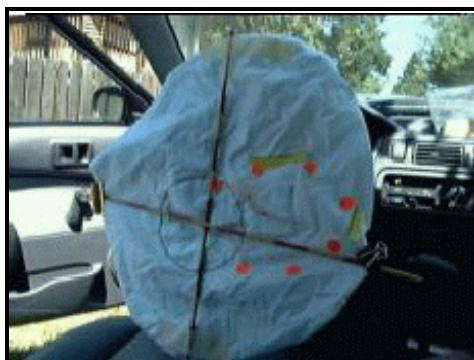
Figure 6. View showing deployed driver's air bag

The front, left driver’s air bag was housed in the steering wheel hub and was concealed by symmetrical double horizontal module cover flaps. The circular air bag was tethered and equipped with two exhaust vent port holes. The lower instrument panel is equipped with a rigid plastic knee bolster. A large scuff mark was documented to the upper right quadrant (right of center) of the air bag fabric. This was documented as a facial make-up transfer and lip stick smudge mark.

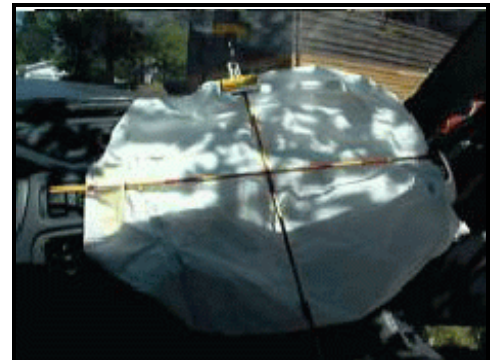
Figure 7. View showing deployed passenger (front, right) air bag

The front, right air bag was located on the instrument panel, top surface plane. The module cover flap is rectangular in design with asymmetric halves. There was no residual damage to the air bag and the module cover flaps opened at their designed tear points.

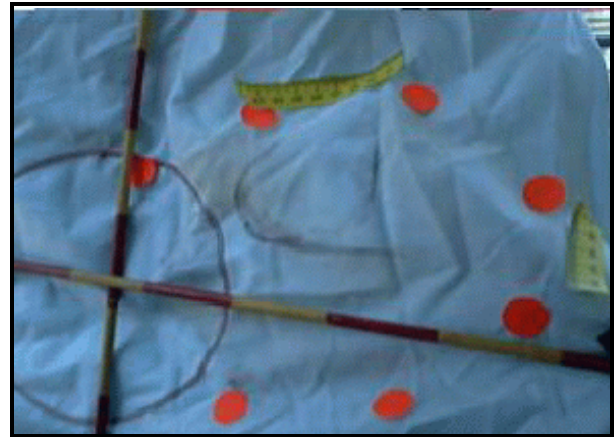
Figure 8. Close-up view showing facial cosmetic transfers and lip stick smudge mark

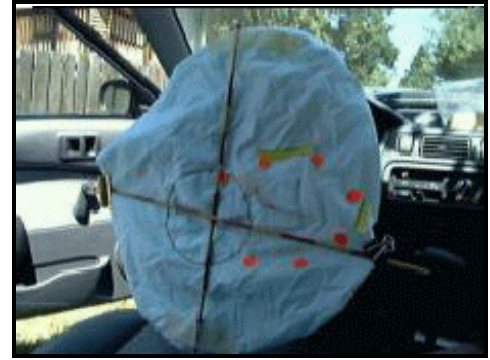
Figure 9. Deployed driver's air bag

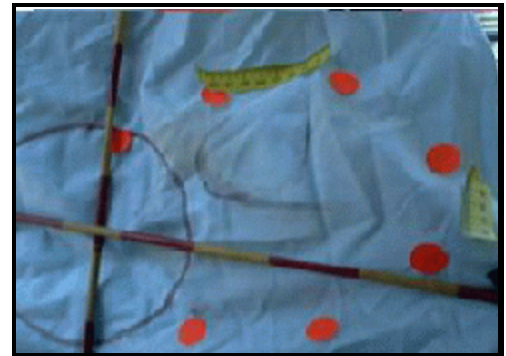
Figure 10. Close up view of large black scuff mark (facial cosmetic transfers)

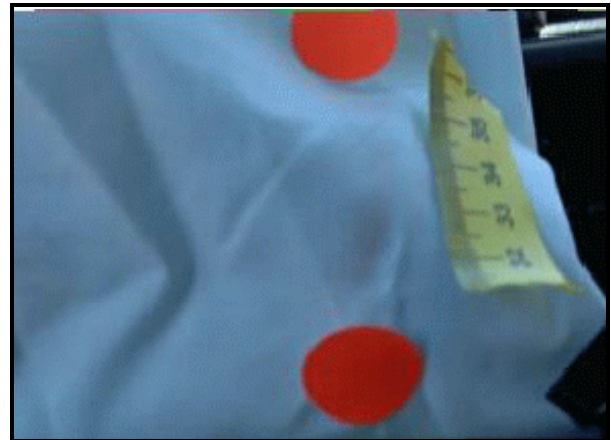
Figure 11. Close up view of lip stick transfer
