Remote, Redesigned Air Bag Special Study

Dynamic Science, Inc., Case Number (1998-082-805E)

1999 Pontiac Grand Am

August/1998

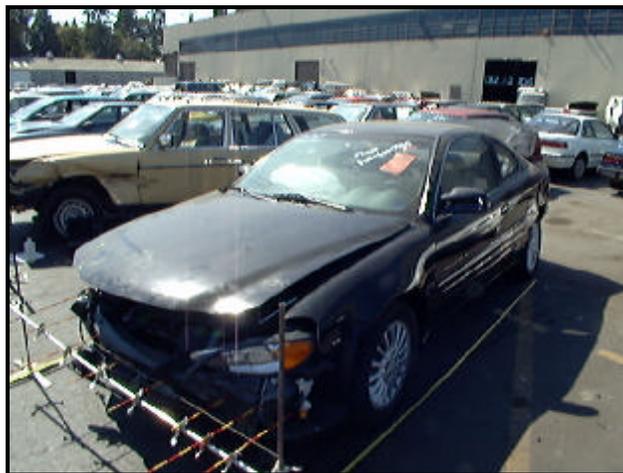
Figure 1. Exterior, Vehicle 1 (impact 2)

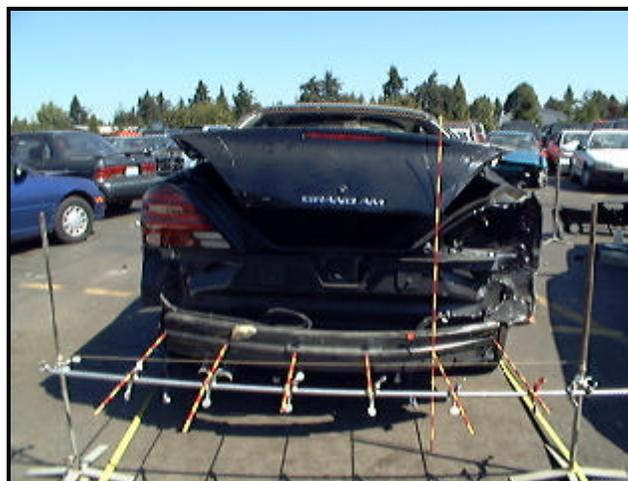
Figure 2. Exterior, Vehicle 1 (impact 3)

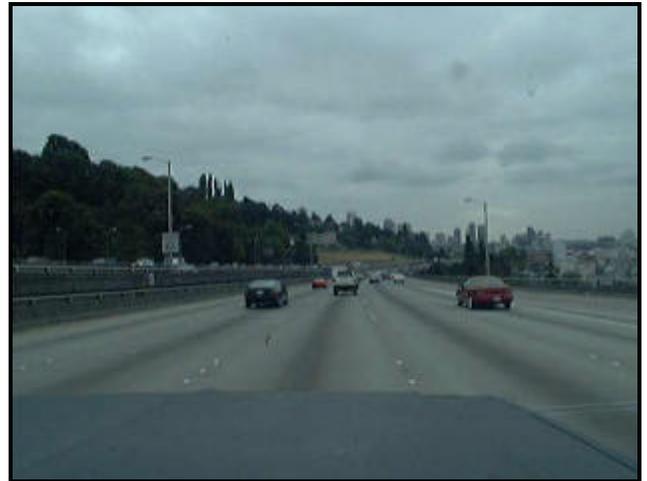
Figure 3. Crash scene, Vehicle 1 approach path.

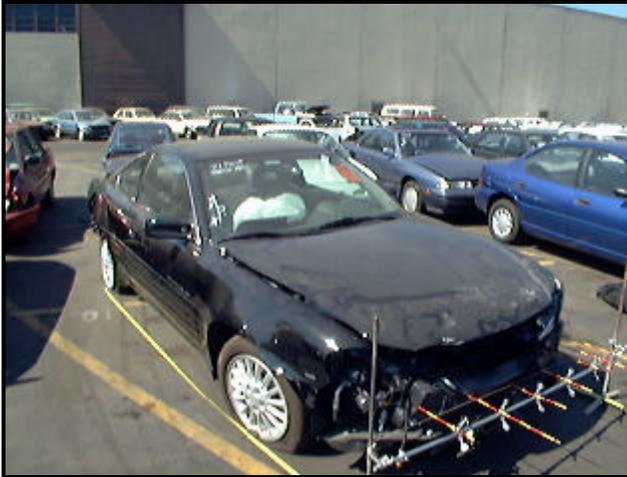
Figure 4. Exterior, Vehicle 1 (1999 Pontiac Grand Am)

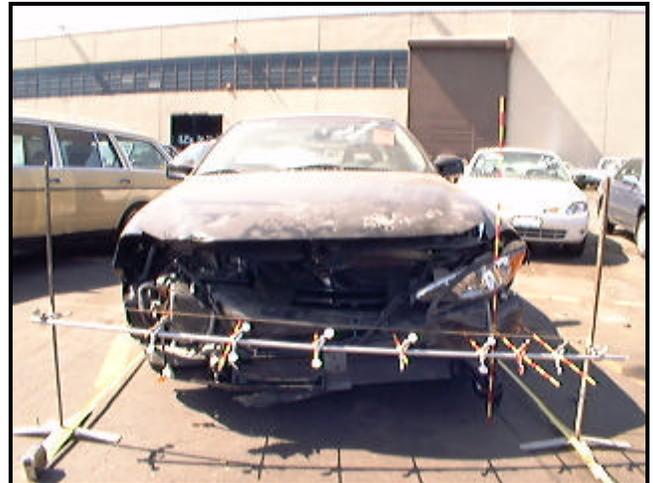
Figure 5. Exterior, Vehicle 1 (1999 Pontiac Grand Am)

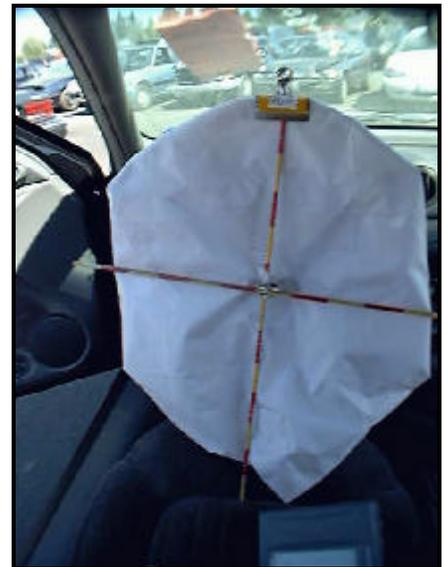
The front left air bag was housed in the steering wheel hub and was concealed by symmetrical I-configuration cover flaps which were not damaged in the crash. The circular air bag was equipped with two tether straps and two vent ports. No contact evidence was found on the air bag and the bag was not damaged.

Figure 6. Driver's frontal air bag.

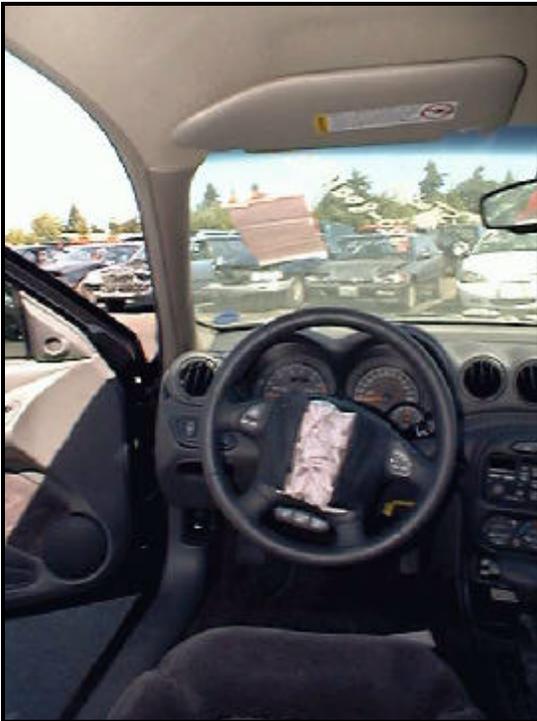
Figure 7. Interior, case vehicle. Occupant 01 seating position.

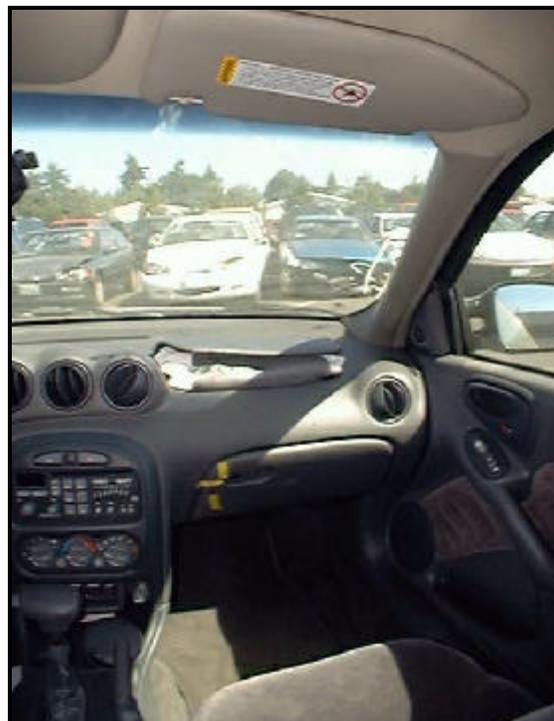
Figure 8. Interior, case vehicle. Occupant 02 seating position.
