TRANSPORTATION RESEARCH CENTER

ON-SITE CHILD AIR BAG-RELATED FATALITY INVESTIGATION

CASE NUMBER - IN98-001
LOCATION - MISSISSIPPI
VEHICLE - 1994 PONTIAC GRAND PRIX
CRASH DATE - January, 1998

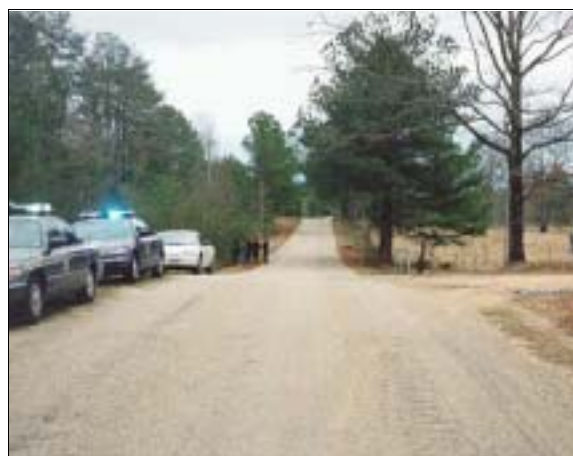
Figure 1: On-scene view of case vehicle's eastbound travel path, while cresting a hill, in middle of roadway (case photo #02)

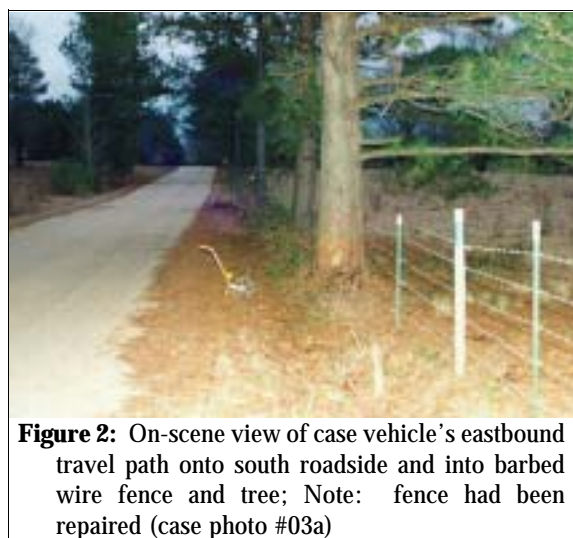
Figure 2: On-scene view of case vehicle's eastbound travel path onto south roadside and into barbed wire fence and tree; Note: fence had been repaired (case photo #03a)

Initially the right fender of the case vehicle sideswiped a fence post and the barbed wire the post supported, bending several metal fence posts (**Figure 2** above). Subsequently, the front center of the case vehicle (**Figures 3, 4, and 5**) impacted the large tree [66 centimeters in diameter (26.0 inches)], causing the case vehicle's driver and front right supplemental restraints (air bags) to deploy. The case vehicle rotated slightly (approximately 10 degrees) counterclockwise before coming to rest near the large tree, heading primarily eastward. The case vehicle was towed from the scene due to damage. The roadway was straight, bituminous, had no shoulders, and was dry at the time of the crash. There were no visible traffic controls, and the estimated coefficient of friction was 0.70%.

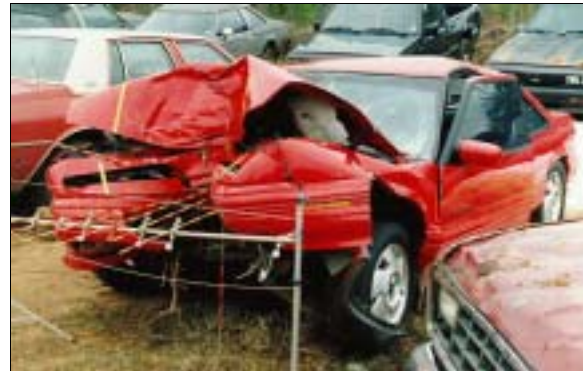
Figure 3: Case vehicle's frontal damage from tree impact, viewed from left of front with contour gauge present (case photo #13)

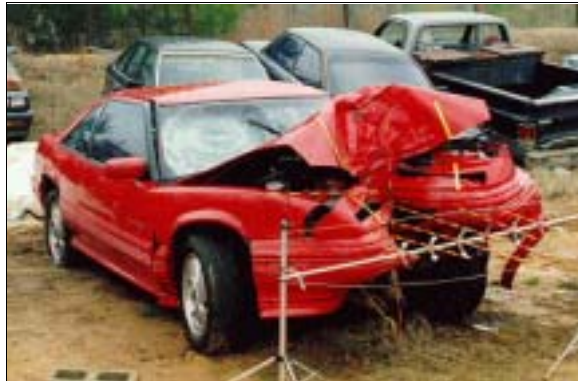
Figure 4: Case vehicle's frontal damage from tree impact, viewed from right of front with contour gauge present; Note: vertical yellow tape outlines direct contact area case photo #18)

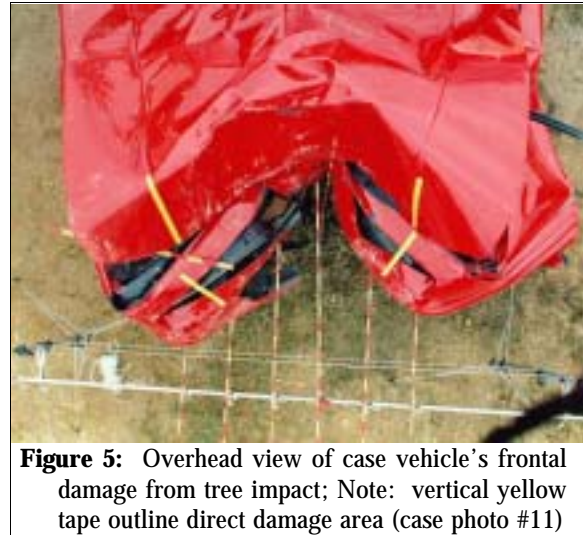
Figure 5: Overhead view of case vehicle's frontal damage from tree impact; Note: vertical yellow tape outline direct damage area (case photo #11)

The direct damage for the case vehicle's primary impact with the tree began 19 centimeters (7.5 inches) in from the front right bumper and extended 68 centimeters (26.8 inches) to the left (**Figure 5** above). The impact pulled in both front corners of the case vehicle resulting in a 78 centimeter (30.7 inches) field L. Maximum crush was measured as 85 centimeters (33.5 inches) near the C₃ position. The front bumper fascia, grille, hood, and radiator were crushed rearward. Both of the front tires were physically restricted from the front end damage (**Figures 3** and **4** above) and only the right front tire was deflated, possibly from interaction with the barbed wire fence. The case vehicle's impact with the large tree altered (i.e., shortened) the wheelbase 3 centimeters (1.2 inches) on the right side and 9 centimeters (3.5 inches) on the left side. The roof was buckled on the driver's side just behind the "B"-pillar, and both the right and left fenders sustained induced damage from the frontal impact.

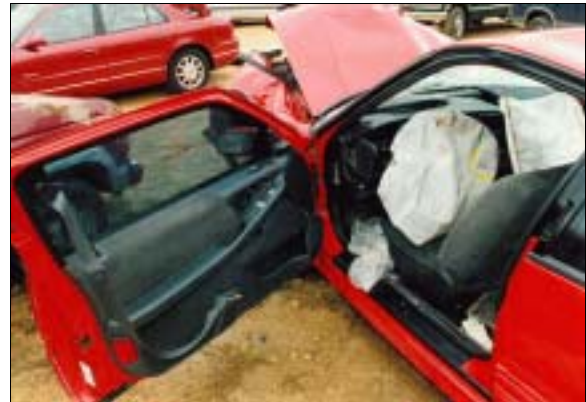
Figure 6: Case vehicle's driver seating area showing deployed driver and front right air bags; Note: three-point passive belt in driver's door (case photo #21)

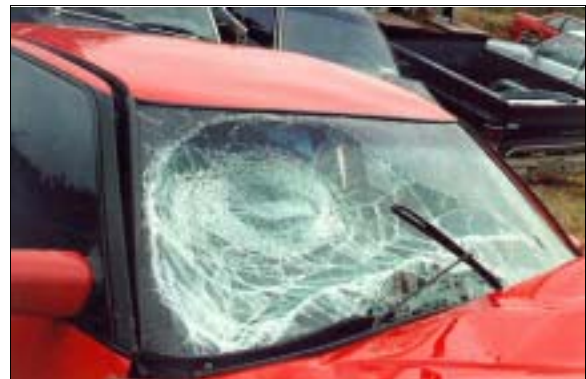
Figure 7: Right side of the case vehicle's windshield which was damaged by front right air bag module's tethered cover flap (case photo #20)

An examination of the case vehicle's interior revealed that the windshield was fractured on the passenger side (**Figure 7** above) from contact by the deploying front right passenger air bag module's cover flap (**Figure 8** above). The energy absorbing steering column sustained complete separation of the steering column's shear capsule (**Figure 9**), with separation measured at 9 centimeters (3.5 inches). The steering wheel rim showed total collapse from interaction with the case vehicle driver's chest. The padded cover on the floor-mounted, center console was broken off and had blood on it from contact by the front right passenger's head (**Figures 10** and **11**). The interior inspection also showed moderate intrusion to the entire front instrument panel, toe pan, and floor pan.

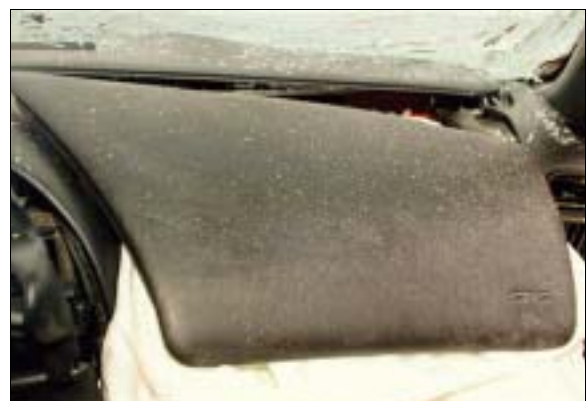
Figure 8: Case vehicle front right air bag module's tethered cover flap showing glass scratches from contacting and damaging right windshield (case photo #36)

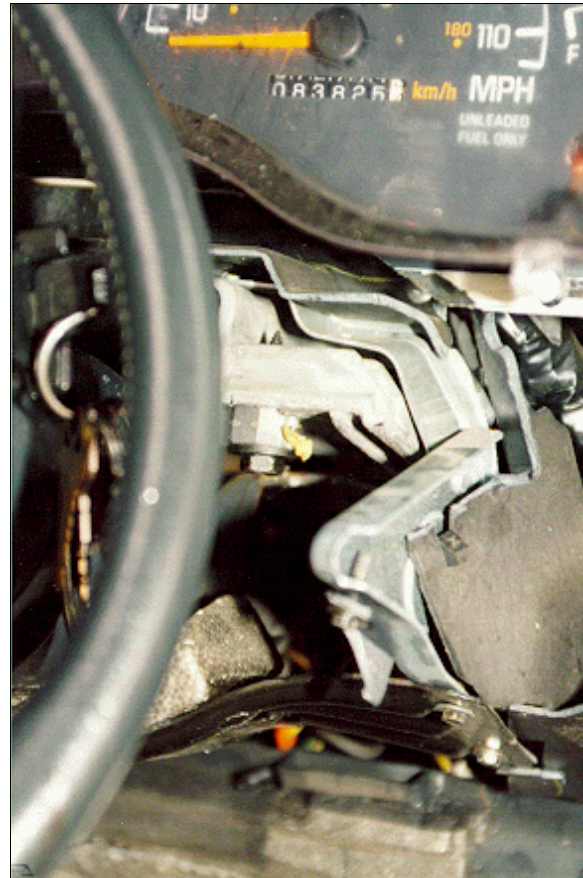
Figure 9: Close-up of case vehicle's steering column showing shear capsule separation (case photo #24)

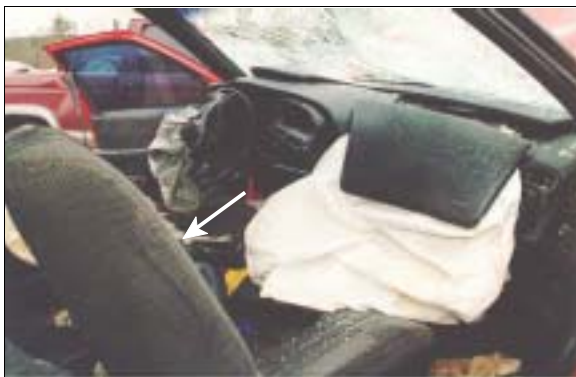
Figure 10: Case vehicle's front right passenger seating area showing deployed driver and front right air bags; Note: broken hinge (arrow) from center console's covered storage box and collapsed steering wheel rim (case photo #26)

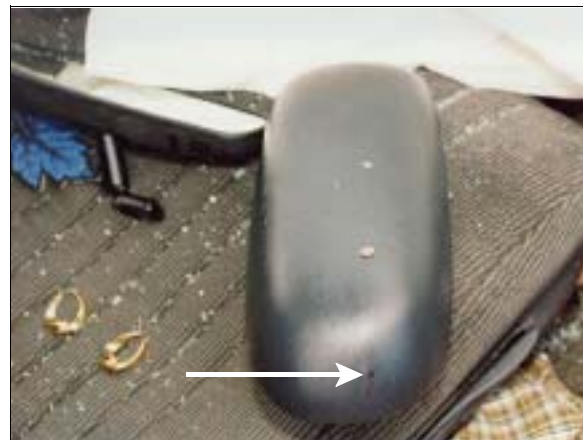
Figure 11: Case vehicle's padded center console cover, broken off by front right passenger's head; Note: arrow marks blood spot (case photo #26a)

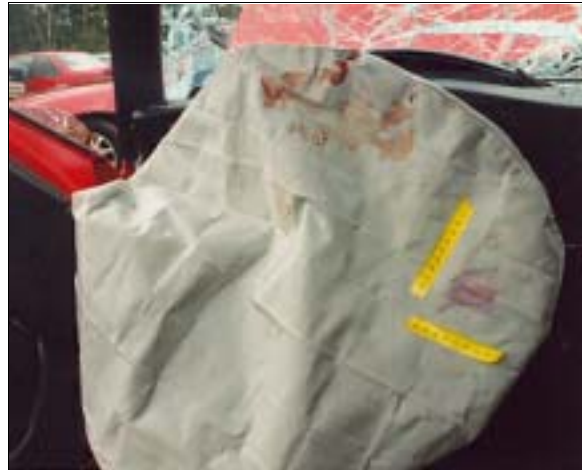
As previously mentioned, the case vehicle was equipped with a SRS that consisted of frontal air bags at the driver and front right passenger seat position. The SRS deployed as a result of the case vehicle's frontal impact with the tree. The case vehicle's driver air bag was located in the steering wheel hub. The module cover consisted of "I"-configuration cover flaps made of thick vinyl with overall dimensions of 18 centimeters (7.1 inches) at the upper and lower horizontal seams and 10 centimeters (3.9 inches) vertically. An inspection of the air bag module's cover flaps and air bag revealed that the cover flaps opened at the designated tear points, and there was no evidence of damage during the deployment to the air bag or the cover flaps. The driver's air bag was designed without any tethers. The driver's air bag had two vent ports, approximately 3 centimeters (1.2 inches) in diameter, located at the 9 and 3 o'clock positions. The deployed driver's air bag was round with diameter 60 centimeters (23.6 inches). An inspection of the driver air bag revealed an area of blood drainage toward the center portion of the upper left quadrant along the top edge (and continuing onto the back top of the air bag) and a lipstick imprint and a blood smear to the upper right portion (**Figure 12**).

Figure 12: Close-up of case vehicle's driver air bag showing lipstick (i.e., upper right) and blood (i.e., upper center) smears (case photo #28)

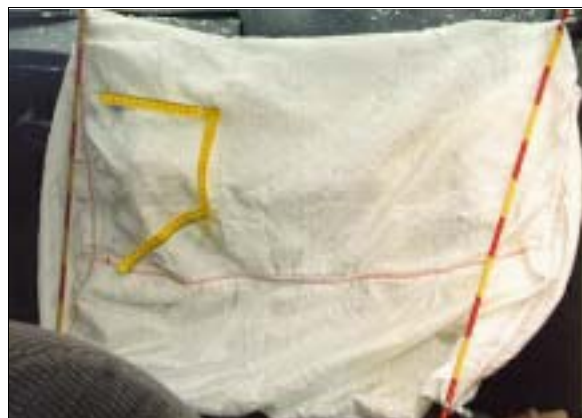
Figure 13: Close-up of case vehicle's front right passenger air bag showing area (i.e., taped) of skin transfer (case photo #32)

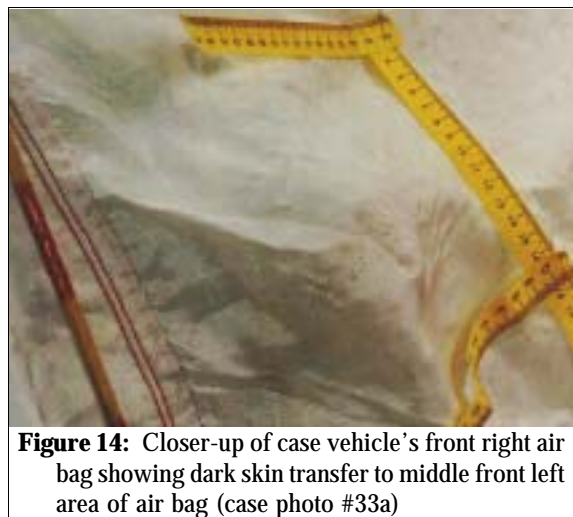
that was 19 centimeters (7.5 inches) above the bottom edge. The front right air bag had two vent ports, approximately 5 centimeters (2.0 inches) in diameter, located at the 10 and 2 o'clock positions. The deployed front right air bag was rectangular with a height of approximately 50 centimeters (19.7 inches) and a width of approximately 64 centimeters (25.2 inches). An inspection of the front right passenger air bag revealed a dark skin transfer to the front left center portion of the air bag (**Figure 13** above and **Figure 14**). The skin transfer started approximately 10 centimeters (3.9 inches) down from the top edge of the air bag and extended downwards 10 centimeters (3.9 inches). The skin transfer was 10 centimeters wide and started 4 centimeters (1.6 inches) in from the left edge. The bottom of the skin transfer was 11 centimeters (4.3 inches) above the tether stitching.

Figure 14: Closer-up of case vehicle's front right air bag showing dark skin transfer to middle front left area of air bag (case photo #33a)
