**CALSPAN ON-SITE ROLLOVER INVESTIGATION  
CALSPAN CASE NO. CA98-003  
VEHICLE: 1998 MERCEDES-BENZ ML 320  
LOCATION: ALABAMA  
CRASH DATE: JANUARY, 1998**

1. <i>Report No.</i> CA98-003	2. <i>Government Accession No.</i>	3. <i>Recipient's Catalog No.</i>	
4. <i>Title and Subtitle</i> Calspan On-Site Rollover Investigation Vehicle: 1998 Mercedes-Benz ML 320 Location: Alabama		5. <i>Report Date:</i> November, 1998

16. <i>Abstract</i>  This on-site investigation focused on the rollover initiation type for a 1998 Mercedes-Benz ML 320 sport utility vehicle that was involved in a on-road rollover crash in Alabama. The driver initiated a rapid left-right steering input which induced a clockwise yaw. The left front alloy wheel subsequently gouged into the raised edge of the asphalt road surface which tripped the vehicle into a lateral side-over-side rollover event. The Mercedes completed seven (7) quarter turns prior to coming to rest on its right side. The belted female driver sustained soft tissue injuries and was treated at a local hospital and released. The ML 320 was equipped with frontal and side impact air bag systems. Both the left and right door-mounted side impact air bags depl

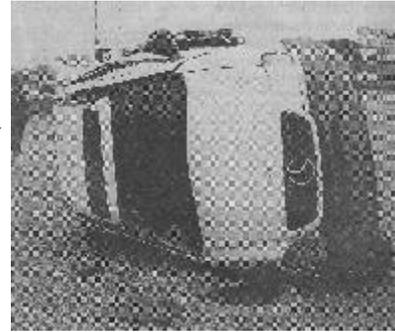
**Figure 1. On-scene view of the ML 320 at final rest.**

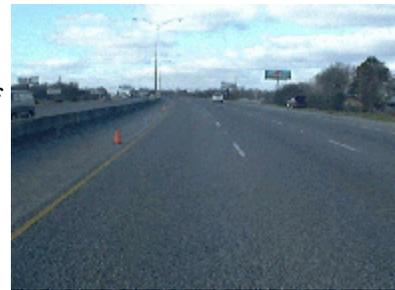
The crash occurred on the northbound lanes of a six lane divided interstate roadway in a posted speed zone of 105 km/h (65 mph) during daylight hours (**Figure 2**). The northbound travel lanes consisted of three (3) lanes of equal width of 3.7 m (12.0'). A continuous pour concrete median barrier physically divided the trafficway. The northbound travel lanes were bordered by a 3.4 m (11.1') paved outboard shoulder and a 3.3 m (10.7') paved inboard shoulder. In the vicinity of the crash site, the interstate was curved to the left with respect to the Mercedes' northbound path of travel. The radius of curvature was calculated at 1,375 m (4,513'). At the point of rollover, the grade was 1.0 percent, positive to the north. The superficial elevation was measured at 1.6 percent. The asphalt travel lanes were raised 2.5 cm (1.0") over the level of the shoulder. It should be noted that the asphalt surface of the travel lanes was in good condition with no visible defects. The surface, however, was coarse with a No. 1-type stone protruding above the asphalt mixture. The surface of the shoulders was a coarser mixture of asphalt with fewer protruding stones. These stones appeared to extend higher above the tar

**Figure 2. Overall view of the northbound travel lanes.**

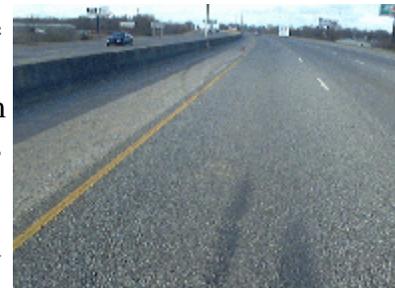
The CW steering reversal induced a clockwise yaw as the vehicle broke traction on the inboard travel lane. The yaw was evidenced by left front and left rear tire marks which began on the inboard travel lane 1.5 m (5.0') right of the yellow inboard edge line (**Figure 4**). The yaw marks crossed the yellow edge line onto the paved left shoulder as the vehicle continued to yaw CW. The yaw marks began to arc back toward the travel lane as the Mercedes-Benz yawed approximately 47 degrees CW (**Figure 5**). The maximum lateral separation (**Figure 6**) between the left front and left rear yaw marks was 206 cm (81"). The total length of the yaw marks were 24.7 m (81.2') and 23.3 m (76.3') respectively for the left front and left rear tires. A calculated speed of 101.4 km/h (63.0

**Figure 4. Initiation of the yaw marks on the inboard travel lane.**

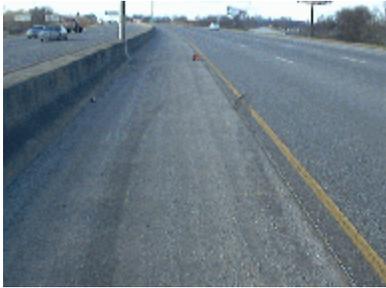
**Figure 5. CCW arc of the left side yaw marks.**

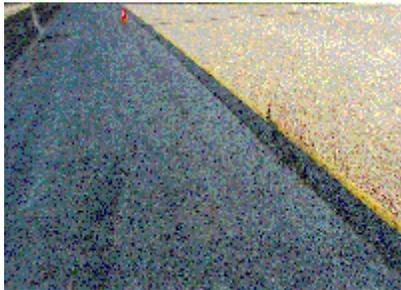
**Figure 6. Lateral separation of the yaw marks.**

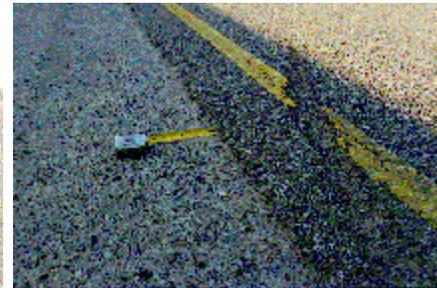
mph) was derived from the yaw marks using the critical curve speed formula. The aggressive asphalt surface of the shoulder in combination with the extent of CW yaw allowed the sidewalls of the left side tires to roll under the aluminum-alloy wheels. As the left front tire mounted a 2.5 cm (1.0") rise in the pavement from the shoulder to the travel lane, the alloy left front wheel of the Mercedes gouged the asphalt surface (**Figure 7**). The gouge extended for a total length of 2.1 m (7.0') and was approximately 7.6 cm (3.0") in width. At this point, the left front tire was probably aired out due to the rotation and wheel engagement with the road surface. The aired out left front tire continued to mark on the asphalt surface adjacent to the gouge mark. The wheel was subsequently deformed to a depth of 0.6 cm (0.25") over a length of 17.8 cm (7.0"). Asphalt was embedded in the outer aspect of the bead at the area of deformation.

**Figure 7. Raised pavement surface and the gouge mark.**

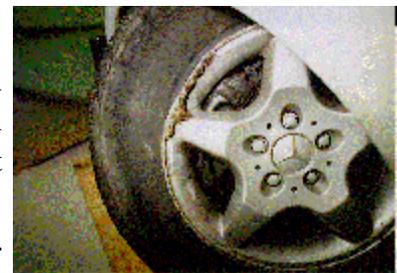
The lateral yaw of 47 degrees and the subsequent engagement of the alloy left front wheel into the asphalt road surface resulted in a tripped side-over-side rollover event (**Figure 8**). The Mercedes-Benz rolled onto its left side initially contacting the left roof side rail area. The first gouge mark on the asphalt surface was located at the inboard edge line of the travel lane 9.2 m (30.3') north of the end of the wheel gouge. The vehicle continued to overturn in a side-over-side attitude, completing seven (7) quarter turns prior to coming to rest on its right side diagonally across the center and inboard travel lane (**Figure 9**). Numerous gouge marks were present on the road surface to track the trajectory and quarter turns of the vehicle. A semi-circular gouge mark was present on the inboard travel lane 24.2 m (79.8') north of the trip point which initiated the rollover event. The gouge was located 2.7 m (8.7') inboard of the yellow edge line and resulted from contact with the right front wheel. Asphalt was embedded into the bead between the alloy wheel and the inflated tire.

**Figure 8. Asphalt embedded into the left front wheel which tripped the ML 320.**

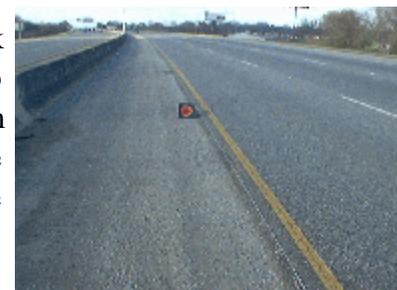
**Figure 9. Rollover trajectory of the ML 320.**

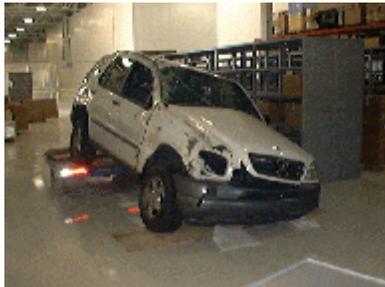
Damage to the Mercedes-Benz ML 320 consisted of vertically oriented abrasions along both sides which extended the full length of the vehicle. The heaviest concentration of abrasions occurred to the roof side rail/upper door window frame areas. Maximum crush was 4.4 cm (1.75") located at the junction of the right upper A-pillar and the right roof side rail (**Figure 10**). The roof did not sustain direct contact damage between the roof rack rails that were affixed directly inboard of the side rail area. The front and rear bumper fascias were damaged at the left side corners, however, there was no underlying damage to the structural components. The laminated windshield was cracked adjacent to the left A-pillar. The left rear door glazing, left rear quarter glazing, backlight glazing (**Figure 11**), and the right front door glazing was shattered during the rollover. The remaining door and quarter window glazing, in addition to the sunroof, remained intact. All four doors remained closed and operational.

**Figure 10. Rollover damage to the right side area of the vehicle.**

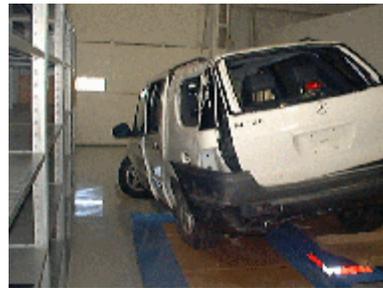
**Figure 11. Left rear three-quarter view of the rollover damage.**

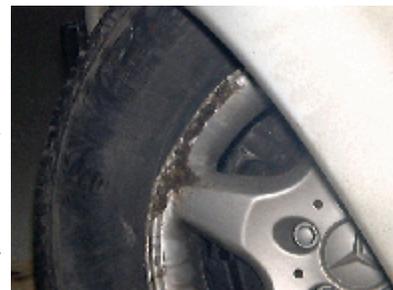
The left front wheel was embedded with asphalt from its contact and tripping action with the asphalt road surface (**Figure 12**). During the rollover, additional impact damage (abrasions and deformation) occurred to the tire and wheel assembly which resulted in separation of the lower left ball joint from the lower control arm. The sidewall area of the left front tire was abraded from contact with the road surface and the outer aspect of the tire tread was abraded from the initial yaw. The left rear alloy wheel was abraded 300 degrees circumferentially with a 43.2 cm (17.0") area of the bead fractured from the wheel. The left rear suspension was damaged due to wheel contact during the rollover. Suspension damage consisted of separation of the lower ball joint, fracturing of the axle spindle, and a large fracture of the inner aspect of the alloy wheel. Both left side tires were completely aired out and separated from the beads, however, the tires remained on the wheels.

**Figure 12. Close-up view of the embedded asphalt into the left front alloy wheel.**

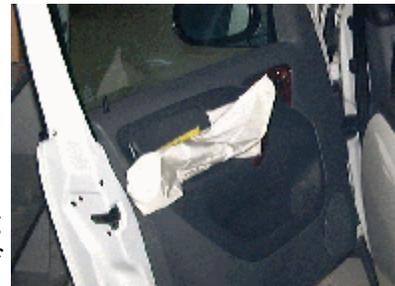
The side impact air bag system consisted of an abdominal/thoracic bag that deployed from a module assembly installed in the rear third area of the front door panels (**Figure 13**). Deployment of the side impact air bags was triggered by a sensor located within the passenger compartment area of the vehicle. The left and right side impact air bags

**Figure 13. Deployed left side impact air bag.**

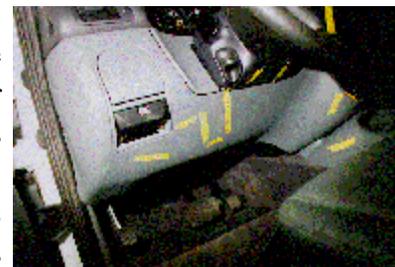
During the lateral overturn sequence, the driver contacted the knee bolster, center console, steering wheel air bag module cover, left upper A-pillar, left side impact air bag, and the left door panel. The driver's lower extremities contacted the bolster, the base of the steering column, and the left side of the console (**Figure 14**). The bolster contact was evidenced by a vertically oriented patterned fabric transfer/scuff that was located 46.4-52.1 cm (18.25-20.5") left of center and 27.9-36.8 cm (11.0-14.5") below the upper instrument panel. Two additional small scuff marks were located on the vertical transfer. On the base of the column at the outboard edges were two scuff marks that probably resulted from contact with the upper aspect of the knees. The driver's right lateral leg contacted the lower left corner of the mid instrument panel and the left side of the center console. Both contact points were evidenced by patterned transfers. As a result of bolster contact, the driver sustained a vertically oriented contusion with abrasion over the medial aspect of the right lower leg.

**Figure 14. Lower extremity contacts to the knee bolster.**

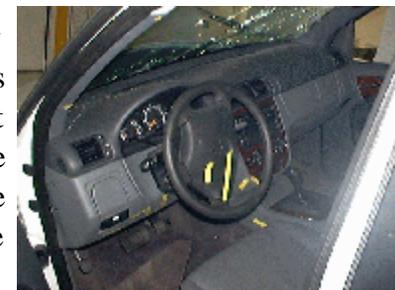
**Figure 15. Scuff marks on the non-deployed driver air bag module cover.**

A large horizontally oriented scuff mark extended across the right upper aspect of the driver's side air bag module cover. The scuff mark

extended from the midpoint of the Mercedes logo to the right upper spoke and measured 14.0 cm (5.5") horizontally and 1.2 cm (0.5") in width. A second scuff mark was noted to the right mid area of the module cover (**Figure 15**). The driver's right hand/wrist probably contacted the non-deployed module cover during the rollover which resulted in an abrasion over right hand and wrist. The driver's left arm probably contacted the left upper A-pillar as evidenced by scuff marks 13.3-15.2 cm (5.25-6.0") above the upper instrument panel and at the juncture with the side rail area. No injury occurred from the A-pillar contact. Her head probably contacted the headliner at the left rear corner area of the sun roof. The trim was compressed against the headliner and a single strand of hair was embedded into the fabric headliner. The driver sustained cervical strain that was induced from the head contact against the headliner. She probably rebounded into the left seat back support during the rollover event which resulted in a contusion over the left scapular area.
