On-scene Investigation / Vehicle to Vehicle
Dynamic Science, Inc. / Case Number: DS98005
1997 Toyota Camry
California
May 1997

1. Report No. DS98005	2. Government Accession No.	3. Recipient Catalog No.	
4. Title and Subtitle In-Depth Accident Investigation		5. Report Date	
7. Author(s) Dynamic Science, Inc.		6. Performing Organization Report No.

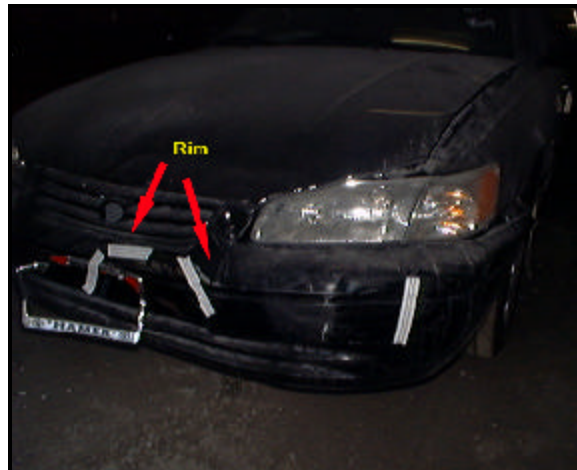
Figure 1. Exterior, case vehicle.

Description:	1997 Toyota Camry LE 4-door	
VIN:	JT2BF22K2V0XXXXXX	
Odometer:	Unknown / digital	
Engine:	Unknown	
Reported Defects:	None noted	
Cargo:	Unknown	
Damage Description:	Slight rearward crushing of front bumper, imprint of V2 tire rim in bumper fascia, windshield fractured.	
CDC:	12FDEW1	
Delta V:	Total	17.2 km/h (10.7 mph)
	Longitudinal	-16.6 km/h (-10.3 mph)
	Latitudinal	-4.4 km/h (-2.8 mph)
	Energy	13,433 joules (9,906 ft-lbs)

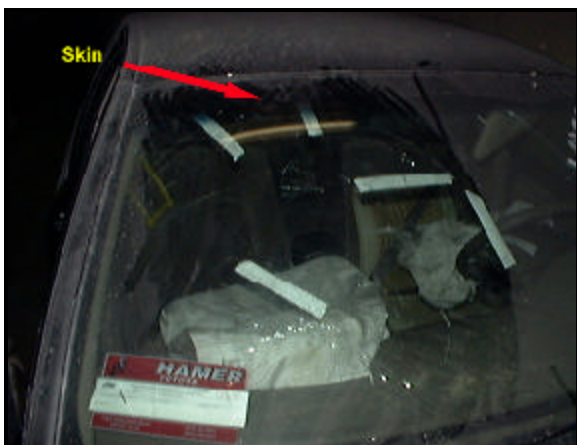
Figure 2. Exterior windshield, case vehicle

also sustained multiple contusions and abrasions to the chin, neck, and chest. The injuries were all as a result of contact with the deploying air bag and contact with the upper portion of the windshield.

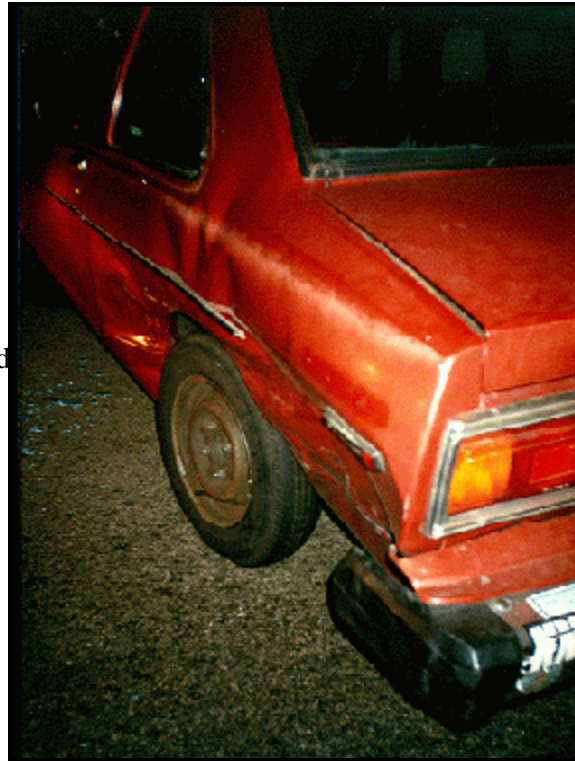
Figure 3. Exterior, Vehicle 2

Description:	1978 Datsun B210	
VIN:	Unknown	
Odometer:	Unknown	
Engine:	Unknown	
Reported Defects:	None noted	
Cargo:	Unknown	
Damage Description:	Light crush damage to left rear quarter panel; vehicle was able to be driven.	
CDC:	09LZEW2	
Delta V:	Total	25.3 km/h (15.7 mph)
	Longitudinal	-8.6 km/h (-5.4 mph)
	Latitudinal	23.7 km/h (14.7 mph)
	Energy	31,730 joules (23,400 ft-lbs.)

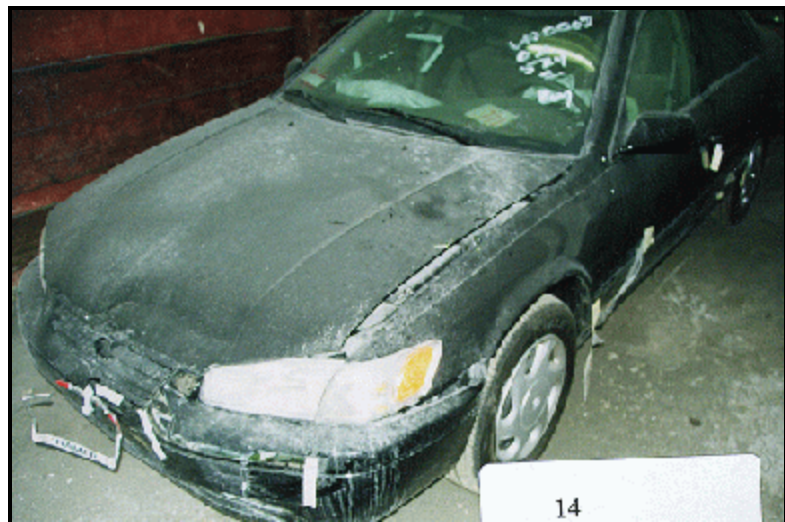
Figure 5. Exterior, case vehicle

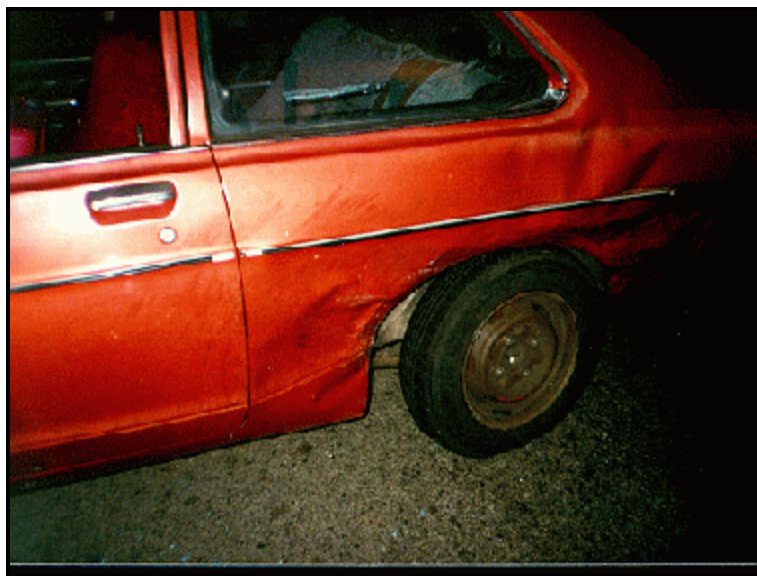
Figure 6. Exterior, other vehicle

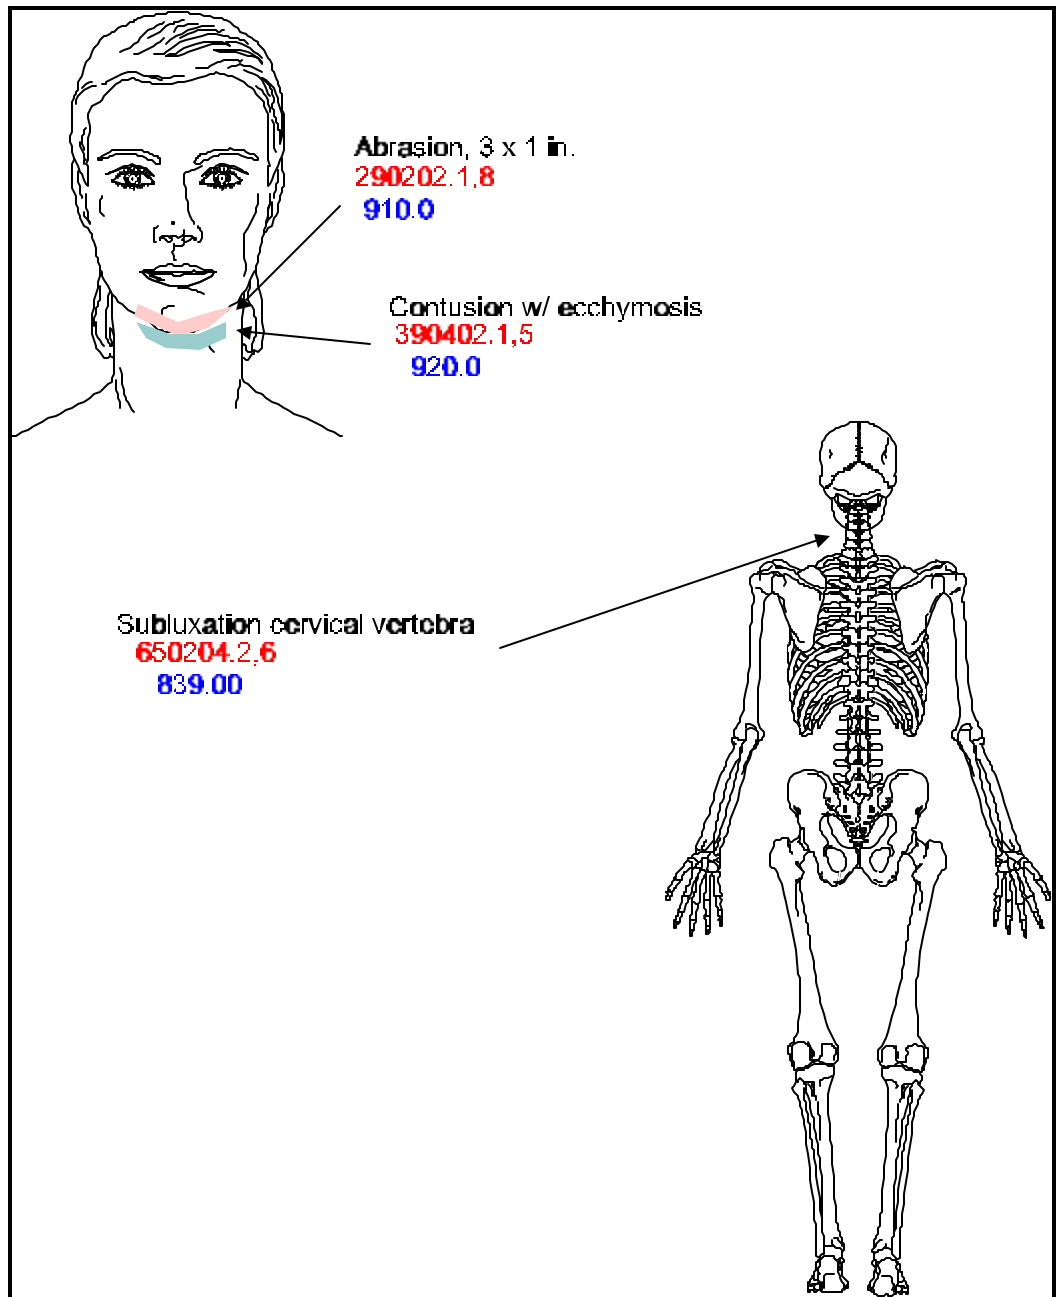
<u>INJURY</u>	<u>OIC CODE</u>	<u>ICD-9</u>	<u>SOURCE</u>
Driver:	Reported pain to right hand and stomach			
RF Occupant:	Subarachnoid hematoma	140684.3,1	852.00	Windshield
	Cerebral contusion, right	140604.3,1	851.06	Windshield
	Subarachnoid hematoma	140684.3,2	852.00	Windshield
	Subdural hemorrhage, parieto-occipital, right	140650.4,1	852.00	Windshield
	C1/C2 subluxation cervical vertebra	650204.3,6	839.01	Air bag
	Abrasion, 3 x 1 in., chin	290202.1,8	910.0	Air bag
	Contusion with ecchymosis, anterior neck	390402.1,5	920.0	Air bag
	Contusion with ecchymosis, upper back below neck	690402.1,7	922.3	Windshield
	Chest abrasion, 1 x ½ in.	490202.1,1	911.0	Air bag
	Chest abrasion, 1 x 1/4 in.	490202.1,1	911.0	Air bag
	Chest contusion	490402.1,0	922.1	Air bag
	Chest abrasion, 1-1/2 x ½ in.	490202.1,4	911.0	Air bag
	Bilateral lung contusions	441410.4,3	861.21	Air bag
	Trachobronchial tree hemorrhage	442699.3,4	862.8	Air bag

Figure 7. Facial and neck injuries

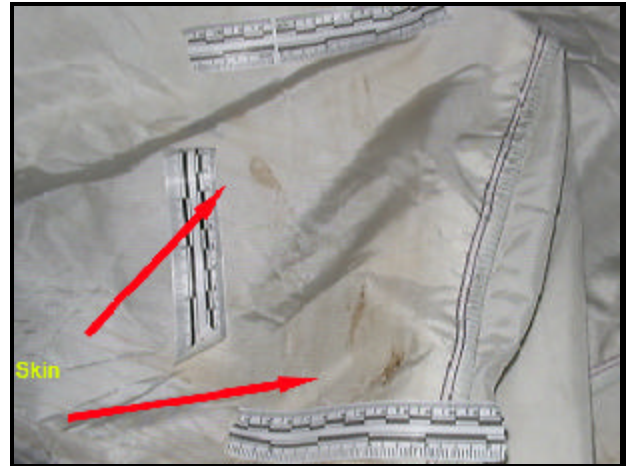
The case vehicle was equipped with a driver's side air bag and a top-mount passenger side air bag. The passenger air bag was rectangular and measured 45 cm (17.7 in.) laterally by 52 cm (20.4 in.) vertically with a maximum excursion of 56 cm (22 in.). At the time of the inspection, the right front seat was positioned 90 cm (35.4 in.) rearward of the face of the instrument panel, 103 cm (40.5 in.) rearward of the base of the module cover. Essentially, this was the middle track position. There was a 20 x 20 cm (7.8 x 7.8 in.) patch of skin found on the right side face of the air bag. There was also a small blue fabric transfer just to the left of the skin transfer.

Figure 9. Skin transfer on air bag

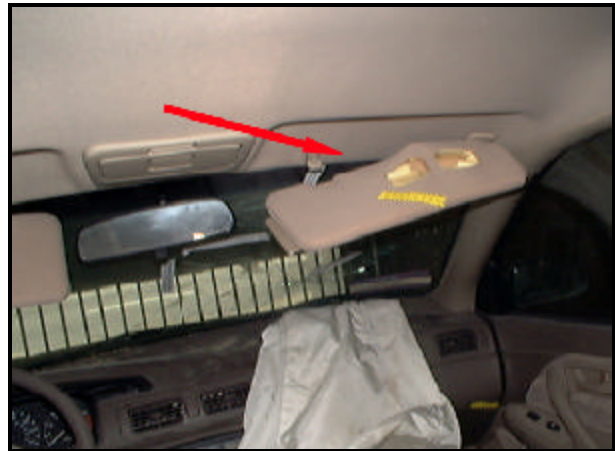
In addition to the skin transfer on the air bag, skin fragments were found on the windshield 10 cm (3.9 in) below the header. The windshield was fractured at this location. The right front visor was damaged due to occupant contact; it was deformed and the built-in mirror had been dislodged. A cloth transfer was found on the lower instrument panel and a portion of the panel had been broken away by occupant contact.

Figure 10. Overview of interior, case vehicle

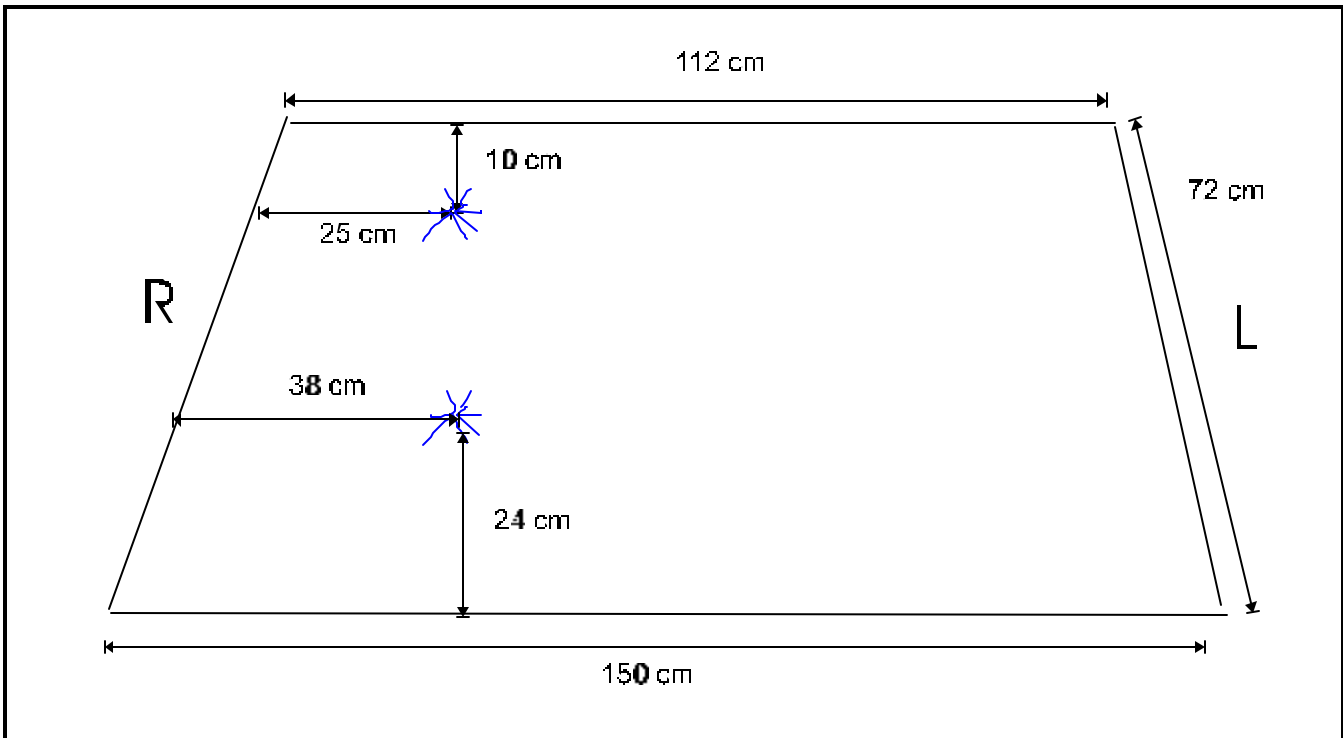
The right front occupant was seated in a forward facing fashion. Prior to impact, the driver braked, bringing the occupant closer to the instrument panel. It appears that at impact this occupant went forward and up at or around the time of deployment. The deploying air bag caught the occupant beneath the chin and in the chest. The occupant continued her forward motion and contacted the windshield with her head. The air bag lifted her up bringing some portion of her head into contact with the visor. As the air bag deployed fully, the occupant was forced backwards toward her seat, where she came to rest.

Figure 11. Windshield contacts
