**TRANSPORTATION SCIENCES
CRASH RESEARCH SECTION**

**CALSPAN ON-SITE AIR BAG/CHILD FATALITY INVESTIGATION
CALSPAN CASE NO. CA98-007
VEHICLE: 1996 FORD CONTOUR
LOCATION: GEORGIA
CRASH DATE: JANUARY, 1998**

1. <i>Report No.</i> CA98-007	2. <i>Government Accession No.</i>	3. <i>Recipient's Catalog No.</i>	
4. <i>Title and Subtitle</i> Calspan On-Site Air Bag/Child Fatality Investigation Vehicle: 1996 Ford Contour Location: Georgia		5. <i>Report Date:</i> August, 1999

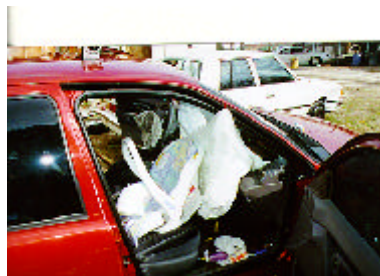
This on-site investigation focused on a single vehicle air bag deployment crash that resulted in the death of a 4 month old female infant. The infant was positioned in a child safety seat that was held on the lap of the front right occupant. The involved vehicle was a 1996 Ford Contour that was equipped with frontal air bags for the driver and right passenger positions. The Contour impacted a barrier curb on an interstate bridge with the front left bumper and undercarriage components which resulted in deployment of the air bag system. The front right air bag expanded against the child safety seat (**Figure 1**) which resulted in fatal head injuries to the infant.

Figure 1. Expansion of the front right air bag against the shell of the infant restraint.

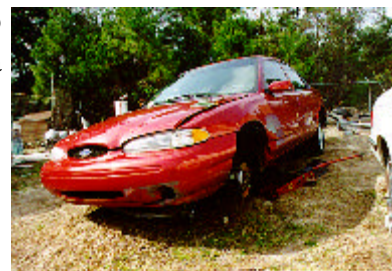
The front left aspect of the bumper fascia impacted the barrier curb (**refer to Figure 2**). The impact redirected the Contour slightly in a clockwise (CW) direction as the bumper overrode the barrier curb which allowed the front left frame rail and suspension components to engage against the curb (**refer to Figure 3**). The left front tire and wheel contacted the face of the curb which resulted in abrasions to the aluminum alloy wheel and gouging to the sidewall of the tire. The inboard aspect left front alloy wheel was fractured by the contact with the barrier curb. The impact deformed the left front corner of the frame rail and displaced the lower control arm approximately 18.8 cm (7.0") rearward which resulted in separation of the lower ball joint from the

Figure 2. Front left three-quarter view documenting the curb impact damage.

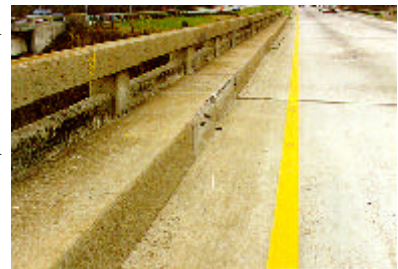
The contact evidence on the barrier curb was 9.1 m (30.0') in length and consisted of abrasions to the concrete surface with fragments of tire rubber and red paint transfers (**refer to Figure 3**). The impact redirected the vehicle onto the inboard travel lane as it continued in an easterly direction. The aired out left front tire was deflected rearward into the trailing edge of the left front wheel opening. The damage to the wheel and suspension components restricted the rotation of the tire, therefore the tire marked on the concrete road surface 1.8 m (6.0') east of the separation point from the curb. This tire print identified the post-crash trajectory of the vehicle.

Figure 3. Ford Contour's impact with the barrier curb.

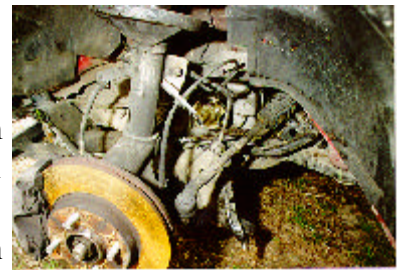
The initial bumper fascia contact against the barrier curb did not result in residual crush to the bumper reinforcement bar. The direct contact damage on the fascia consisted of a heavy concrete abrasion pattern that began 34.9 cm (13.75") left of the vehicle's center line and extended 34.9 cm (13.75") to the front left bumper corner. The bumper overrode the 33.0 cm (13.0") barrier curb which allowed the front left undercarriage components to engage with the curb as the vehicle was redirected slightly in a clockwise direction. The outboard aspect of the leading edge of the front left frame crossmember was displaced 1.3 cm (0.5") rearward and was heavily abraded from the concrete curb impact. As the Contour continued forward, the lower aspect of the left lower control arm contacted the curb which resulted in 17.8 cm (7.0") of rearward displacement of the control arm and separation of the lower ball-joint from the steering spindle (refer to Figure 4). Ball-joint separation resulted from the straight machined shaft of the joint pulling out of the compression bore on the lower control arm unit. This compression union did not utilize a tapered shaft or the use of a castle nut/cotter key configuration.

Figure 4. Undercarriage damage and separation of the left lower ball-joint.

The lower ball-joint separation allowed displacement of the left front tire into the trailing aspect of the wheel opening. The tire/wheel contacted and dented the rear aspect of the left front fender and abraded the plastic inner fender liner. Rearward displacement of the left front axle resulted in complete separation of the left inboard constant velocity (CV) joint from the output shaft on the transaxle.

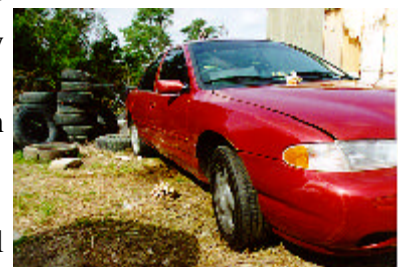
The right side of the Ford Contour exhibited a similar superficial sideswipe-type damage pattern that was recent to the crash involving the left side of the vehicle. This damage pattern began at the right front bumper corner and extended 30.4 cm (12.0") rearward onto the side

Figure 5. Sideswipe damage to the right side of the Contour.

surface of the fascia. Abrasions and shallow dents were noted to the right sill of the vehicle and to the right lower C-pillar/right rear door panel (**refer to Figure 5**). There were no abrasions/contact evidence on the right front and/or right rear tires and wheels. This damage pattern was consistent with a barrier curb impact to the right side of the concrete bridgerail, however, there was no evidence over the entire length of the bridge to support this impact. Several “fresh” areas of abrasive contact were noted to the right barrier curb, however, these areas did not contain red paint transfers. In addition, the road debris along the base of the curb was not disturbed from recent contact.

Although the right side sideswipe damage (CDC of 12-FRLE-9) could not directly be linked to this crash, the damage was recent since the exposed sheet metal was free of surface rust, similar to the left side damage. This contact pattern would have resulted from a shallow angle departure from the outboard travel lane and subsequent contact with the barrier curb. The contact probably would have initiated an evasive counterclockwise steering input by the driver which could have resulted in the departure from the inboard travel lane. It should be noted that the body shop included this right side damage in the overall repair estimate for the crash related damage.

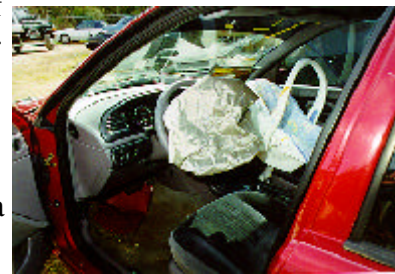
Figure 6. Deployed front left air bag.

barrier curb of the left side bridgerail. The front left air bag deployed from the four-spoke steering wheel rim mounted module assembly (refer to **Figure 6**). The module cover consisted of symmetrical cover flaps with overall dimensions of 19.1 cm (7.5") at the horizontal tear seam and 7.6 cm (3.0") vertically. At the time of vehicle inspection, the steering wheel was rotated approximately 180 degrees CW. The air bag membrane was 58.4 cm (23.0") in diameter and was constructed of two different fabrics sewn with an internal peripheral seam. The forward panel was a light color fabric with a close weave pattern while the outer panel (panel exposed to the driver) was a typical coarser woven fabric. The outer panel was lined internally with a neoprene-type liner. The bag was vented by two 1.9 cm (0.75") diameter vent ports that were located at the 11 and 1 o'clock sectors of the bag, centered 7.4 cm (2.9") inboard of the peripheral seam. The front left air bag was tethered by two 12.7 cm (5.0") wide tethers sewn to the face of the bag at the 3 and 9 o'clock positions. The 17.8 cm (7.0") diameter reinforcement was sewn to the face of the bag with two rows of stitching.

There was no direct contact evidence on the bag from occupant involvement. Superficial transfers were noted to the inner panel of the bag circumferentially 360 degrees from the bags expansion against the cover flaps. There was no compression of the energy absorbing steering column.

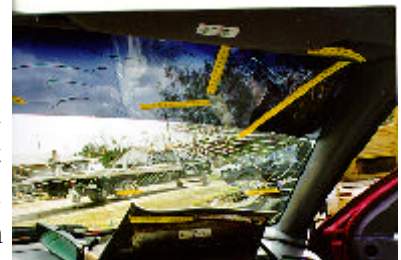
Figure 7. Cover flap and air bag contact to the windshield.

The leading edge of the cover flap impacted and fractured the laminated windshield at three distinct points (**refer to Figure 7**). The left corner of the flap impacted and fractured the windshield glazing 19.1-19.7 cm (7.5-7.75") right of center and 16.5-18.4 cm (6.5-7.25") above the top surface of the upper instrument panel. A vertically oriented scuff mark surrounded the mid point of the fracture. The bowing of the upper flap resulted in contact by the mid aspect of the leading edge of the flap. This point was located 35.6 cm (14.0") right of center and 15.2 cm (6.0") above the instrument panel. The right corner of the flap impacted and fractured the windshield 53.3-55.9 cm (21.0-22.0") right of center and 15.2 cm (6.0") above the panel.

The subsequent expansion of the frontal passenger air bag against the forward positioned child safety seat altered the deployment path of the bag. The bag was deflected in a forward direction against the windshield. Bag contact to the windshield was evidenced by a patterned white air bag membrane transfer that was located 22.9-28.6 cm (9.0-11.25") right of center and extended (34.9-39.4 cm 13.75-15.5") above the referenced instrument panel. The contact fractured the windshield in a star-like pattern that was centered 26.7 cm (10.5") right of center and 33.0 cm (13.0") above the upper panel.

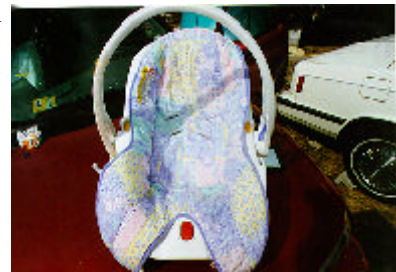
The involved child safety seat (CSS) was manufactured by Cosco on 06/16/97 and was identified by Model No. 02 733 PJE (**refer to Figure 8**). The CSS was improperly used at the time of the crash. It was designed to be used as a rear-facing infant restraint. The restraint consisted of an ABS-type plastic one-piece shell with a pivoting carrying handle affixed to the mid point of the shell. A foam pad with a fabric liner provided a soft surface for the infant. The CSS was manufactured with a 3-point harness, however, the harness straps were removed from the shell of the restraint. The belts were not present in the vehicle, therefore it was suspected that the harness was removed prior to this crash. A locking clip was taped to the base of the shell.

Figure 8. Overall view of the Cosco infant restarint.

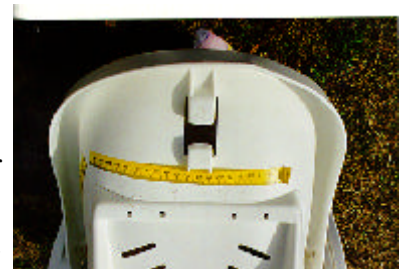
Figure 9. Cover flap abrasion and fracture to the shell of the child safety seat.

flap opened against the upper rear aspect of the shell of the restraint. This contact sequence was evidenced by an abrasion with a whitish transfer embedded into the leading edge of the flap and a horizontally oriented abrasion with gray vinyl embedded into the shell of the restraint. This abrasion pattern was located across the manufacture date clocks that were embossed into the shell of the restraint (**refer to Figure 9**). The abrasion was 14.2 cm (5.6") horizontally and 1.9 cm (0.75") in height. This contact fractured the shell in both a horizontal and vertical direction across the back of the shell above and to the left of the harness adjustment slots. This would have been the approximate location of the infant's head.

The cover flap contact and subsequent expansion of the bag membrane accelerated the restraint in an upward and rearward direction. The carrying handle impacted the upper right quadrant of the windshield. A large white plastic transfer was noted to the glazing 34.3-48.3 cm (13.5-19.0") right of center and 38.1-50.8 cm (15.0-20.0") above the upper instrument panel. Several abrasions were noted to the posterior aspect of the carrying handle. Two additional rust transfers were noted to the handle that resulted from bag contact. The rust was transferred onto the bag from expansion against the sheet metal liner of the cover flap. The left side pivot of the carrying handle was fractured by the deployment sequence which resulted in partial separation of the handle. There was no evidence or pre-existing damage to the restraint.

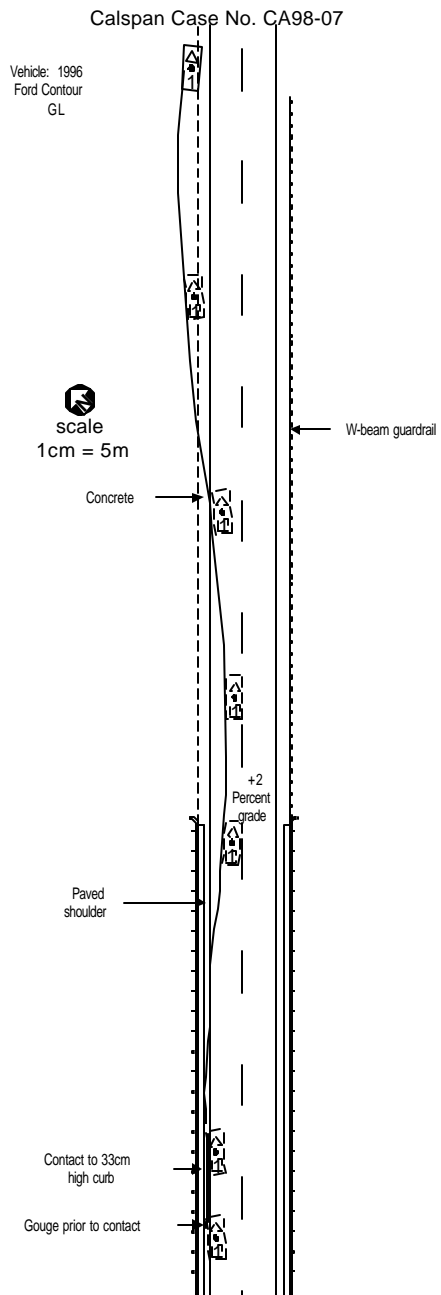
Figure 10. Crash Schematic

The Contour subsequently traveled 33.5 m (109.9') following the initial point of impact on the inboard travel lane prior to exiting the east edge of the bridge structure (Georgia/South Carolina state line). The vehicle traveled an additional 33.4 m (109.7') in a tracking mode on the inboard travel lane prior to departing the inboard yellow edge line. The vehicle traversed the inboard shoulder and entered the depressed grass median. The Contour came to a controlled stop on the median approximately 115.8 m (379.9') east of the initial impact point with the barrier curb. The rotating left front tire print of the grass shoulder arced back toward the travel lanes which indicated that the driver steered in a clockwise direction prior to coming to rest. At rest, the vehicle was approximately parallel to the shoulder, facing in easterly direction. The crash schematic is attached to this summary report as **Figure 10**.
