# INDIANA UNIVERSITY

### ON-SITE REDESIGNED AIR BAG INVESTIGATION

CASE NUMBER - IN98-009  
LOCATION - MISSOURI  
VEHICLE - 1998 SATURN SL2  
CRASH DATE - January, 1998

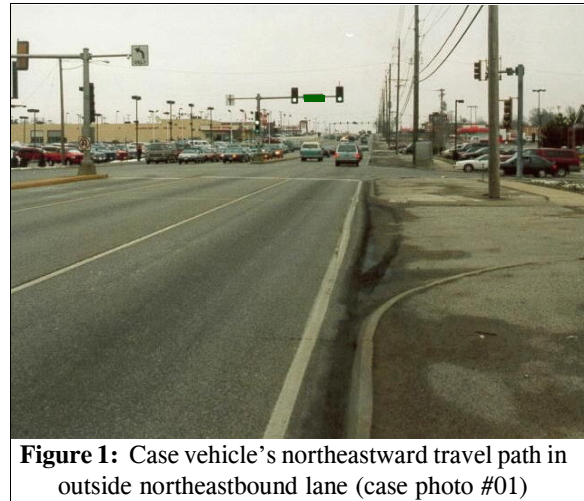
The case vehicle was traveling essentially northeastward in the outside, northeastbound through lane of a five-lane, divided, U.S. trafficway (**Figure 1**) and was approaching a four-leg intersection (i.e., both the northeast and southwestbound roadways had two through lanes, while the northeast roadway had one left-hand turn lane). According to Police Crash Report, the driver intended to turn right at the intersection and travel southeastward. According to the driver's husband (i.e., interviewee, who was not involved in the crash), she intended to continue through the intersection in her northeast path of travel. Based upon the case vehicle's crush profile (i.e., primarily front left damage), the closing trajectories of the two vehicles more closely resembled a perpendicular impact configuration than they did an acute angle configuration. If the case vehicle had been turning right, then this contractor would have expected a much greater amount of left front damage than was present. The Ford was traveling essentially southeastward in the inside southeastbound through lane of a four-lane, undivided, intersecting city roadway (**Figure 2**) and intended to continue its southeastbound travel path (i.e., there was one through lane in both the southeast and northwestbound directions; however, in the southeastbound direction, there was one left-hand turn lane and one through/"right-hand turn" lane). The case vehicle's driver made no avoidance maneuvers prior to the crash. The crash occurred in the four-leg intersection of the two trafficways.

**Figure 1:** Case vehicle's northeastward travel path in outside northeastbound lane (case photo #01)

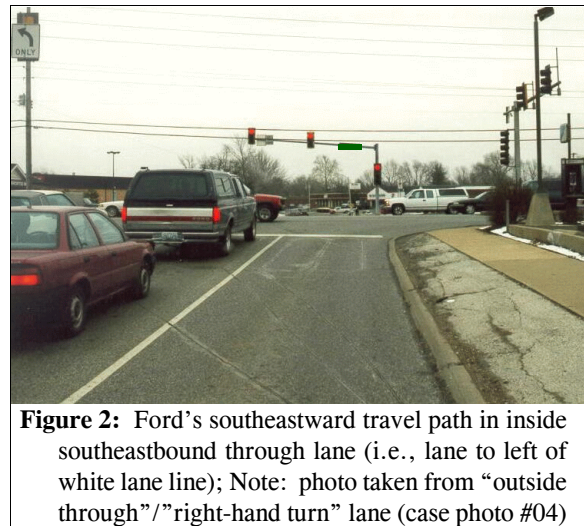
**Figure 2:** Ford's southeastward travel path in inside southeastbound through lane (i.e., lane to left of white lane line); Note: photo taken from "outside through"/"right-hand turn" lane (case photo #04)

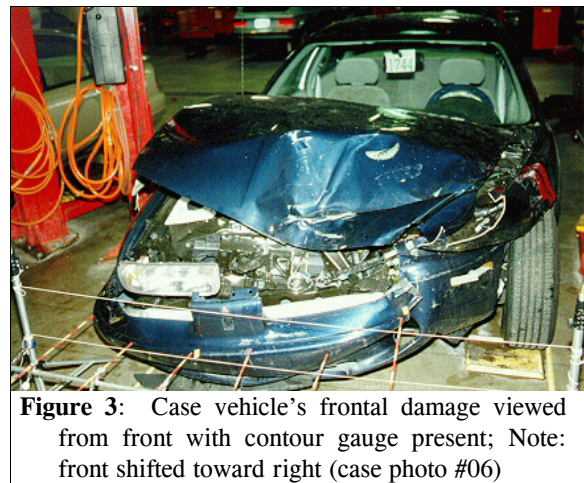
The front (**Figure 3** below) of the case vehicle impacted the right front of the Ford (**Figure 4** below), causing the case vehicle's driver and front right supplemental restraints (air bags) to deploy. The case vehicle rotated rapidly clockwise and the Ford rotated counterclockwise resulting in a side slap impact between the case vehicle's left quarter panel (**Figure 5** below) and the Ford's right quarter panel (**Figure 4** below). According to the Police Crash Report, the case vehicle was redirected southeastward while continuing to rotate clockwise. The case vehicle reportedly came to rest heading southward in a vacant lot located off the south quadrant of the intersection. In all, the case vehicle rotated approximately 160 degrees clockwise from its original path of travel. The Ford was redirected

**Figure 3:** Case vehicle's frontal damage viewed from front with contour gauge present; Note: front shifted toward right (case photo #06)

The case vehicle's initial contact with the Ford involved the front left two-thirds (**Figure 3** above and **Figure 6**). Direct damage began 13 centimeters (5.1 inches) to the right of center and extended, a measured distance of 72 centimeters (28.3 inches), along the front bumper to the front left bumper corner. Maximum crush for the frontal impact was measured as 20 centimeters (7.9 inches) at  $C_1$ . The wheelbase on the case vehicle's left and right sides was shortened only about 1 centimeter (0.4 inches). For the side slap impact, direct damage began 35 centimeters (13.8 inches) in front of the left rear axle and extended, a measured distance of 120 centimeters (47.2 inches), along the left side to the left rear bumper corner (**Figure 5** and **Figure 7** below). Maximum crush for the side slap impact was measured as 12 centimeters (4.7 inches) at  $C_3$ . During the initial impact, the case vehicle's front bumper, bumper fascia, grille, hood, radiator, left headlight and turn signal assemblies, and left fender were directly damaged and crushed rearward. None of the case vehicle's tires were physically

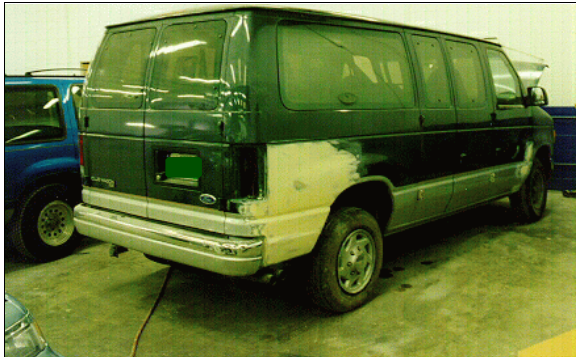
**Figure 4:** Ford's damaged right side showing primary impact to the right fender (replaced) and side slap impact to the right quarter panel (case photo #33)

Based on the vehicle inspection, the CDCs for the Ford are estimated as: **01-RYEW-1 (40)** and **03-RBEW-1 (90)**. The Ford's exact damage is not determinable because the vehicle was virtually repaired (**Figure 4** above and **Figure 13**). The WinSMASH reconstruction program, missing vehicle algorithm, was used on the Ford's highest severity (i.e., right side) impact. The Total, Longitudinal, and Lateral Delta Vs are, respectively: 13.4 km.p.h. (8.3 m.p.h.), -11.0 km.p.h. (-6.8 m.p.h.), and -7.7 km.p.h. (-4.8 m.p.h.). Likewise, the WinSMASH reconstruction program, missing vehicle algorithm, was used on the Ford's second highest severity (i.e., side slap) impact. The Total, Longitudinal, and Lateral Delta Vs are, respectively: 4.2 km.p.h. (2.6 m.p.h.), 0.0 km.p.h. (0.0 m.p.h.), and -4.2 km.p.h. (-2.6 m.p.h.). The Ford was towed due to damage.

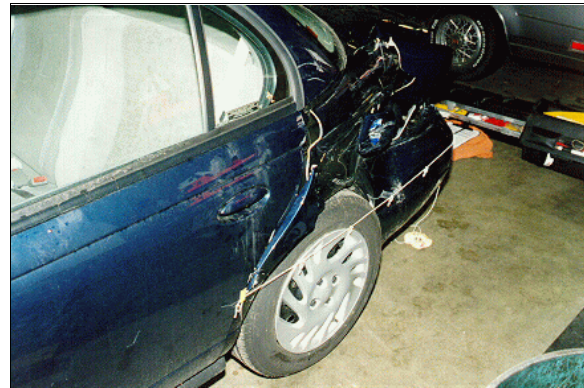
**Figure 5:** Case vehicle's side slap damage viewed from front of left (case photo #10)

restricted or deflated. The right headlight and turn signal assemblies sustained induced damage as well as both the right and left fenders. During the side slap impact, the case vehicle's left rear door, left quarter panel, left brake light and turn signal assemblies, and left bumper corner were directly damaged and crushed inward.

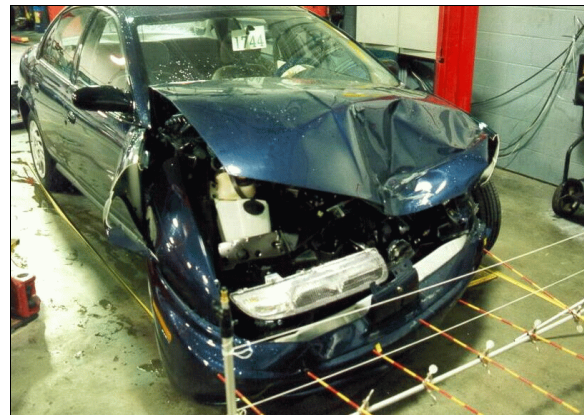
**Figure 6:** Case vehicle's frontal damage viewed from right of front with contour gauge present; Note: rightward shift of front (case photo #20)

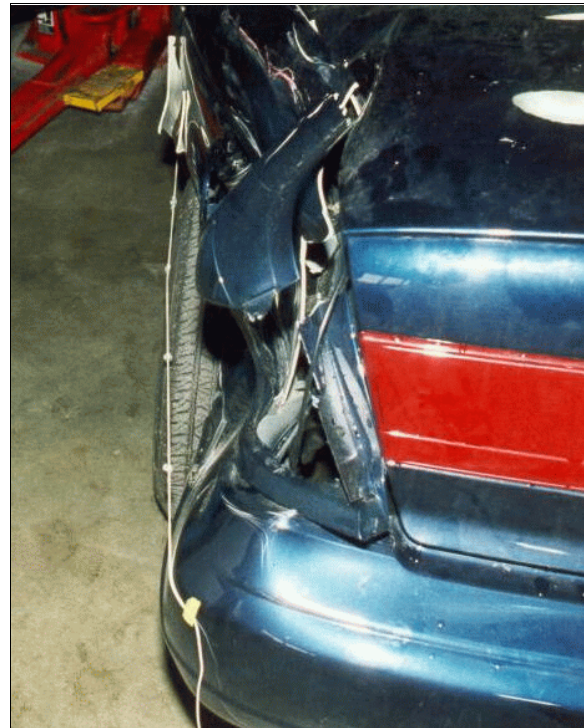
Figure 7: Case vehicle's side slap damage viewed from back along reference line (case photo #14)

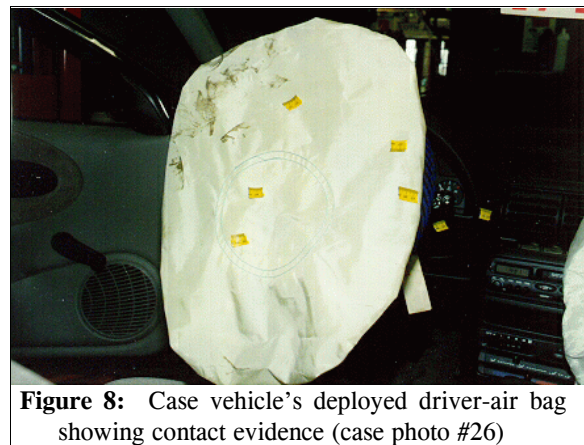
Figure 8: Case vehicle's deployed driver-air bag showing contact evidence (case photo #26)

air bag was elliptical with a height of approximately 54 centimeters (21.3 inches) and a width of approximately 41 centimeters (16.1 inches). An inspection of the driver's air bag revealed four areas of scattered scuffs on the air bag's front surface (**Figure 8** above). There was an obliquely oriented scuff mark located within the inner circular stitching, the center of which was located 3 centimeters (1.2 inches) below the longitudinal centerline of the air bag and 5 centimeters (2.0 inches) left of the vertical centerline. Furthermore, there was a spot within the inner circular stitching that was located toward the 12 o'clock position. In addition, there was a transversely oriented scuff mark located 15 centimeters (5.9 inches) above the longitudinal centerline of the air bag and 5 centimeters (2.0 inches) right of the vertical centerline. Finally, there was a 5 centimeter (2.0 inch) obliquely oriented scuff located 2 centimeters (0.8 inches) inward of the right circular edge near the 3 o'clock position.

The driver was transported by ambulance to the hospital. She sustained serious injuries and was treated and released. According to the interview with her husband, the injuries sustained by the case vehicle's driver included: 4 to 5 fractured left ribs, blunt head trauma, and sprains to her left shoulder and left hip. The driver's husband reported that the driver believes she was unconscious for a short period of time, perhaps 15-to-30 seconds. This occupant's primary chest injuries (i.e., AIS = 3) were caused by her contact with the left side interior surface of the driver's door and occurred during the side slap impact. Only the driver's reported blunt head trauma was most likely caused by her interaction with case vehicle's driver air bag.

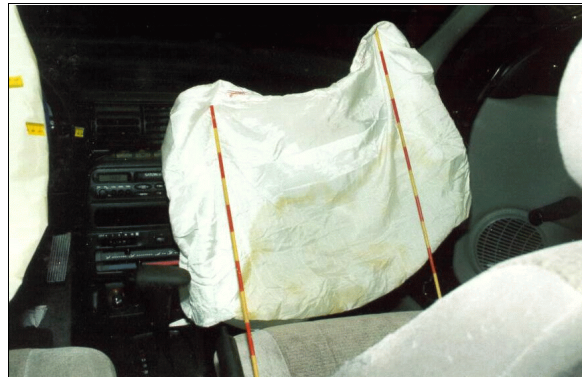
The front right passenger's air bag was located in the middle of the instrument panel. There was a single, essentially rectangular, modular, cover flap. The cover flap was made of a thick vinyl over a thick cardboard type frame. The flap's dimensions were 31 centimeters (12.2 inches) at the lower horizontal seam and 12 centimeters (4.7 inches) along both vertical seams. The profile of the case vehicle's instrument panel resulted in a 4 centimeter (1.6 inch) setback of the leading edge of the cover flap relative to the protruding right instrument panel. An inspection of the front right air bag module's cover flap and air bag revealed that the cover flap opened at the designated tear points, and there was no evidence of damage during the deployment to the air bag or the cover flap. The front right passenger's air bag was designed with one tether, measuring 36 centimeters (14.1 inches) in width. The front right air bag had no vent ports. The deployed front right air bag was rectangular with a height of approximately 38 centimeters (15.0 inches) and a width of approximately 70 centimeters (27.6 inches). An inspection of the front surface revealed that there was no contact evidence readily apparent on the front right air bag (**Figure 9**).

**Figure 9:** Case vehicle's deployed front right passenger air bag showing no obvious contact evidence (case photo #27)

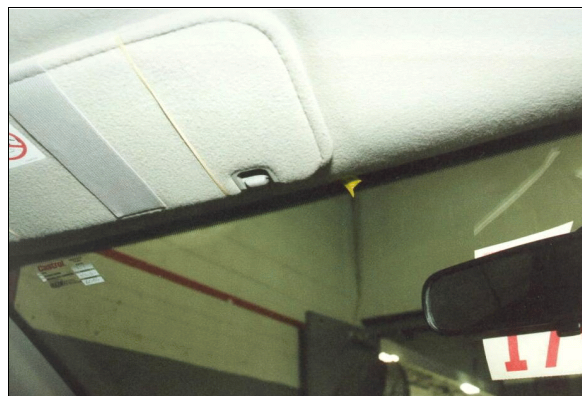
Inspection of the case vehicle's interior revealed a possible skin deposit on the windshield's header, just to the right of the sun visor (**Figure 10**). Furthermore, there were two scrape marks on the center instrument panel, just to the right of the right edge of the steering wheel's rim. In addition, the shear capsule was displaced 4 centimeters (1.6 inches—**Figure 11** below).

**Figure 10:** Possible contact evidence (i.e., yellow tape) on windshield header next to driver's sun visor (case photo #22)

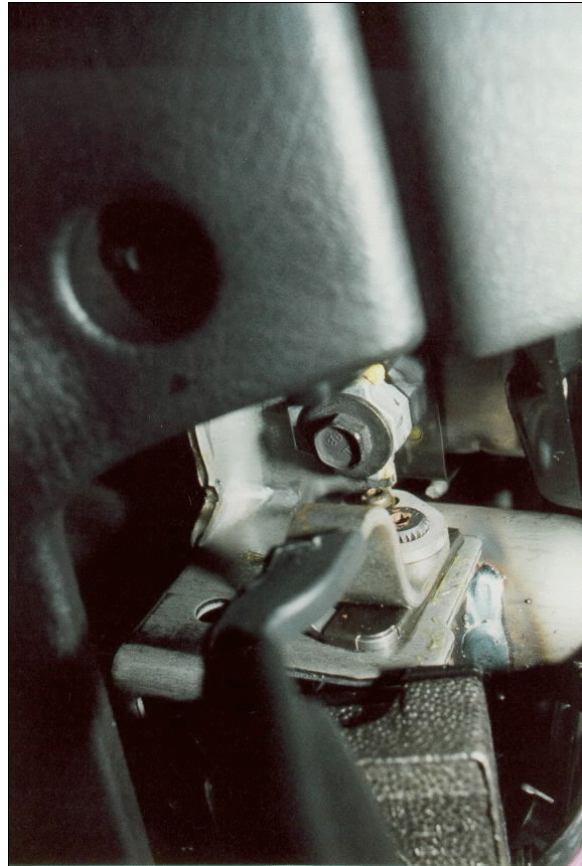
**Figure 11:** Case vehicle's shear capsule separation (case photo #24)

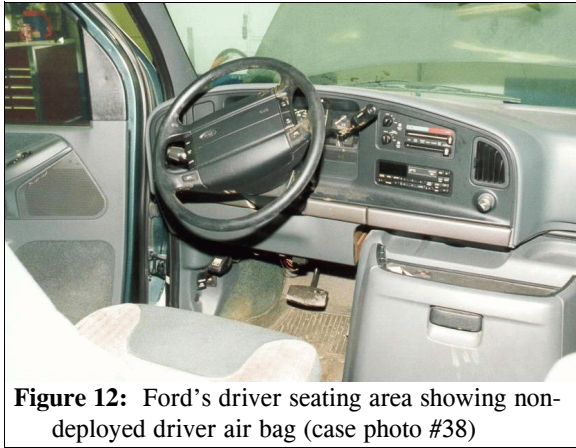
The 1996 Ford E350 Club Wagon was a rear wheel drive, 4x2, twelve-passenger, four-door, full-sized van (VIN: 1FBHE31H4TH-----) equipped with a 5.8L, V-8 engine and a three-speed automatic transmission. Braking was achieved by a power-assisted, front disc and rear drum, four-wheel, anti-lock system. The Ford was equipped with a driver (only) supplemental restraint (air bag) that did not deploy during either the primary impact on the right front or side slap impact

to the right back (**Figure 12**). The case vehicle's wheelbase was 351 centimeters (138.0 inches), and the odometer reading at inspection was 44,022 kilometers (27,354 miles).

**Figure 12:** Ford's driver seating area showing non-deployed driver air bag (case photo #38)

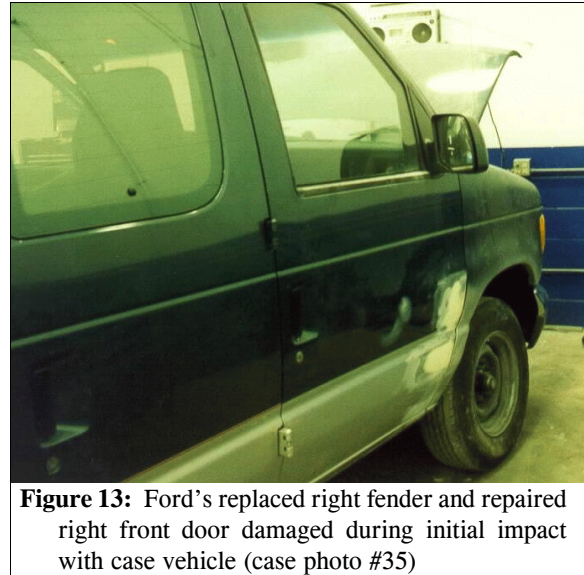
**Figure 13:** Ford's replaced right fender and repaired right front door damaged during initial impact with case vehicle (case photo #35)
