On-scene Investigation / Vehicle to Vehicle  
Dynamic Science, Inc. / Case Number: DS98011  
1998 BMW 740i  
Texas  
March 1998

1. Report No. DS98011		2. Government Accession No.		3. Recipient Catalog No.	
4. Title and Subtitle In-Depth Accident Investigation				5. Report Date May 1998

**Dynamic Science, Inc.**  
**Accident Investigation**  
**Case Number: DS98011**

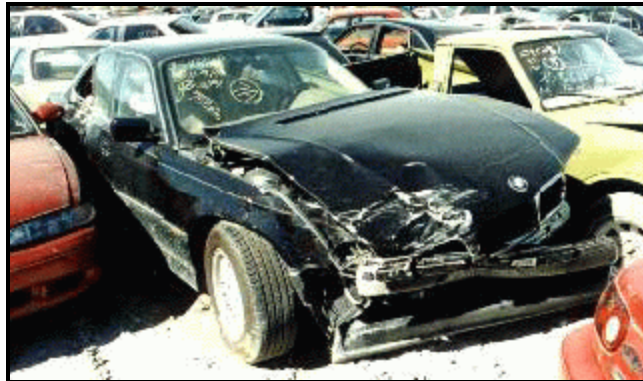
Figure 1. Exterior, case vehicle

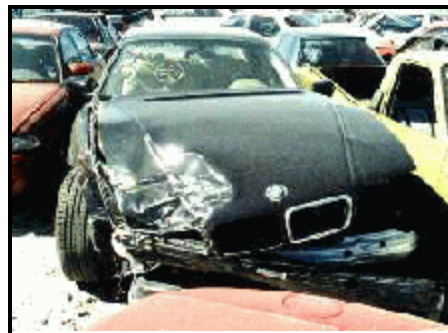
Description:	1998 BMW 740i four-door	
VIN:	WBAGF8329WDxxxxx	
Odometer:	733 miles	
Engine:	8 cyl	
Reported Defects:	None	
Cargo:	None	
Damage Description:	Moderate rearward and lateral crush to the right front corner. Hood buckled. Secondary impact to the right rear door area. Vehicle totaled by insurance company.	
CDC:	Impact #1: 02FZEW1 Impact #2: 03RPEW2	
Estimated speed	19 km/h (12 MPH)	
Delta V:	Total	11.4 km/h (7.5 mph)
	Longitudinal	-3.9 km/h (-2.6 mph) <sup>2</sup>
	Latitudinal	-10.8 km/h (-7.1 mph)
	Energy	17,684 joules (13,050 ft-lbs)

**Figure 4.** Exterior, case vehicle

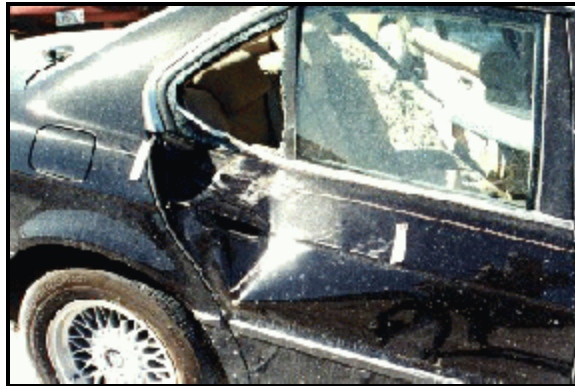
**Figure 6.** Exterior, case vehicle

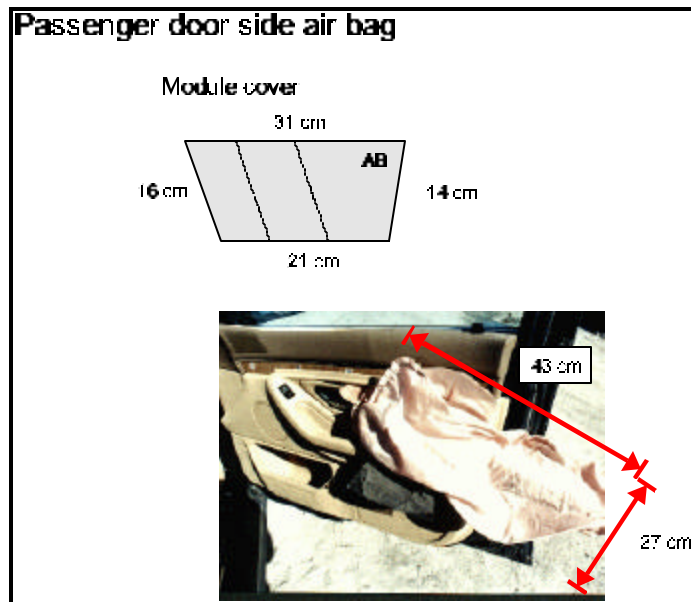
**Figure 8.** Passenger door side air bag

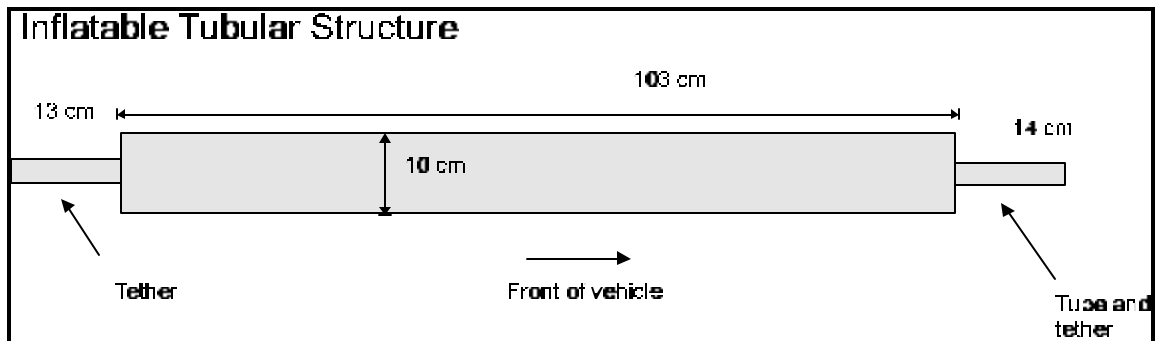
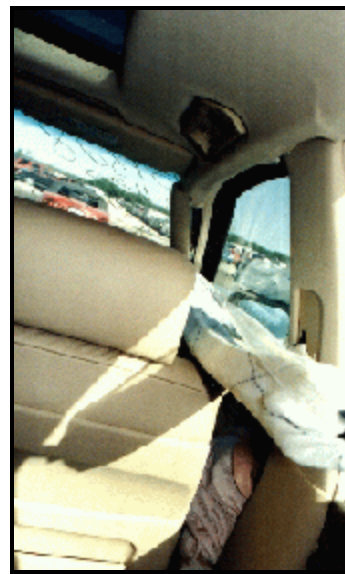
windshield pillar to the roof. According to BMW literature on the ITS, the tube is designed to stay inflated for approximately 6 seconds after deploying.

Figure 9. Inflatable tubular structure

Figure 10. Inflatable tubular structure
