CALSPAN ON-SITE DEPOWERED AIR BAG DEPLOYMENT INVESTIGATION

CALSPAN CASE NO. CA98-014

VEHICLE - 1998 LINCOLN NAVIGATOR

CRASH DATE - MARCH, 1998

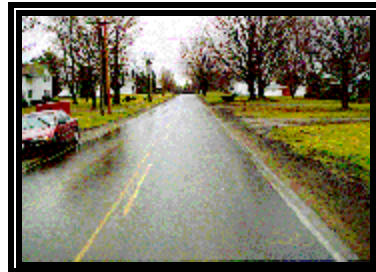
The crash occurred in the daylight hours of March 1998 on a straight and level segment of a two lane north/south roadway. The asphalt road surface was dry at the time of the crash. The weather was not a factor. At the crash scene, there was a residence with a U-shaped private driveway on the west side of the road. The speed limit in the area of the crash scene was 64 km/h (40 mph). Figure 1 is a southbound view of the scene.

Figure 1: Southbound approach view of the crash scene.

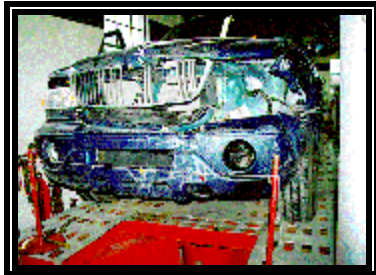
The front of the Lincoln impacted the rear of the Mazda in a 12/06 o'clock impact configuration. The Lincoln sustained 79.0 cm (31.0 in) of direct contact damage to the left and center portions of the front bumper (Figures 2 and 3). The direct damage began 3.8 cm (1.5 in) left of center and continued left to

the left front bumper corner. The measured crush profile of the bumper reinforcement bar was as follows: C1=21.8 cm (8.6 in), C2=19.0 cm (7.5 in), C3=15.2 cm (6.0 in), C4=8.9 cm (3.5 in), C5=0, C6=0. Maximum crush occurred at C1. There was no measurable reduction in the left side wheelbase measurement. The left front fender deformed slightly rearward binding the front door at the hinge pillar. The Collision Deformation Classification (CDC) of the Lincoln was 12-FYEW-1. Speed reconstruction indicated the Lincoln was traveling approximately 30 mph at the time of the crash. The delta V of the Lincoln was calculated to be approximately 13 km/h (8 mph) by the damage only routine of the SMASH program. The delta V determined by SMASH appears to be underestimated based on SCI experience and forensic analysis of the damage pattern. A momentum calculation determined the delta V of the Lincoln was approximately 19 km/h (12 mph). The 19 km/h (12 mph) delta V is more consistent with the vehicular damage. As a result of the crash, the Navigator's depowered frontal air bag system deployed. Repair estimates for the Lincoln exceeded \$8,000.

Figure 2: Close-up view of the Lincoln's damage frontal plane.

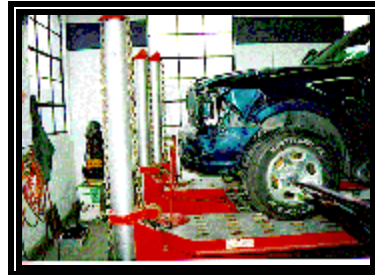
Figure 3: Left lateral view across the Lincoln's front plane.

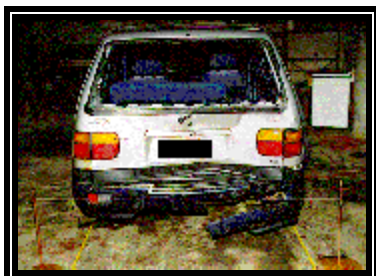
Inspection of the 1991 Mazda MPV revealed the vehicle had sustained 92.0 cm (36.3 in) of direct contact damage to the rear bumper (Figure 4). The damage began 12.7 cm (5.0 in) left of center and continued rightward to the right rear bumper corner. The measured crush profile of the bumper reinforcement bar was as follows: C1=0, C2=0, C3=10.8 cm (4.3 in), C4=16.5 cm (6.5 in), C5=16.5 cm (6.5 in), C6=16.5 cm (6.5 in). There was no measurable change in the right side wheelbase measurement. The right rear unitized structure deformed forward and was in contact with the right rear tire (Figure 5). The backlight disintegrated from the impact force. The CDC of the Mazda was 06-BZAW-2

Figure 4: Rear view of the Mazda MPV

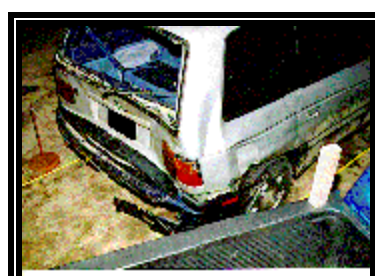
Figure 5: Right rear view of the Mazda.

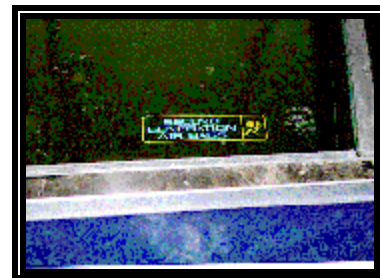
The Lincoln was equipped with a Supplemental Restraint System (SRS) that consisted of "Second Generation" depowered air bags for the driver and right front passenger (Figure 6). The driver air bag module was located in the typical manner in the center hub of the tilt steering wheel (Figure 7). The steering wheel was positioned in the center of its adjustment range. There was no steering wheel rim deformation or movement of the steering column's shear capsules. The H-configuration air bag module opened as designed at the designated tear points during the deployment sequence. The width of the horizontal seam measured 19.3 cm (7.6 in). The height of the upper and lower flaps measured 19.8 cm (7.8 in) and 8.9 cm (3.5 in) respectively. A 5 cm x 5 cm (2 in x 2 in) scuff mark was located on the lower left corner of the upper cover flap. This scuff was attributed to contact with the steering wheel rim.

Figure 6: Second Generation Air bag sticker on the left window glazing.

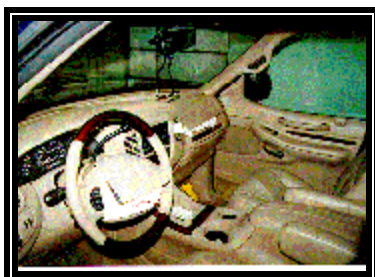
Figure 7: Front interior view.

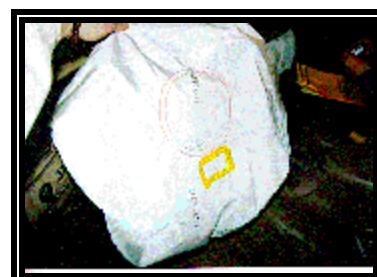
The driver air bag was tethered by two 13 cm (5 in) wide straps. In its deflated state, the air bag measured 62.2 cm (24.5 in) in diameter. The face of the bag was stamped with the following identification number: 113712R. There was a light tan transfer mark 3.8 cm (1.5 in) in length located in the 6 o'clock sector, 11.4 cm (4.5 in) below the center of the bag. This contact was a possible fabric transfer from the driver's clothing. The air bag was vented by two 3.3 cm (1.3 in) diameter ports on the back side of the bag. The ports were located in the 11 and 1 o'clock sectors. The back side of the bag exhibited black scuff marks in the 10, 2 and 6 o'clock sectors attributed to interaction with the interior surfaces of the module cover flaps in the deployment sequence.

Figure 8: Driver air bag.
