CALSPAN LIMITED ON-SITE REDESIGNED AIR BAG INVESTIGATION
VERIDIAN CASE NO. CA98-16
VEHICLE: 1998 DODGE DAKOTA SPORT PICKUP TRUCK
LOCATION: MICHIGAN
CRASH DATE: JANUARY 1998

1. <i>Report No.</i> CA98-16	2. <i>Government Accession No.</i>	3. <i>Recipient's Catalog No.</i>	
4. <i>Title and Subtitle</i> Calspan Limited On-Site Redesigned Air Bag Investigation Vehicle: 1998 Dodge Dakota Sport Pickup Truck Location: Michigan		5. <i>Report Date:</i> May 2000

14. <i>Sponsoring Agency Code</i>	
15. <i>Supplementary Notes</i> Limited on-site investigation of a severe crash that resulted in deployment of the redesigned frontal air bags in a 1998 Dodge Dakota Sport pickup truck.

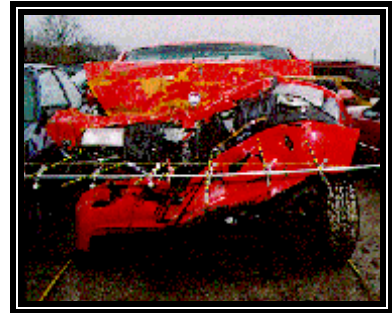
Figure 1. Overall view of the Dodge Dakota's damaged frontal plane.

The 1998 Dodge Dakota pick-up truck sustained severe frontal damage as a result of its impact with the back plane of the semi-trailer. The direct contact damage began at the front left bumper corner and extended 141.0 cm (55.5 in) to the right, across the full width of the bumper fascia. The damage extended vertically onto the grille and hood areas of the Dakota. Circular contact damage from the left rear tail lamps of the semi-trailer was evidenced at the front right hood area of the Dakota (**Figure 3**). Maximum crush was located approximately 66.2 cm (26.0 in) inboard of the front left bumper corner and measured 67.1 cm (26.4 in) in depth. A crush profile was documented at bumper level and is reported in **Table 1** and identified in **Figures 3 and 4**. The damage resulted in a 12 o'clock direction of force with an incremental upward displacement of 20 assigned due to the vertical displacement of the left side frame rail. The resultant Collision Deformation Classification (CDC) was 32-FDEW-4 with the incremented value. The wheelbases were reduced on the left and right sides by 7.0 cm (2.8 in) and 6.0 cm (2.4 in), respectively.

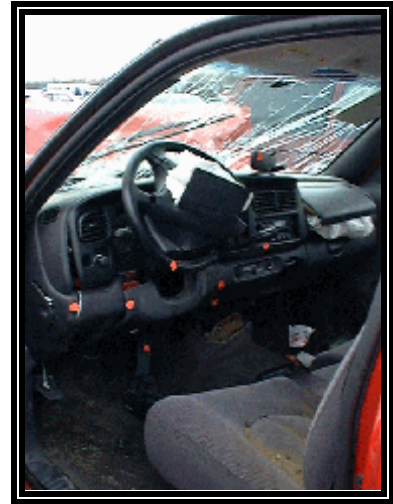
Figure 2. Overall view of the Dakota's Interior.

The interior of the Dakota was configured as a three passenger vehicle with a split-bench front seat (**Figure 2**) with separate back supports and integral head restraints for the outboard positions. The windows and seat were manually controlled and the steering column was fixed.

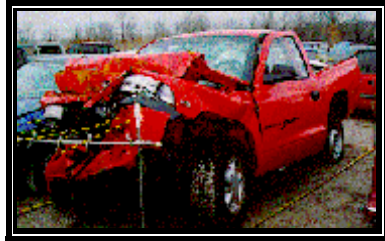
Figure 3. Left three-quarter view of the Dakota.

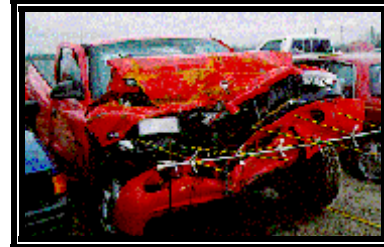
Figure 4. Right three-quarter view of the Dakota.

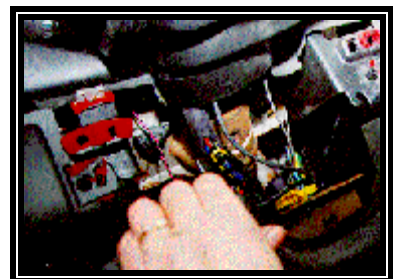
The upper steering wheel rim (rotated 180 degrees at crash) sustained 8.5 cm (3.3 in) of forward deformation. The back aspect of the steering wheel hub and the lower portion of the steering wheel rim were in contact with the left upper instrument panel which resulted from occupant loading. The left and right shear capsules were displaced by approximately 5.1 cm (2.0 in) and 4.0 cm (1.6 in) respectively (**Figure 5**). The energy absorbing steering column was compressed approximately 3.5 cm (1.4 in).

Figure 5. Left and right shear capsules.

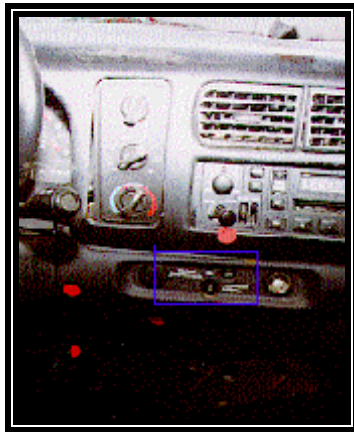
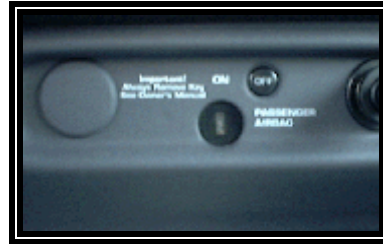
The front right air bag shut-off switch was located in the lower aspect of the center instrument panel (**Figures 6 and 7**). The switch was in the on-position at the time of the crash which resulted in deployment of the front right air bag.

Figure 6. Center instrument panel and highlighted shut-off switch for the Dodge Dakota.

Figure 7. Close-up view of an exemplar shut-off switch for the right front air bag of a 1998 Dodge Dakota.

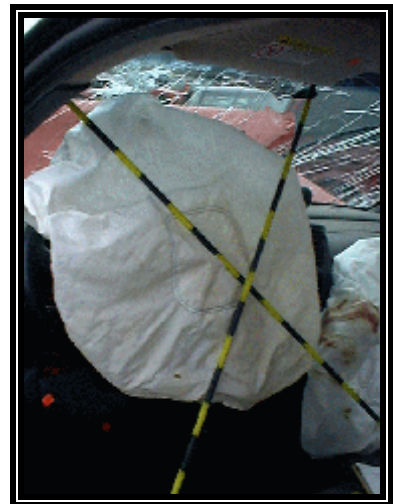
The front left air bag was housed in the 4-spoke steering wheel hub and was concealed by asymmetrical H-configuration cover flaps. The upper cover flap had a total width of 15 cm (6 in) at the horizontal tear seam and a height of 10 cm (4 in). The lower cover flap shared the same width and was approximately 2.5 cm (1.0 in) in height. A faint abrasion pattern was evident on the lower aspect of the upper cover flap. The front left air bag measured 66 cm (26 in) in diameter in its deflated state and was tethered by two internal straps (**Figure 8**). The nylon air bag was not equipped with vent ports. A blood stain was located on the upper left quadrant of the air bag on and adjacent to the peripheral seam. The blood extended onto the face and back side of the air bag and measured 7.0 cm (2.8 in) in width and 3.0 cm (1.2 in) in height. There was no direct contact evidence to the air bag membrane from expansion within the air bag module cover flaps during deployment, or from driver loading.

Figure 8. Deployed front left redesigned air bag.

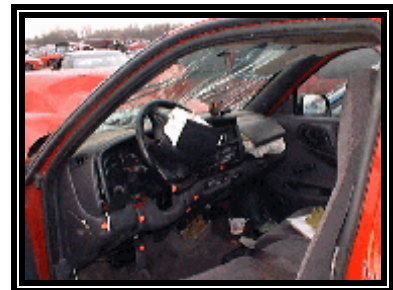
The unrestrained driver initiated a forward trajectory in response to the frontal impact force (**Figure 9**). He initially loaded the deployed front left air bag with his chest which protected his chest from injury. There was no contact evidence on the air bag, however, a blood stain was noted on the upper left quadrant. Due to the severity of the crash and the vertical displacement of the frontal structure, the driver partially submarined the steering assembly. His abdominal area compressed the lower aspect of the air bag and loaded through the redesigned air bag, engaging against the lower steering wheel rim. This contact resulted in a Grade II spleen laceration. The loading force deformed the wheel rim forward 8.5 cm (3.3 in) and compressed the shear capsules 5 cm (2 in) and 4.0 cm (1.6 in) for the left and right sides, respectively.

Figure 9. Driver trajectory and contact points within the vehicle.
