TRANSPORTATION RESEARCH CENTER

REMOTE REDESIGNED AIR BAG REPORT

CASE NUMBER - IN98-017
LOCATION - MICHIGAN
VEHICLE - 1998 PLYMOUTH BREEZE
CRASH DATE - January, 1998

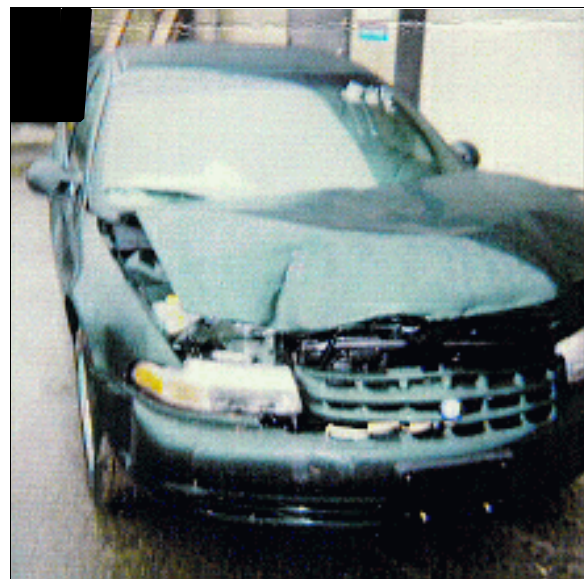
Figure 1: Rental company photo of damage to case vehicle's front; Note: damage appears to involve primarily front right half

The case vehicle's contact (**Figure 1** above) with the Chevrolet involved its front right half (most likely). Based on the photograph, direct damage began near the front right bumper corner and extended an unknown distance along the front bumper. Maximum crush was estimated to be 8 centimeters (3.1 inches). Based on the available photograph, the case vehicle's front bumper fascia, grille, and hood were directly damaged and crushed rearward. It is unknown if any of the case vehicle's tires were damaged or deflated. According to the case vehicle's driver, neither of the front tires were physically restricted. Both the right and left headlight and turn signal assemblies sustained induced damage as well both the left and right fenders.

Based on the one available photograph, the CDC for the case vehicle is estimated as: **01-FZEW-1 (20)**. The WinSMASH reconstruction program, CDC damage only algorithm, was used on the case vehicle's highest severity impact. The Total, Longitudinal, and Lateral Delta Vs are, respectively: 15.4 km.p.h. (9.6 m.p.h.), -14.5 km.p.h. (-9.0 m.p.h.), and -5.3 km.p.h. (-3.3 m.p.h.). The case vehicle was towed due to damage.
