Remote Investigation / Vehicle to Vehicle
Dynamic Science, Inc. / Case Number: DS9817
1998 Oldsmobile Achieva
1998 Chevrolet Cavalier
Florida
January 1998

1. Report No. DS9817		2. Government Accession No.		3. Recipient Catalog No.	
4. Title and Subtitle In-Depth Accident Investigation				5. Report Date 9/14/2000

**Dynamic Science, Inc.
Accident Investigation
Case Number: DS9817**

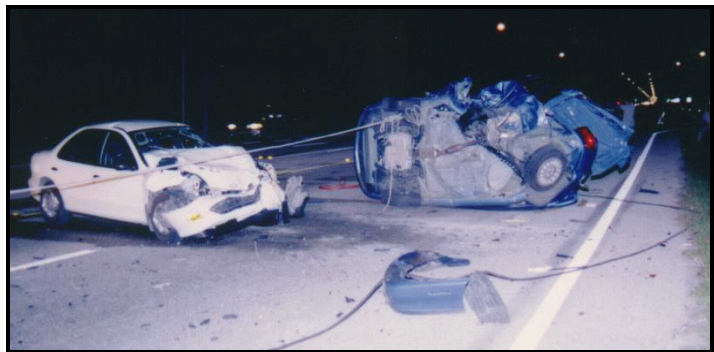
Figure 1. Final rest (east).

Vehicle 1 pushed Vehicle 2 backwards into a clockwise rotation until Vehicle 2 was facing south. Vehicle 1 rotated, tripped, and overturned. It came to rest on its right side facing generally north.

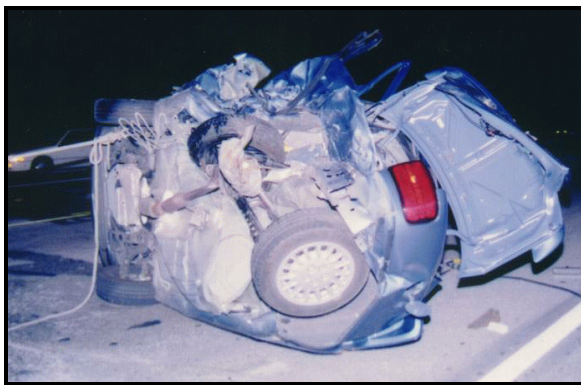
Figure 3. Vehicle 1, 1998 Oldsmobile Achieva.

Description:	1998 Oldsmobile Achieva ²	
VIN:	1G3NL52M7WMXXXXXX	
Odometer:	Unknown	
Engine:	3.1L V6	
Reported Defects:	None indicated	
Cargo:	Unknown	
Damage Description:	Heavy damage to the left rear and left passenger area. Rollover damage to right side.	
CDC:	#1 07LZEW4 #2 Unknown	
Delta V:	Total	40.4 km/h (25.1 mph)
	Longitudinal	35.0 km/h (21.8 mph)
	Latitudinal	20.2 km/h (12.6 mph)
	Energy	99,876 joules (73,732 ft-lbs)

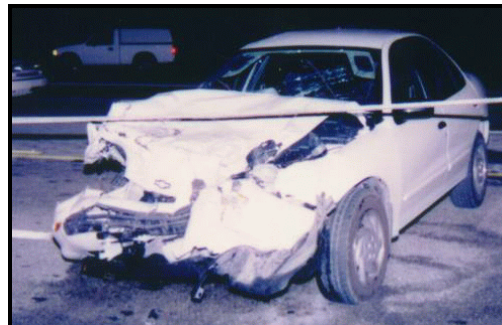
Figure 5. Vehicle 2, 1998 Chevrolet Cavalier.

Description:	1998 Chevrolet Cavalier, four-door sedan	
VIN:	1G1JF52T8W7XXXXXX	
Odometer:	Unknown	
Engine:	2.4 L L4	
Reported Defects:	None noted	
Cargo:	Unknown	
Damage Description:	Moderate to heavy crush to the front bumper, grille, and hood.	
CDC:	11FDEW2	
Delta V:	Total	42.4 km/h (26.3 mph)
	Longitudinal	-36.7 km/h (-22.8 mph)
	Latitudinal	21.2 km/h (13.2 mph)
	Energy	122,088 joules (90,100 ft-lbs)

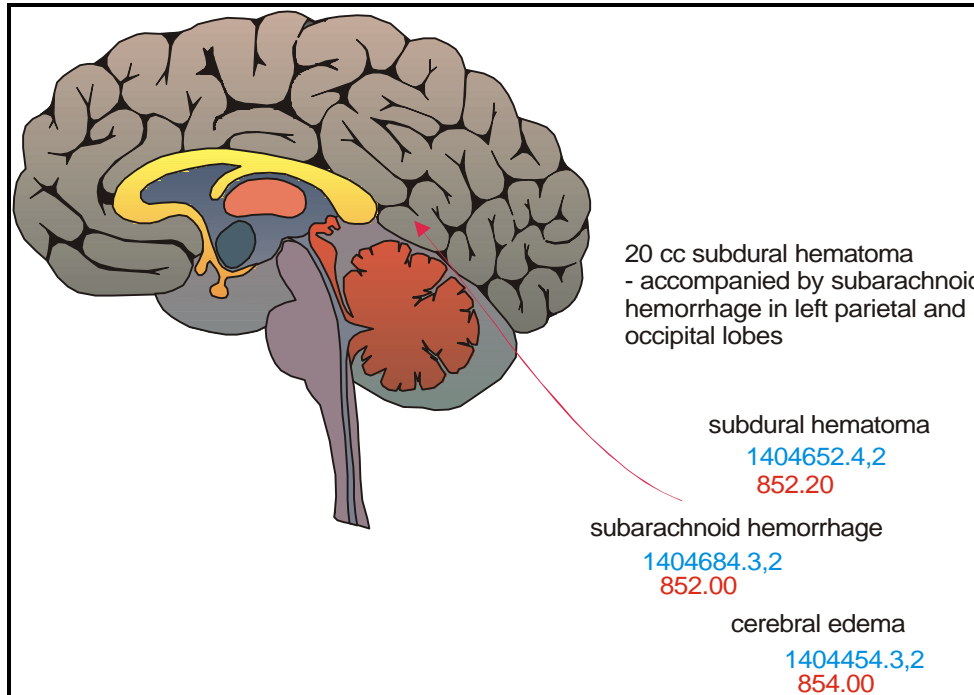
Figure 7. Brain injuries

<u>INJURY</u>	<u>OIC CODE</u>	<u>ICD-9</u>	<u>SOURCE</u>
Driver	Subdural hematoma	140652.4,2	852.20	Head restraint
	Subarachnoid hemorrhage	140684.3,2	852.00	Head restraint
	Cerebral edema	140454.3,2	854.00	Head restraint
	Bilateral hemothoraces with posterior fractures of T9 bilaterally and T10 and 11 on the left	450222.3,3	807.04 ³ 860.2 ⁴	Seat back
	Contusion with fracture, posterior C4 vertebral body	650230.2,6	805.04	Head restraint
	Fracture, left and right sacrioliliac joints	852800.3,6	805.6	Unknown
	Fracture, neck of femur	851812.3,1	820.0	Center IP
	Dislocated fractures, anterior symphysis pubis	853000.3,5	808.2	Door panel
	Diaphragm contusion	440602.2,8	862.0	Unknown
	Mesentery contusions	542010.2,8	Unk.	Unknown
	Bladder laceration	540620.2,8	867.0	Unknown
	Subgaleal hematoma	190402.1,2	920.0	Unknown
	Abrasion, 10 x 3 in., posterior left hip	890202.1,2	916.0	Seat bottom
	Abrasion, 7 x 1/4 in., right lateral hip	890202.1,1	916.0	Center console

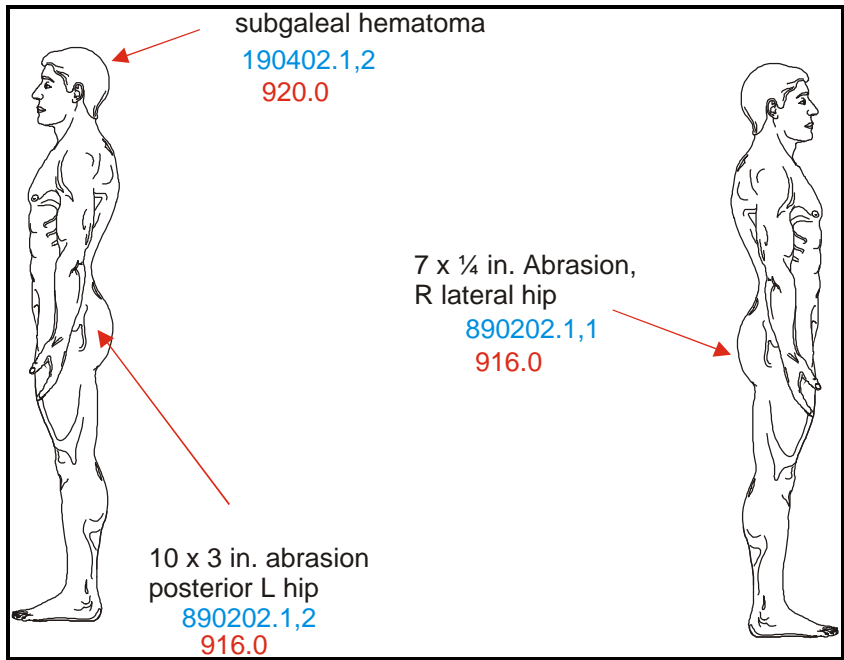
Figure 9. External injuries

<u>INJURY</u>	<u>OIC CODE</u>	<u>ICD-9</u>	<u>SOURCE</u>
Linear abrasion, 14 in. long, right calf	890202.1,1	916.0	Unknown
Abrasion left hip	890202.1,2	916.0	Webbing
Abrasion right hip	890202.1,1	916.0	Webbing
Abrasion, 11 x 2-3 in., right anterior thigh	890202.1,1	916.0	Steering wheel rim
Abrasion, 8 in., left anterior thigh	890202.1,2	916.0	Webbing
Abrasion, 6 x 2, right knee	890202.1,1	916.0	Left IP
Abrasion, 2 in., right ankle	890202.1,1	916.0	Unknown
Abrasion, left shin	890202.1,2	916.0	Unknown

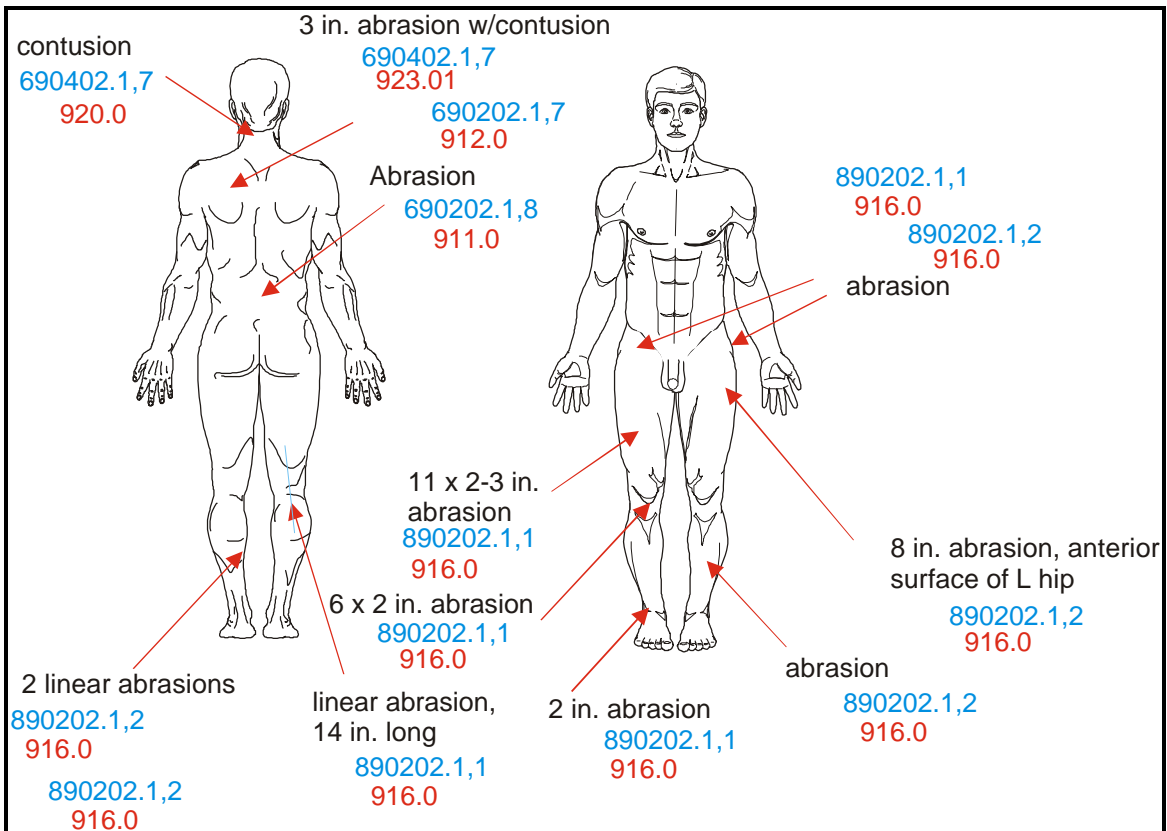
Figure 8. External injuries

Contusion, base of scalp	690402.1,7	920.0	Head rest
	Abrasion w/contusion, 3 in., left scapula	690402.1,7 690202.1,7	923.01 912.0	Seat back
	Abrasion, lower back	690202.1,8	911.0	Seat back
	Linear abrasion, left calf	890202.1,2	916.0	Unknown
	Linear abrasion, left calf	890202.1,2	916.0	Unknown

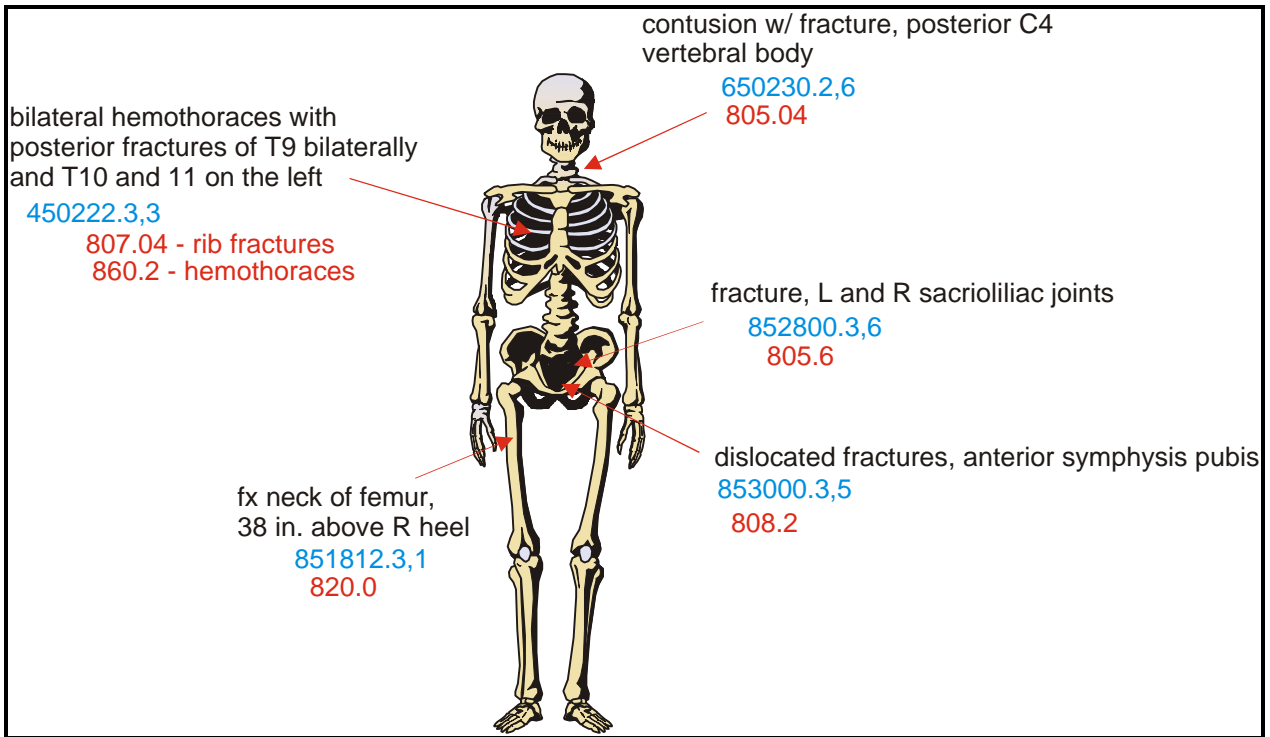
Figure 10. Skeletal injuries

The driver of Vehicle 1 was trapped in his vehicle after the crash and was fatally injured. He sustained a subdural hematoma, a C-4 fracture, bilateral hemothoraces with posterior fractures of T9 bilaterally and T10 and 11 on the left, extensive retroperitoneal hematoma with pelvic fractures, a lacerated bladder, a fractured right femur, and multiple contusions and abrasions.
