**TRANSPORTATION SCIENCES  
CRASH RESEARCH SECTION**

**CALSPAN ON-SITE AIR BAG SUCCESS INVESTIGATION  
CALSPAN CASE NO. CA98-18  
VEHICLE: 1998 FORD ESCORT ZX2  
LOCATION: NEW YORK  
CRASH DATE: JANUARY 1998**

1. <i>Report No.</i> CA98-18	2. <i>Government Accession No.</i>	3. <i>Recipient's Catalog No.</i>	
4. <i>Title and Subtitle</i> Calspan On-Site Air Bag Success Investigation Vehicle: 1998 Ford Escort ZX2 Location: New York		5. <i>Report Date:</i> August, 1999

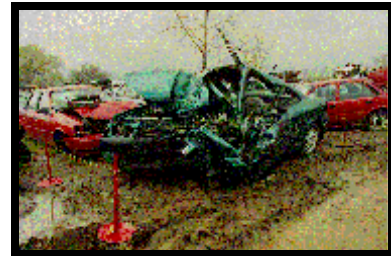
**Figure 1. Frontal damage to the Ford Escort.**

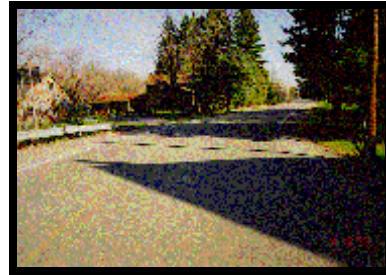
The 20 year old female driver of the Ford Escort had completed a 14 hour work shift at a local ski resort and was returning to her residence. She was traveling in a northerly direction on the two-lane state route at a driver estimated speed of 64 km/h (40 mph). The reconstruction of the crash indicated that her initial travel speed was probably in the 80-89 km/h (50-55 mph) range. On the approach to the crash site, the state route consisted on a series of moderate S-curves which the driver successfully negotiated. As she entered the right curve, the driver continued on a straight line trajectory and crossed the centerline into the southbound travel lane (**Figure 2**).

**Figure 2. Pre-crash trajectory of the Ford Escort.**

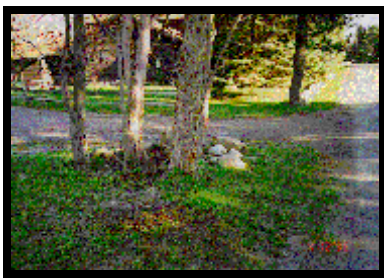
The front left area of the Ford Escort impacted a 35.6 cm (14.0") diameter tree that was located 3.6 m (12.0') outboard of the west edge line (**Figure 3**). The impact speed was computed at 77.0 km/h (47.8 mph) by the damage and trajectory algorithm of the WinSMASH program. The 12 o'clock direction of force impact crushed the frontal structure to a maximum depth of 114.3 cm (45.0"), located 25 cm (10") left of the vehicle's centerline, directly outboard of the driver's position (**Figure 4**). The speed change was computed at 68.0 km/h (42.3 mph) by the WinSMASH program. Due to the 12 o'clock impact force, the longitudinal component equaled the total speed change of 68.0 km/h. As a result of the severe frontal impact, the vehicle's frontal driver and passenger air bags deployed.

**Figure 3. Struck tree and final rest position of the Escort.**

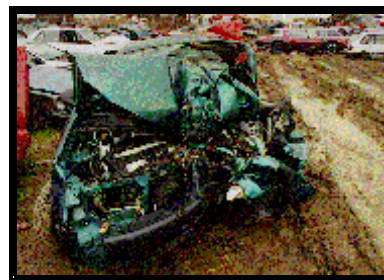
**Figure 4. Frontal damage to the Ford Escort.**

The Ford crushed to maximum engagement and initiated a counterclockwise (CCW) rotation as the vehicle traveled to rest. The Escort rotated approximately 36 degrees CCW before coming to rest engaged against the struck tree. Although the damage to the vehicle was rated as severe, the tree sustained minimal bark damage.

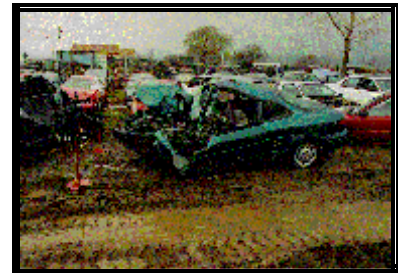
The Ford Escort sustained severe frontal damage as a result of the tree impact sequence (**Figure 5**). Maximum crush was 114.3 cm (45.0") located on the front bumper fascia, 25 cm (10") left of center. The crush profile was located directly outboard of the driver's compartment. The direct contact damage began at the vehicle's centerline (on the hood face) and extended 33.0 cm (13.0") to the left. The narrow impact deformed the frontal structure in a U-configuration which resulted in a combined induced and direct contact damage length (Field L) of 68.6 cm (27.0"). This measurement extended from corner-to-corner across the bumper reinforcement bar, parallel to the reference line which reflected the original length of the vehicle. The left bumper corner was displaced rearward while the right corner was displaced both rearward [99.1 cm (39")] and laterally [61 cm (24")]. The impact separated the bumper fascia from the reinforcement bar, therefore the crush profile was documented at the reinforcement bar (**Figure 6**). The crush profile was as follows: C1 = 99.1 cm (39.0"), C2 = 114.3 cm (45.0), C3 = 69.9 cm (27.5"), C4 = 48.3 cm (19.0"), C5 = 20.2 cm (8.0"), C6 = 18.7 cm (7.4").

The 12 o'clock direction of force impact displaced the frontal structure rearward resulting in a Collision Deformation Classification (CDC) extent zone of 6, which extended rearward of the original base of the windshield. The overall CDC for this impact sequence was 12-FYEN-6. The frontal deformation reduced the left wheelbase by 70.4 cm (27.7") and the right wheelbase by 5.1 cm (2.0").

**Figure 5. Left side view of the crush profile.**

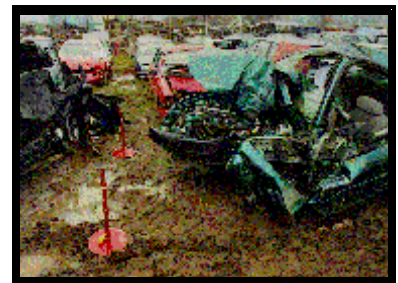
**Figure 6. Close-up view of the severe frontal crush.**

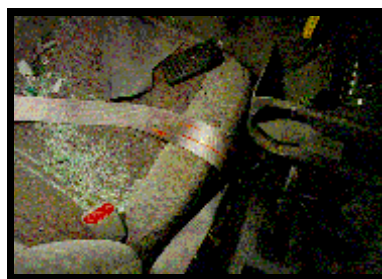
The orange fabric (clothing) transfers were embedded into both sides of the belt webbing as the driver loaded the belt and compressed the webbing into her thoracic area. The lower aspect of the webbing at the left hip/abdominal regions probably folded over as the driver loaded the system which contributed to the transfers occurring on both sides of the webbing. The heaviest area of the fabric transfer occurred to the inner aspect of the webbing (side against driver) and extended 4.1 cm (1.6") below to 19.1 cm (7.5") above the latchplate stop button. The transfer consisted of three longitudinally oriented transfers that were parallel to the length of the webbing. The second area of orange fabric was on the forward aspect of the webbing located 8.6 cm (3.4") below the referenced stop button to 1.9 cm (0.75") above the button. The transfer extended longitudinally across the rear third aspect of the webbing.

**Figure 7. Orange fabric transfers embedded into the belt webbing.**

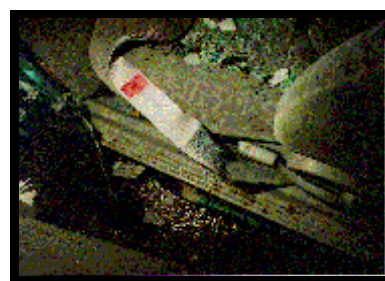
Driver loading against the belt webbing fully deployed the management loop. This was accomplished by complete separation of the stitching which provided an additional 23.4 cm (9.25") of length to the lap belt webbing (**Figure 8**). The elongation of the belt loop provided the driver with a greater ridedown of the belt system and contact with the fully deployed driver air bag which provided additional ridedown from the crash forces. In the fully deployed mode, the red Replace Belt label became visible as it extended 20.3 cm (8.0") above the floor mounted vinyl sleeve. This label provided a visual advisement to repair personnel to replace the belt system in a repairable crash.

**Figure 8. Deployed energy management loop.**

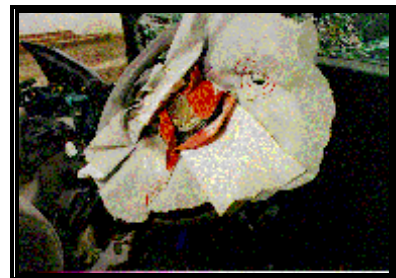
Although the driver air bag was cut from the vehicle, a large segment of the forward panel remained which contained the vent ports and tether straps. The bag was vented by two 2.5 cm (1.0") diameter ports located at the 10 and 2 o'clock sectors. Two 10.2 cm (4.0") wide band tether straps were positioned at the 12 and 6 o'clock sectors (**Figure 9**). The identification number of 011792R was stamped onto the bag membrane at the 6 o'clock sector.

**Figure 9. Vent ports and internal tethers of the driver air bag.**

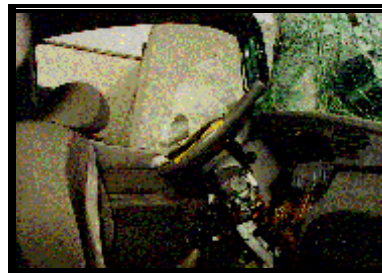
At impact, the supplemental frontal driver and passenger air bags deployed as the driver initiated a forward trajectory in response to the 12 o'clock impact force. She initially loaded the manual restraint system as evidenced by the fabric transfers and the deployment of the energy management loop. The belt system provided the driver with a ridedown effect as she loaded the air bag. Due to the high delta V crash, the driver compressed the bag against the steering wheel rim which resulted in 3.8 cm (1.5") of upper rim displacement. The bag provided the driver with an additional ridedown to the severe crash forces (**Figure 11**). The driver sustained a right orbital contusion that resulted from bag loading and a concussion with brief loss of conscious from restraint (belt and bag) loading and the impact force.

**Figure 10. Driver loading of the air bag and steering assembly.**
