# INDIANA UNIVERSITY

## TRANSPORTATION RESEARCH CENTER

## REMOTE AIR BAG DEPLOYMENT REPORT

CASE NUMBER - IN98-020  
LOCATION - Texas  
VEHICLE - 1994 FORD PROBE  
CRASH DATE - February 1997

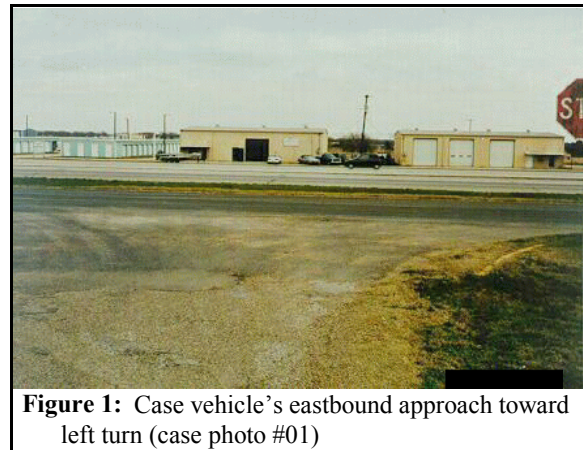
The case vehicle was traveling east in the eastbound lane of a two-lane, undivided city street, approaching the cap of a Tee intersection and intending to turn left to travel northbound (**Figure 1**). The other vehicle was traveling south in the southbound lane of the intersecting two-lane, undivided frontage road, and intended to continue southbound. The case vehicle's driver cut the corner sharply and was traveling north in the southbound lane. The case vehicle's driver had taken her foot off the accelerator and was reaching for the brake when the crash occurred. The driver of the other vehicle steered to the left and braked, attempting to avoid the crash.

**Figure 1:** Case vehicle's eastbound approach toward left turn (case photo #01)

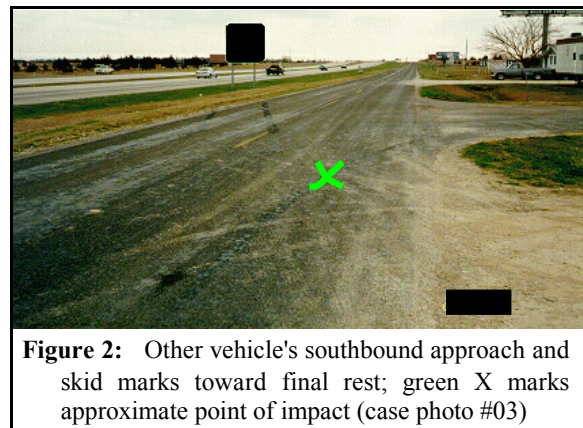
The crash occurred in the southbound lane, immediately north of the intersection. The front right corner of the case vehicle impacted the right front corner of the other vehicle, causing the case vehicle's driver and front right air bags to deploy (**Figure 2**). The case vehicle was slightly redirected in a northeasterly direction and came to rest a short distance from the point of impact. The other vehicle's avoidance maneuvers resulted in the vehicle entering the northbound lane, leaving approximately 10 meters [33 feet] of skid marks prior to coming to final rest. At final rest, the other vehicle was positioned partially off the east edge of the roadway in the northbound lane heading south-southeast.

**Figure 2:** Other vehicle's southbound approach and skid marks toward final rest; green X marks approximate point of impact (case photo #03)

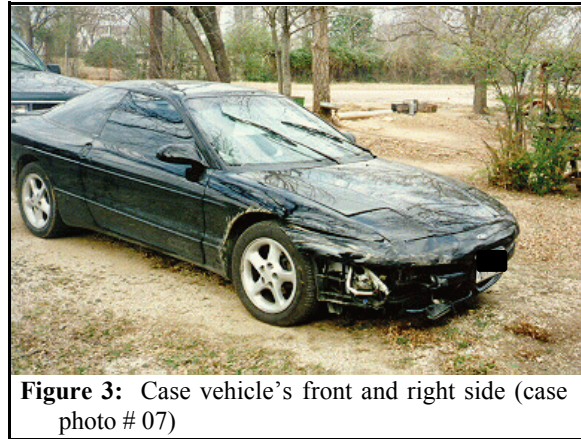
Based on the available photographs, direct contact extended from the case vehicle's front right bumper corner inward nearly to the center of the front bumper (**Figure 3**). The damage indicates that the case vehicle's front probably underrode the other vehicle's right front bumper corner and right front side. The corner of the case vehicle's fiberglass front right bumper fascia was torn away (**Figure 4**). Neither of the front tires appear to be physically restricted from the impact damage. The lower right area of the windshield was cracked due to contact by the front right air bag's cover flap during its deployment. The upper right portion of the windshield had a diagonal slit and was pushed outward as a result of contact by the front right passenger (**Figure 5**).

The case vehicle was towed, but not due to damage. Based on the available photographs, the visually estimated CDC is: **11-FZEW-1 (340)** for the case vehicle. Because of the swiping-type nature of this crash, no reconstruction program was used. This contractor's visually estimated Delta V is 10 - 14 km.p.h. [6 - 9 m.p.h.], indicating a crash of minor severity.

**Figure 3:** Case vehicle's front and right side (case photo # 07)

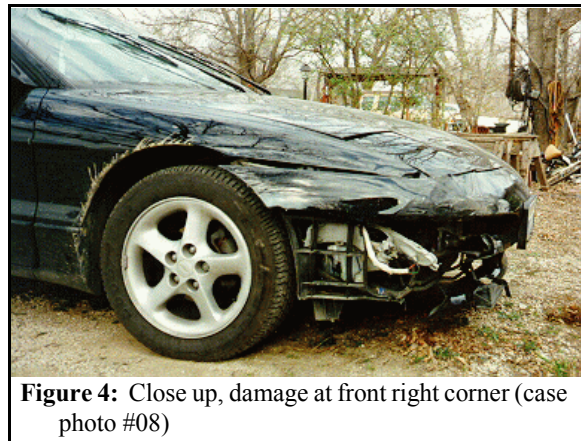
**Figure 4:** Close up, damage at front right corner (case photo #08)

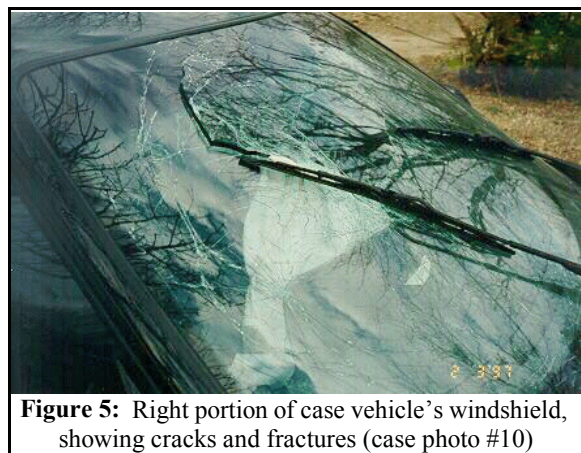
**Figure 5:** Right portion of case vehicle's windshield, showing cracks and fractures (case photo #10)

The front right passenger air bag was mounted on the mid-instrument panel location. The available photographs indicate that the single cover flap opened at the designated tear points, with no obvious damage to the cover flap or the air bag. The cover flap contacted the windshield, cracking the glazing and probably abrading the flap (**Figure 5**).

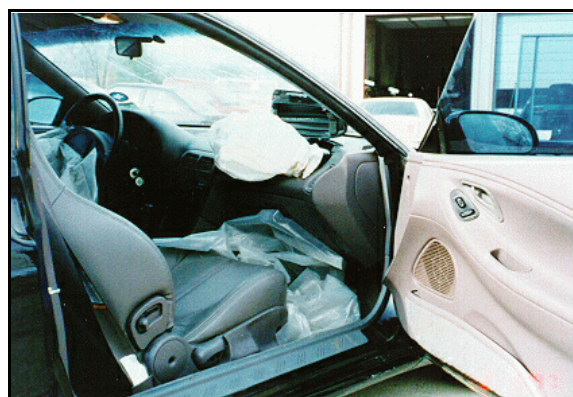
Immediately prior to the crash the case vehicle's front right passenger was seated upright with his back against the seat back, both feet dangling over the front edge of the seat's cushion angled downward, and both his arms at his side. According to the case vehicle's driver, the front right passenger's seat track was located in its middle position, and the seat back was upright. Based on the interior photographs, the front right seat track appears to be between the middle and forward most position (**Figure 6**).

**Figure 6:** Case vehicle's front right seating area showing deployed front air bags and interior surface of right front door (case photo #12)

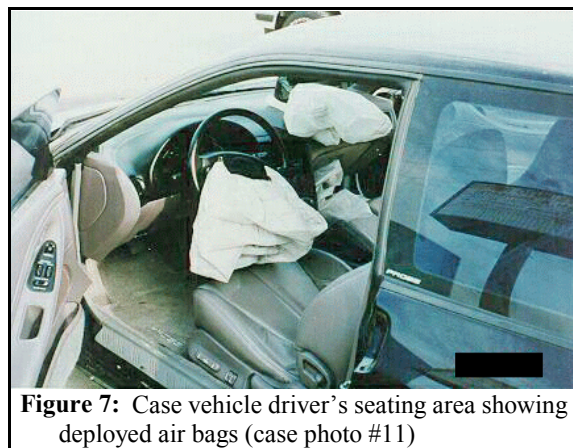
**Figure 7:** Case vehicle driver's seating area showing deployed air bags (case photo #11)

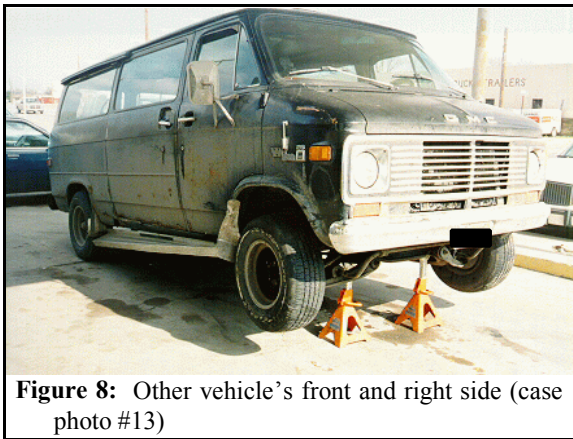
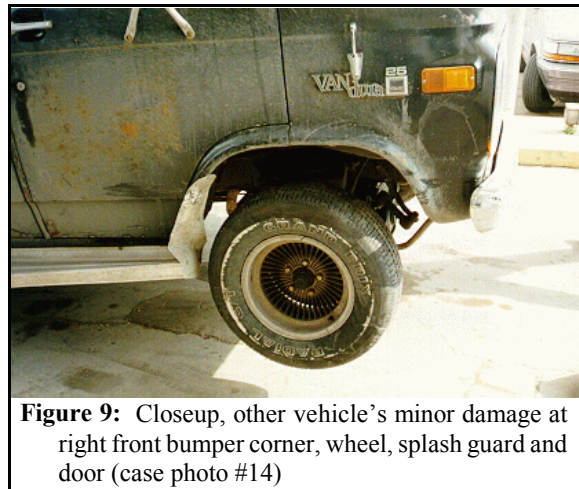
Based on the available photographs, damage to the van indicates a swiping-type engagement concentrated to the right front fender, wheel assembly, splash guard and door. The CDC was visually estimated to be **12-RYES-1 (10)** for the van. This contractor's visually estimated Delta V is 10 - 14 km.p.h. [6 - 9 m.p.h.], indicating a crash of minor severity.
