Remote Investigation / Vehicle to Vehicle Dynamic Science, Inc., Case Number (DS98021) Colorado October, 1997 This document is disseminated under the sponsorship of the Department of Transportation in the interest of information exchange. The United States Government assumes no responsibility for the contents or use thereof.

Technic	cal Report Documentation Page	
1. Report No. DS98021	2. Government Accession No.		3. Recipient Catalog No.	
4. Title and Subtitle In-Depth Accident Invest	tigation		5. Report Date October 1998

Dynamic Science, Inc. Accident Investigation Case Number: DS98021

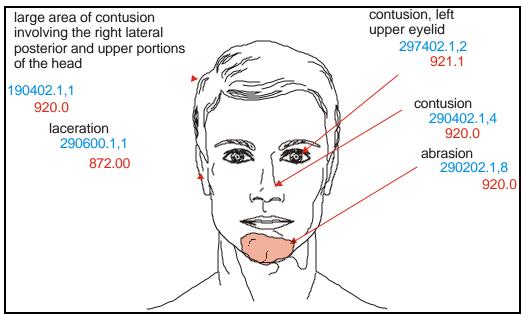
<u>INJURY</u>	OIC CODE	<u>ICD-9</u>	<u>SOURCE</u>
Case vehicle				
Driver:	Contusion, under and lateral aspects of the temperoparietal and occipital areas of the left cerebral hemisphere	140604.3,3	851.06	Possibly roof and/or B-pillar
	Fracture, extension of posterior fracture laterally and then inward to involve both the temporal fossa and the sphenoid bone	150200.3,8	801.2	Possibly roof and/or B-pillar
	"L" shaped fracture right posterior surface of skull	150400.2,1	800.2	Possibly roof and/or B-pillar
	35 cc subdural hemorrhage	140438.4,6	NA	Possibly roof and/or B-pillar
	Bilateral subarachnoid hemorrhage	140466.3,6	NA	Possibly roof and/or B-pillar
	Fracture, right clavicle	752200.2,1	810.0	Air bag
	Large area of contusion involving right lateral posterior and upper portions of the head	190402.1,1	920.0	Possibly roof and/or B-pillar
	Laceration, right ear	290600.1,1	872.0	Side glass (flying)
	Contusion, left upper eyelid	297402.1,2	921.1	Air bag

Contusion, nose	290402.1,4	920.0	Air bag
	Abrasion, chin	290202.1,8	920.0	Air bag
	Ecchymoses, lateral aspect, both forearms	790402.1,1 790402.1,2	923.10 923.10	Air bag
	Laceration, tip of middle finger	790600.1,2	883.0	Side glass (flying)
	Abrasion, left knee	890202.1,2	916.0	IP
	Abrasion, lower leg	890202.1,2	916.0	IP

Figure 6. Facial injuries, driver, case vehicle

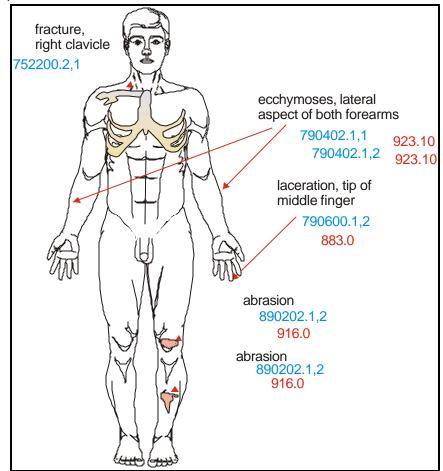
Figure 7. Soft tissue injuries, driver, case vehicle

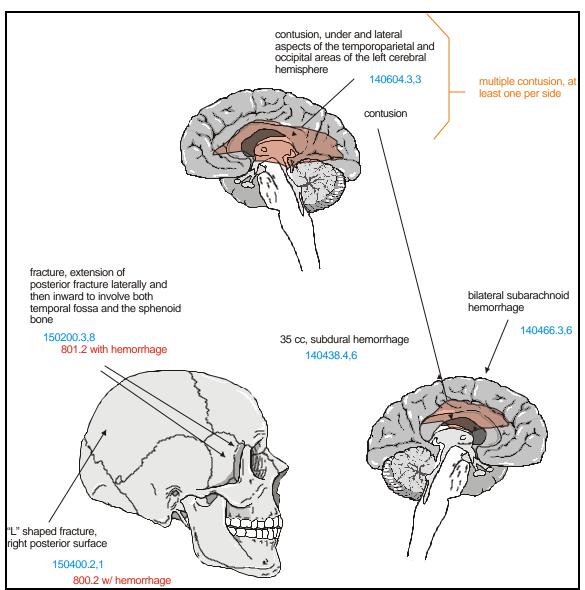
According to the autopsy report, the driver of the case vehicle sustained a series of closed head injuries that included a scalp contusion, skull fractures, cerebral contusions, subarachnoid hemorrhage, subdural hemorrhage, and intra-ventricular hemorrhage; he also sustained a right clavicle fracture. At this point in time, it seems that the air bag caused the facial injuries, and the air bag may have pushed the head backwards or upwards into a hard interior surface.

Figure 8. Skull/brain injuries, driver, case vehicle

The driver of the case vehicle was likely seated upright in a normal position. It is this investigator's opinion that he had both hands on the steering wheel. He was not wearing the available lap and shoulder belt. The case vehicle was in the midst of a left-hand turning maneuver. At some point in this turn, the driver of the Volvo began braking. The driver of the case vehicle likely looked toward his right upon hearing the braking sounds. At impact, the driver moved forward and to the right, bringing his left knee and lower leg into contact with the instrument panel. The air bag deployed at this point, striking the driver fully in the face; this caused the contusion to the eye and nose and the abrasion to the chin. As the air bag deployed laterally, both lower arms were contacted and sustained contusions. The right window disintegrated and the flying glass appears to have caused the right side finger and ear lacerations. The deploying air bag forced the driver's head upward and possibly to the left. It appears likely that the rear/top of the driver's head struck either the roof or possibly the B-pillar, causing the skull fractures and resultant brain injuries.
